As per Blackwater Gold's Accidents and Malfunctions Management Plan, the information below acts as the 30-day follow up report to the "Initial Incident Report – June 24, 2025" submitted on June 25, 2025.

Blackwater
Mine

30 Day Follow up Report

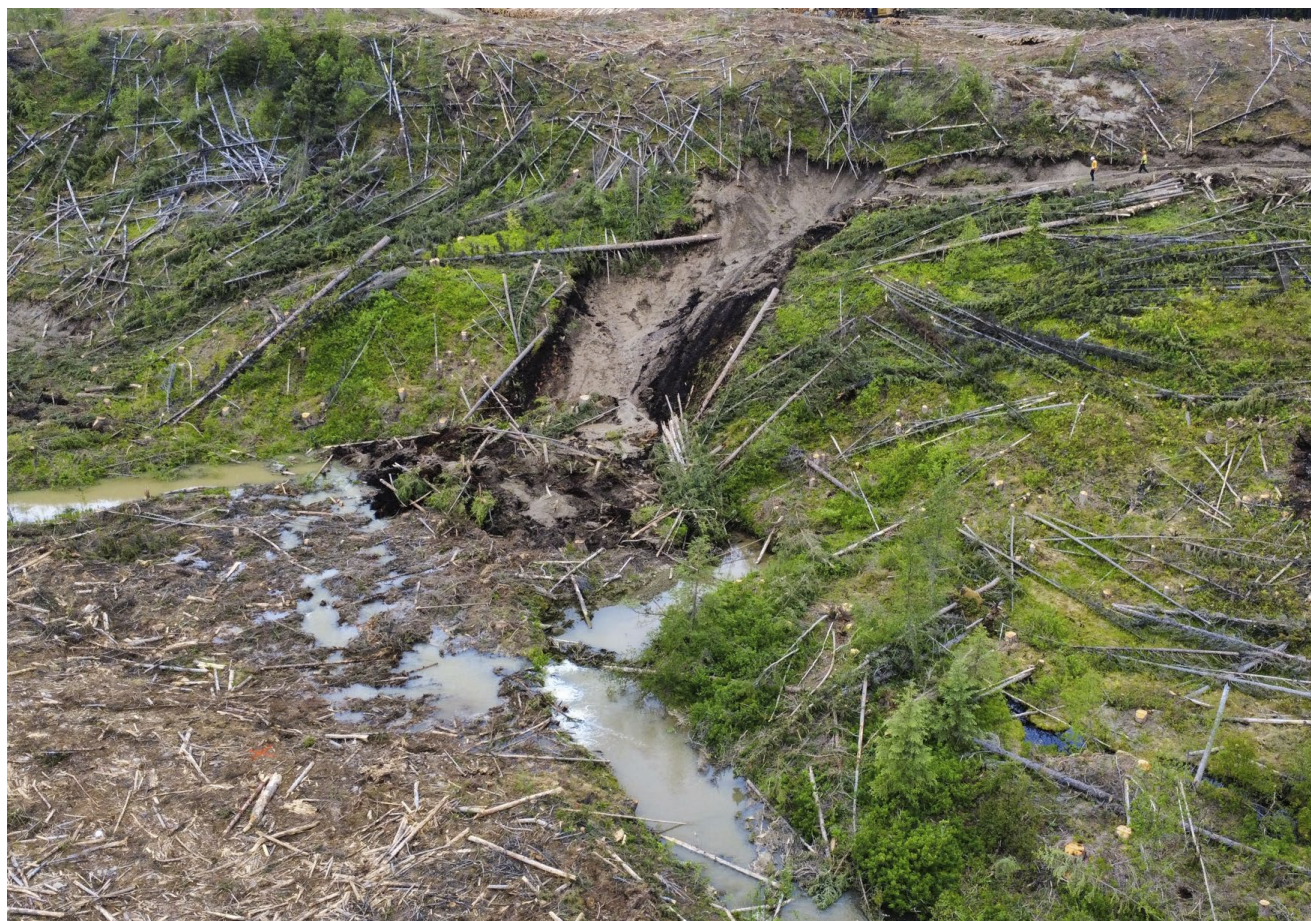
While logging in the footprint of the Freshwater Reservoir (FWR), a saturated slope was identified requiring special procedures. The area was hand felled to avoid mechanical equipment in the area. However, during timber recovery, the slope failed, and material entered Davidson Creek below. Approximately 322 m³ of material was estimated to have sloughed.

Photo 2. Aerial overview of slope failure impacting Davidson Creek post-incident.

After the incident occurred, the assessment concluded the area was stable and the results of the post-incident sampling confirmed that no significant impacts were observed as a result. Therefore, the area was left in situ and monitored to minimize further impacts to the creek. Fish salvage activities related to the upcoming FWR construction works ensured the affected area was removed of fish on July 20th. Remaining material to be removed will be completed through the construction of the FWR which has commenced.

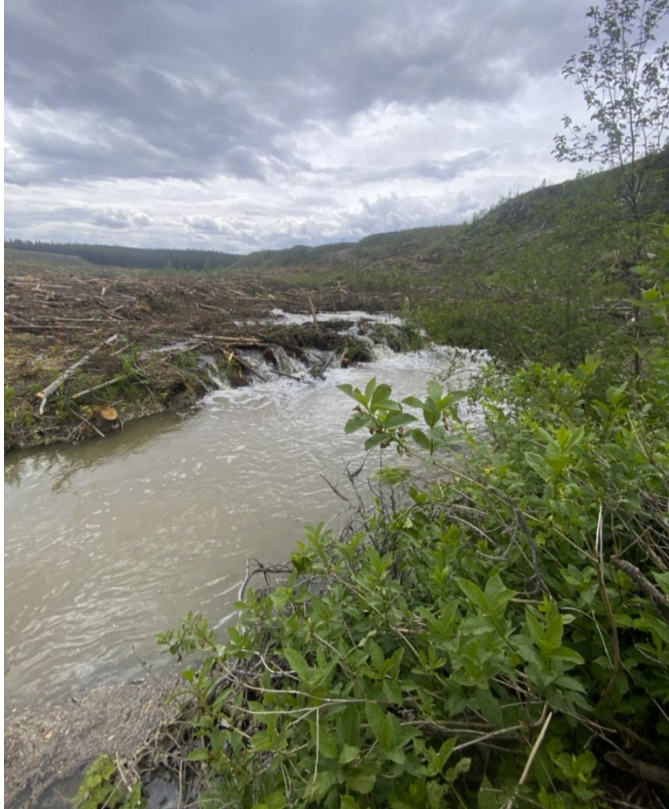
Flows in Davidson Creek were briefly impacted by material entering the creek. However, flows returned to previous levels shortly after the incident occurred as the creek naturally travelled around the area where material entered the creek walks were completed once environment personnel arrived at the scene and did not identify any stranding or mortalities.

Photo 3. Ground photo depicting water circumventing the failure location and returning to Davidson Creek downstream.

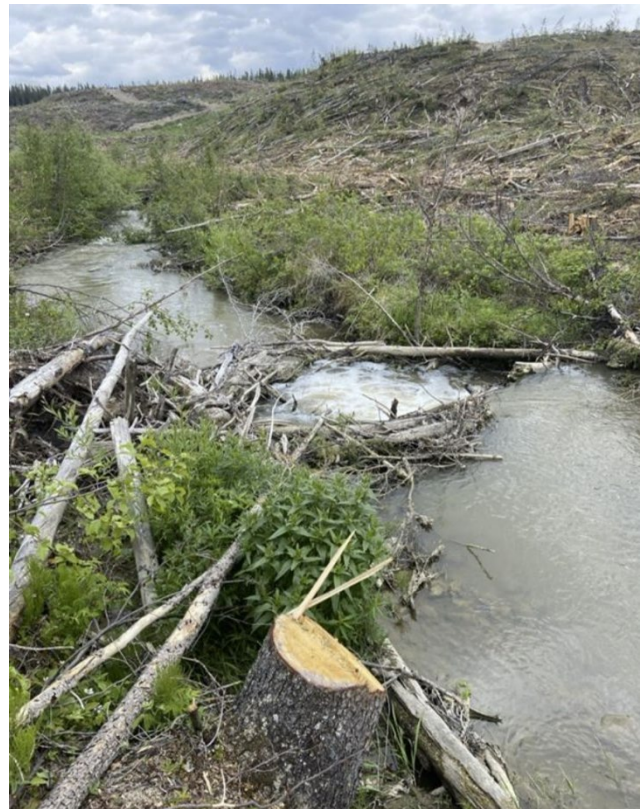
Photo 4. Downstream ground photo of Davidson Creek confirming wetted stream width maintained post-incident.

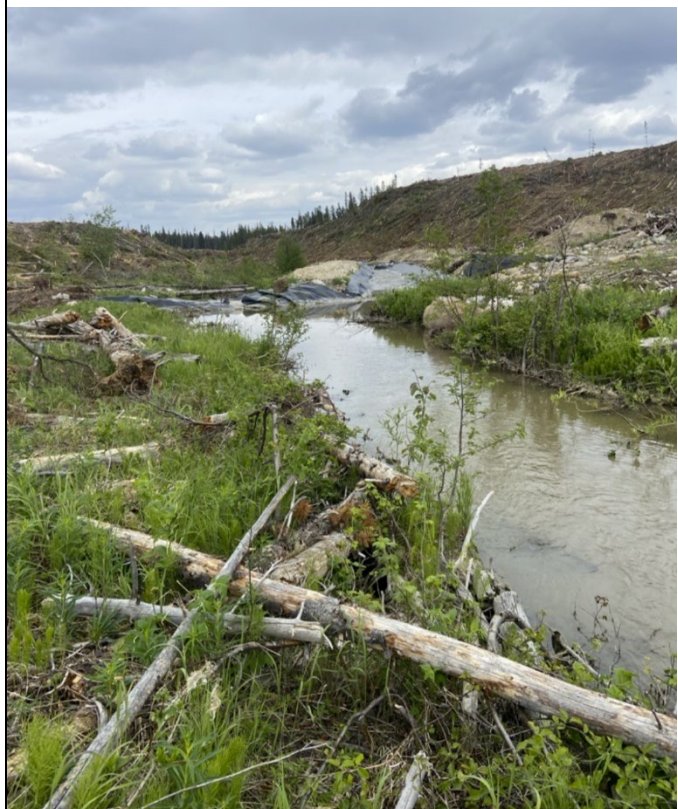
Photo 5. Downstream ground photo of Davidson Creek confirming wetted stream width maintained post-incident.
