Prepared for
BW Gold Ltd.
3083-595 Burrard Street
Vancouver, British Columbia V7X 1L3
Canada

Prepared by
Knight Piésold Ltd.
1400-750 West Pender Street
Vancouver, British Columbia V6C 2T8
Canada

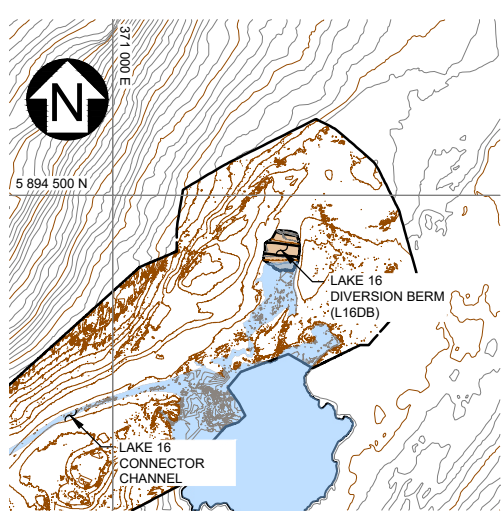
INSET
LAKE 16 DIVERSION BERM
SCALE A

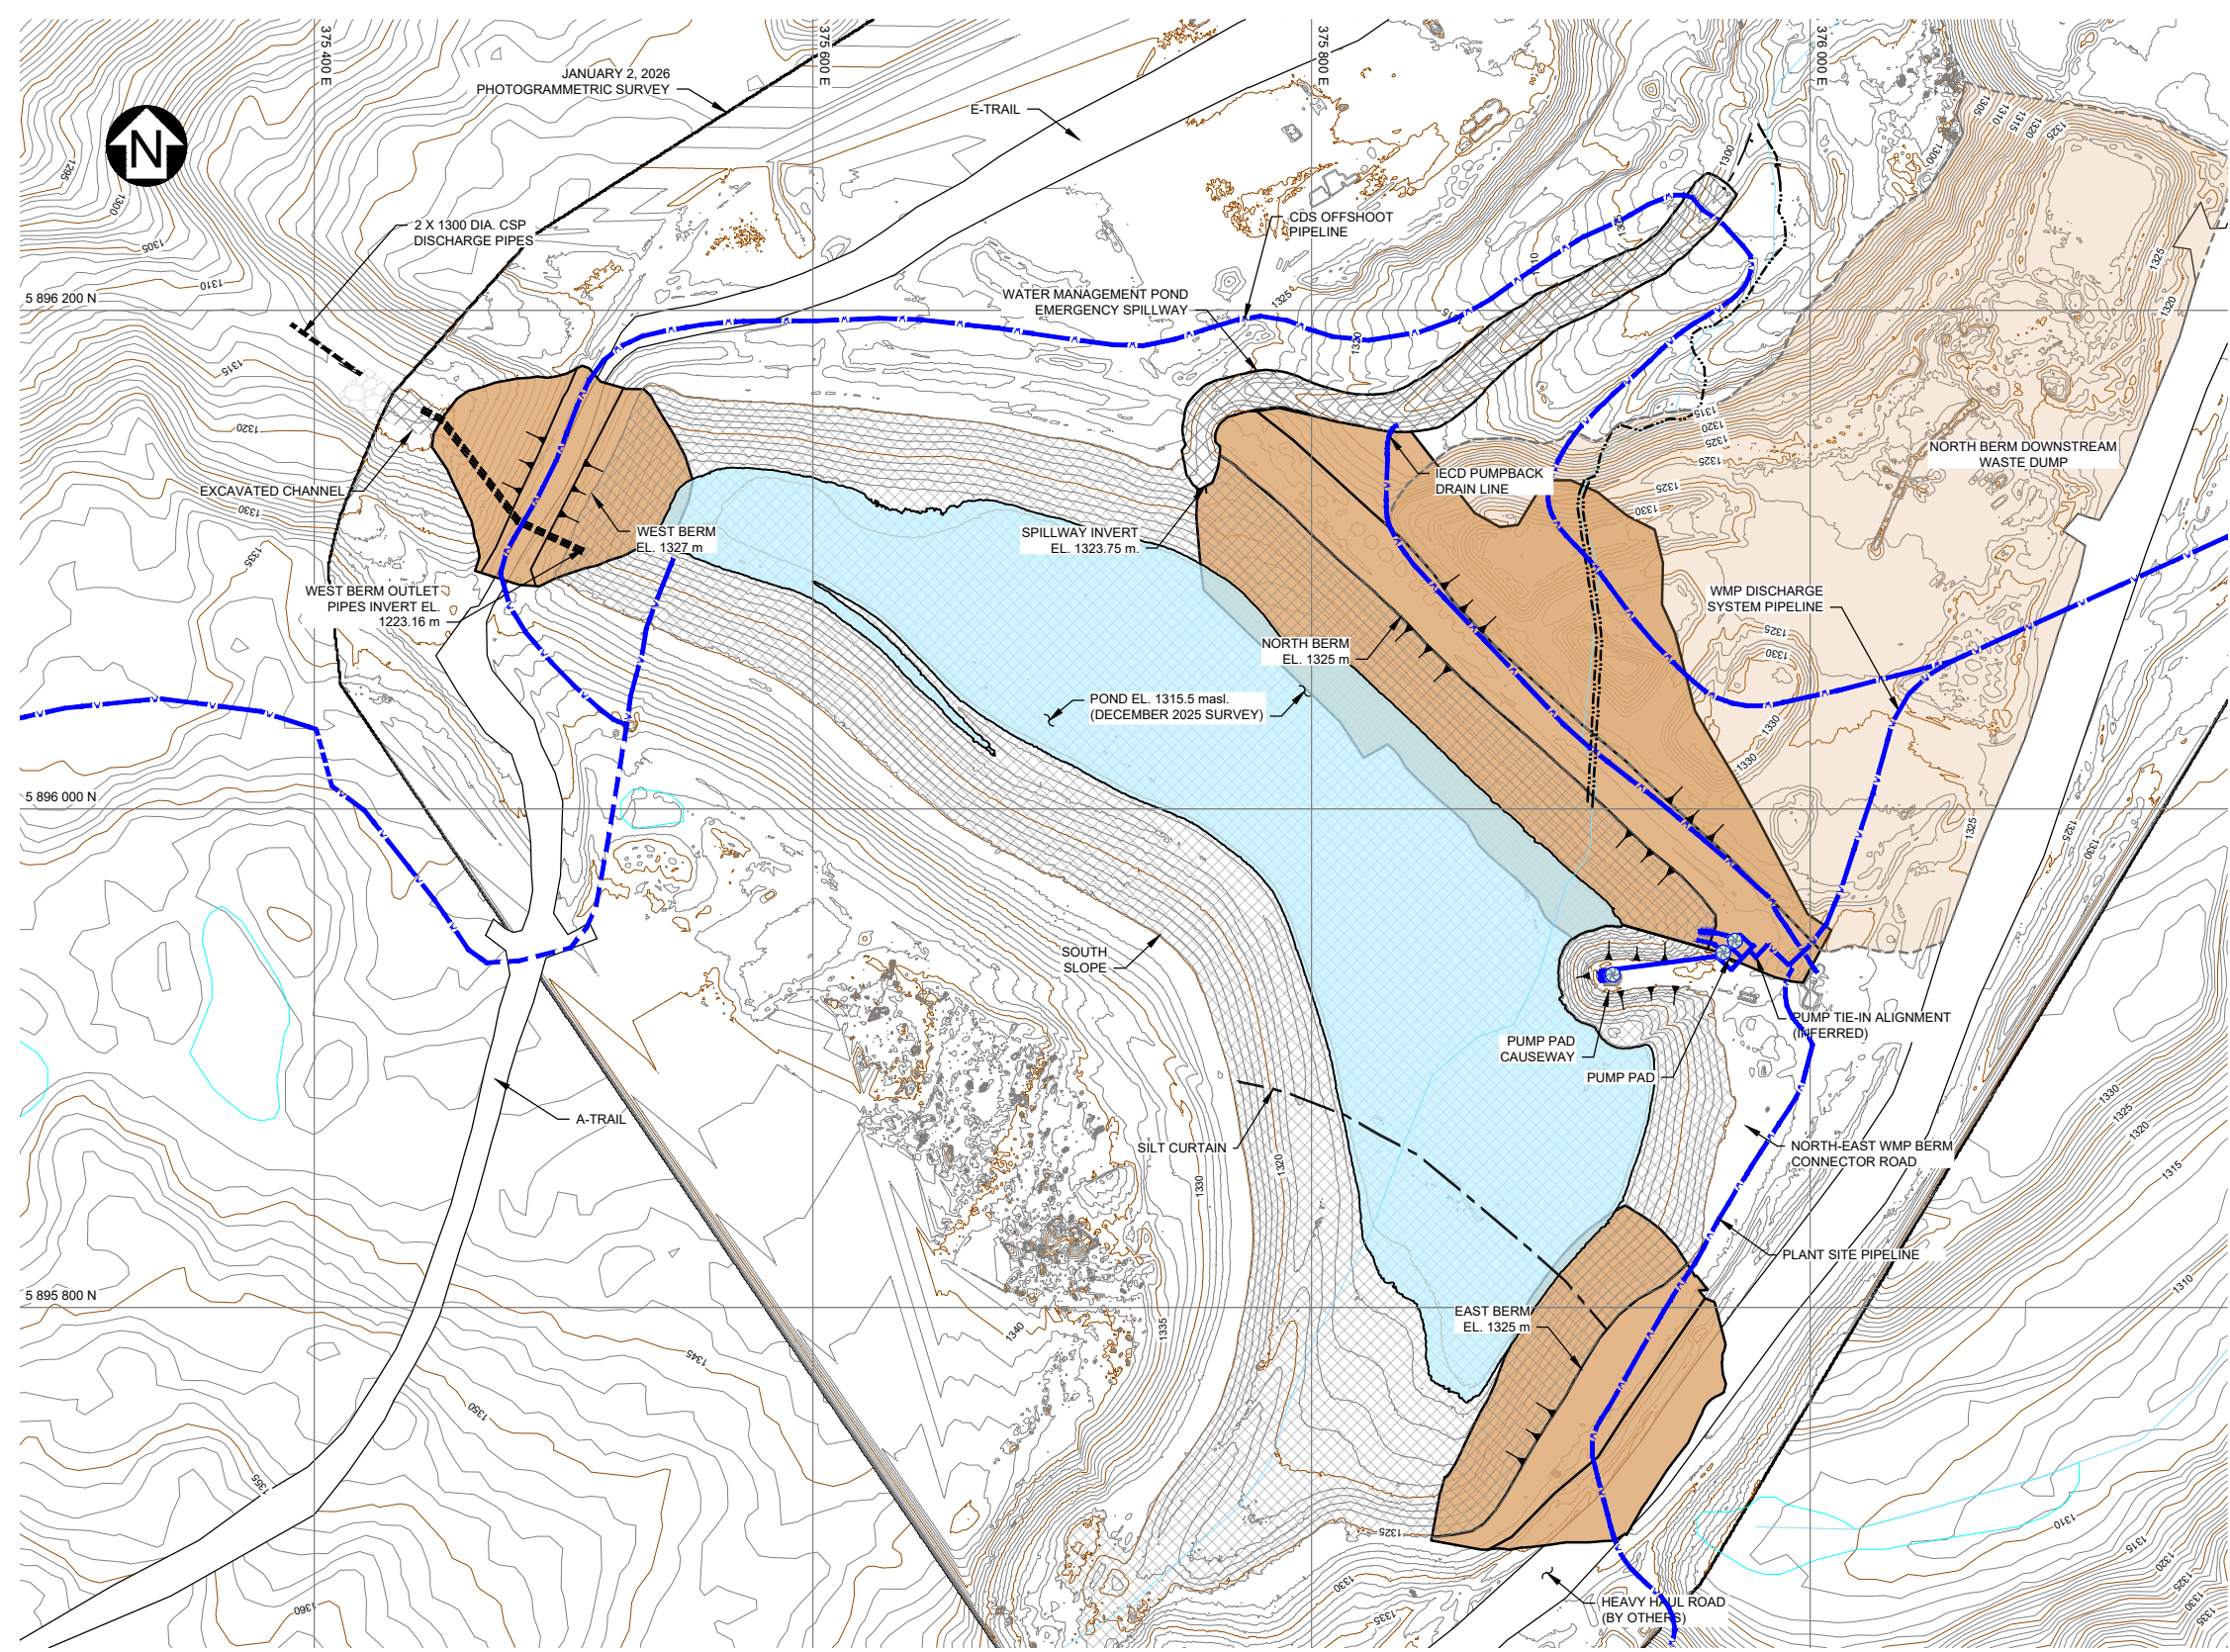
SAVED: W:\PLVA-PI\8110045758\AA\ca\8\FIGS\B21_3182026 9:25:02 AM - RM\LELLAN PRINTED: 3/27/2026 11:36:24 AM FIG 4.1 - NDHALIWA ACAD VERSION: 25.05 (LMS TECH)
 XREF FILES: Hydro; topo; tm; contours; Designed; Trains; WMP; discharge; access; road; Polishing; Pond; Mine Area; Creek; Liner; WMP; Dore; Flyover; 2025-01-12; WMP; ASB; Spillway; TPO; Dore; Flyover; 2024-01-02; Water Management Pond; IMAGE FILES;

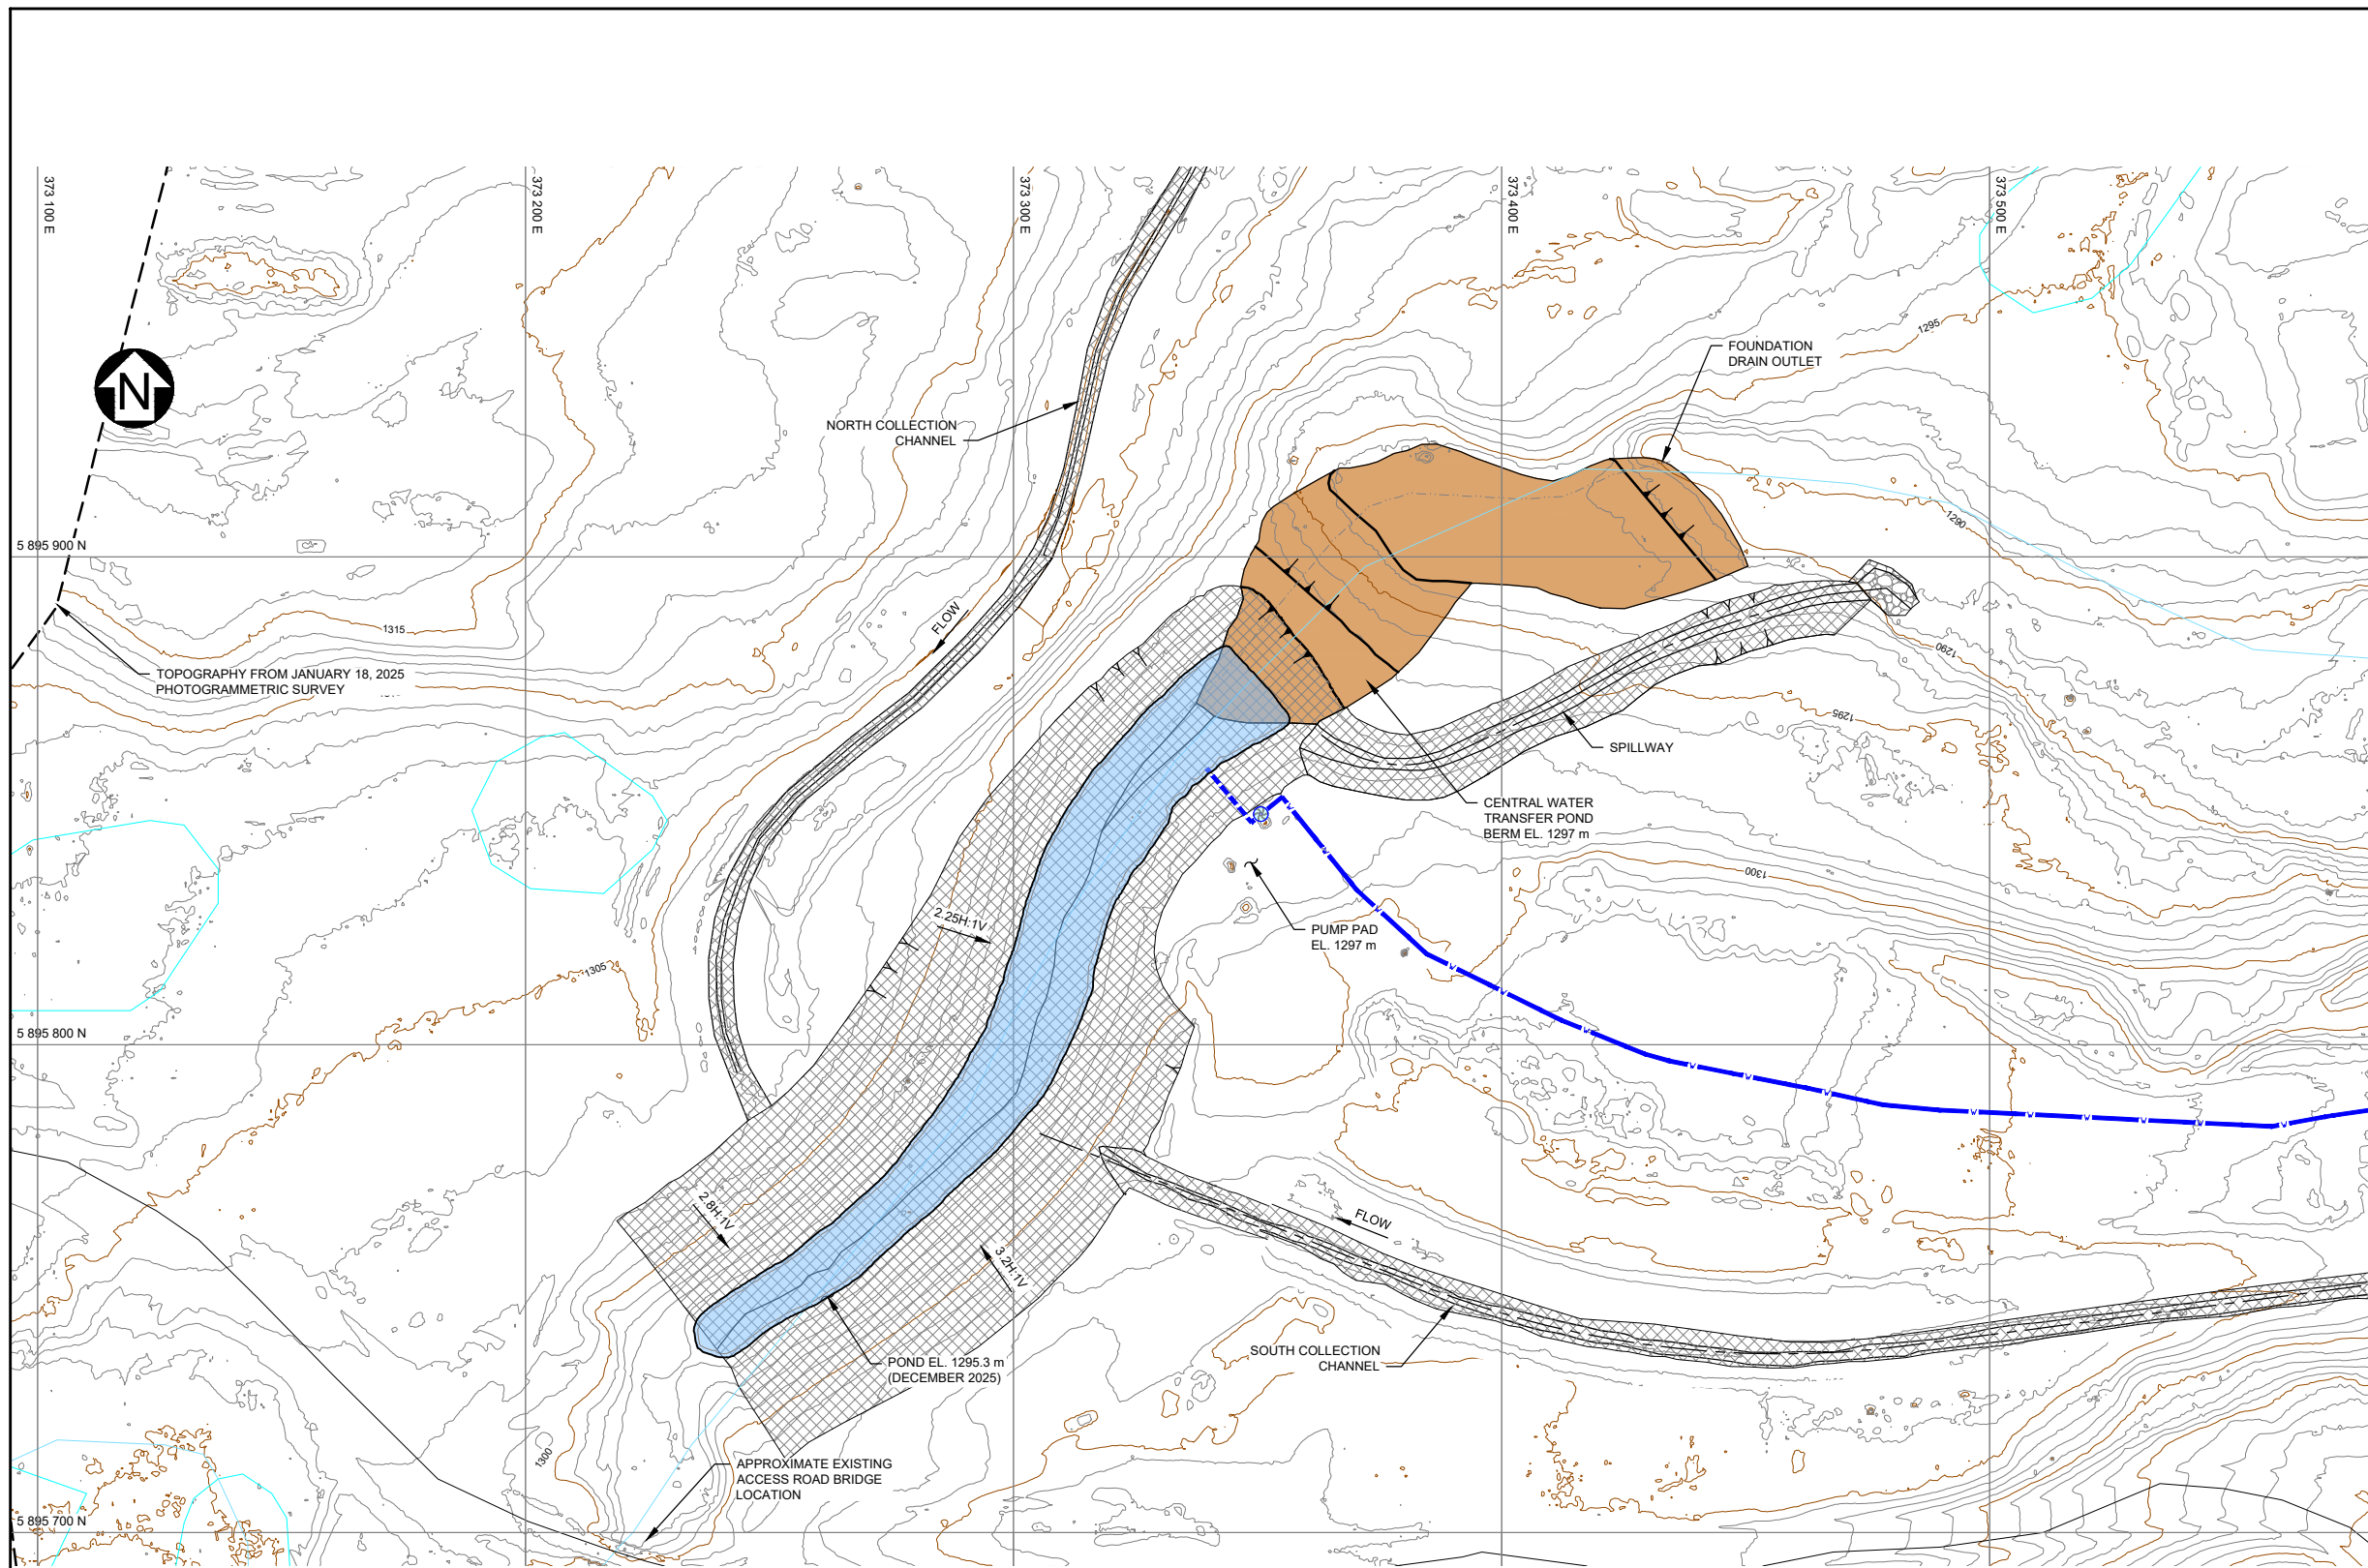
- LEGEND:**
- EMBANKMENT FILL
 - ZONE G
 - HDPE LINER
 - FRESH WATER
 - EXISTING ACCESS TRAILS
 - FOUNDATION DRAIN
 - CDS DISCHARGE PIPELINE (AS-BUILT)
 - PUMP

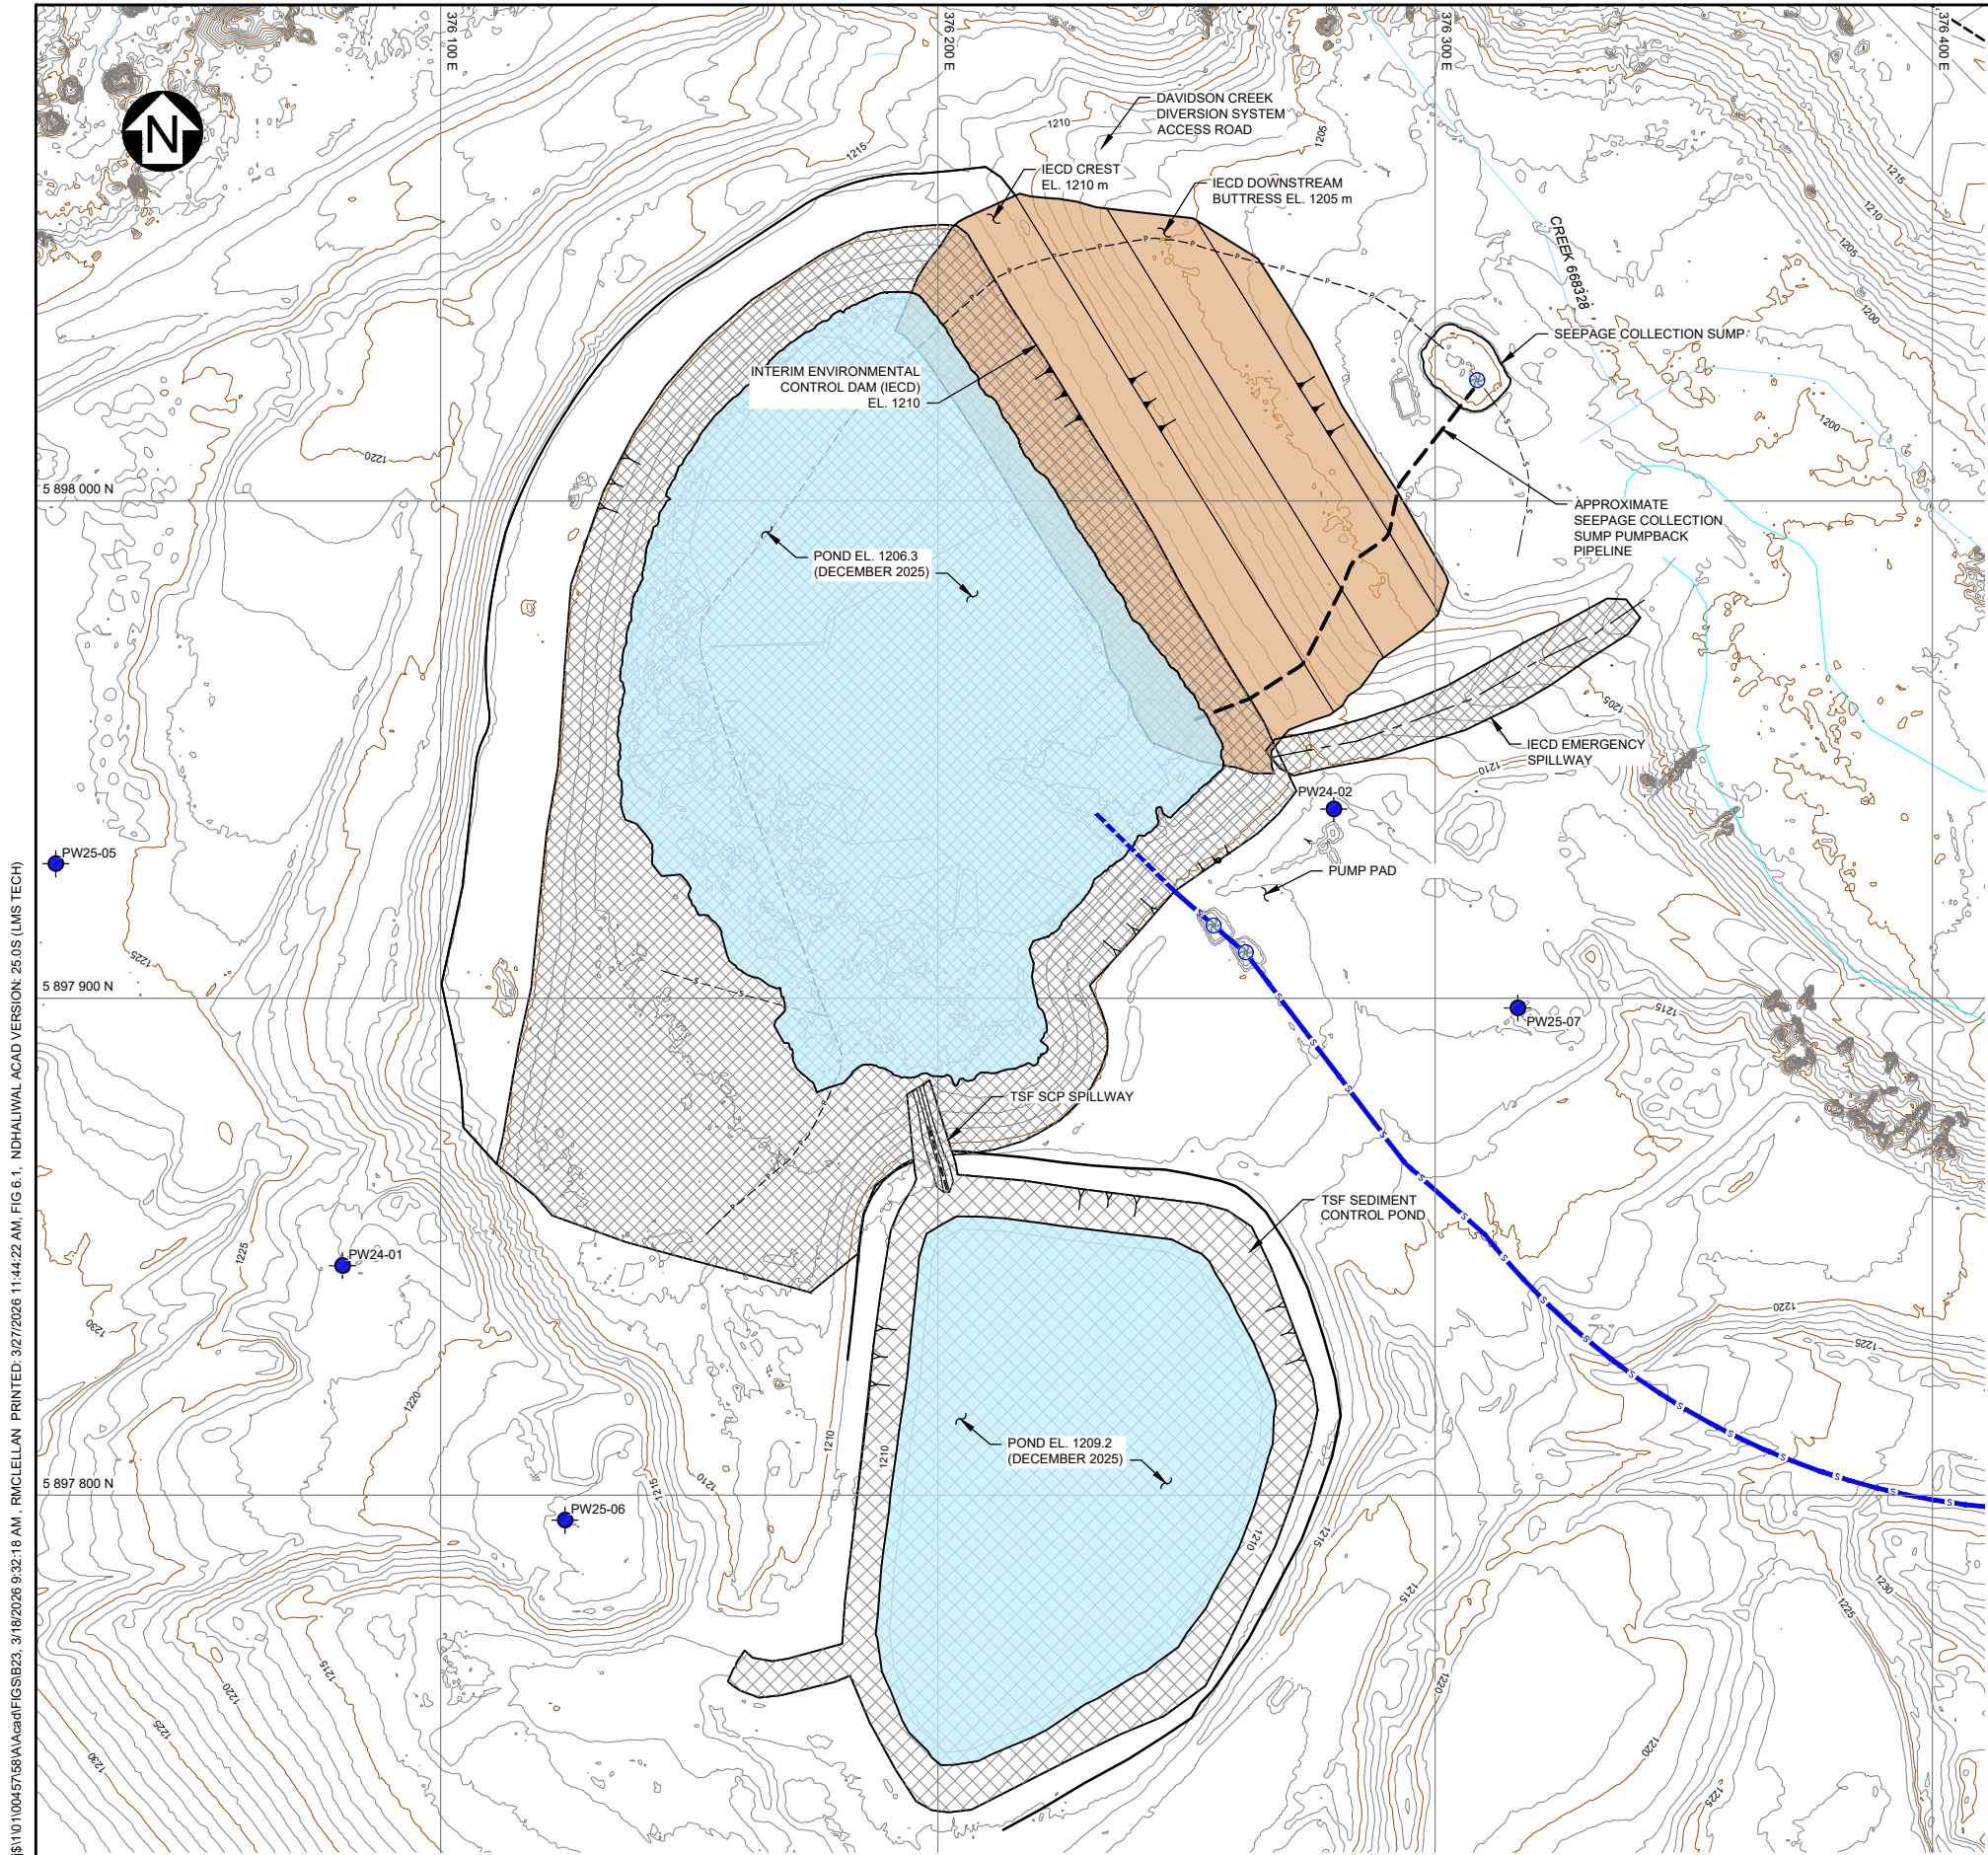
- LEGEND:**
- EMBANKMENT FILL
 - HDPE LINER
 - MINE WATER
 - PUMP
 - SEEPAGE PUMPBACK PIPELINE (DESIGN)
 - PRIMARY FOUNDATION DRAIN
 - SECONDARY FOUNDATION DRAIN
 - ACCESS ROAD
 - PUMPING WELL

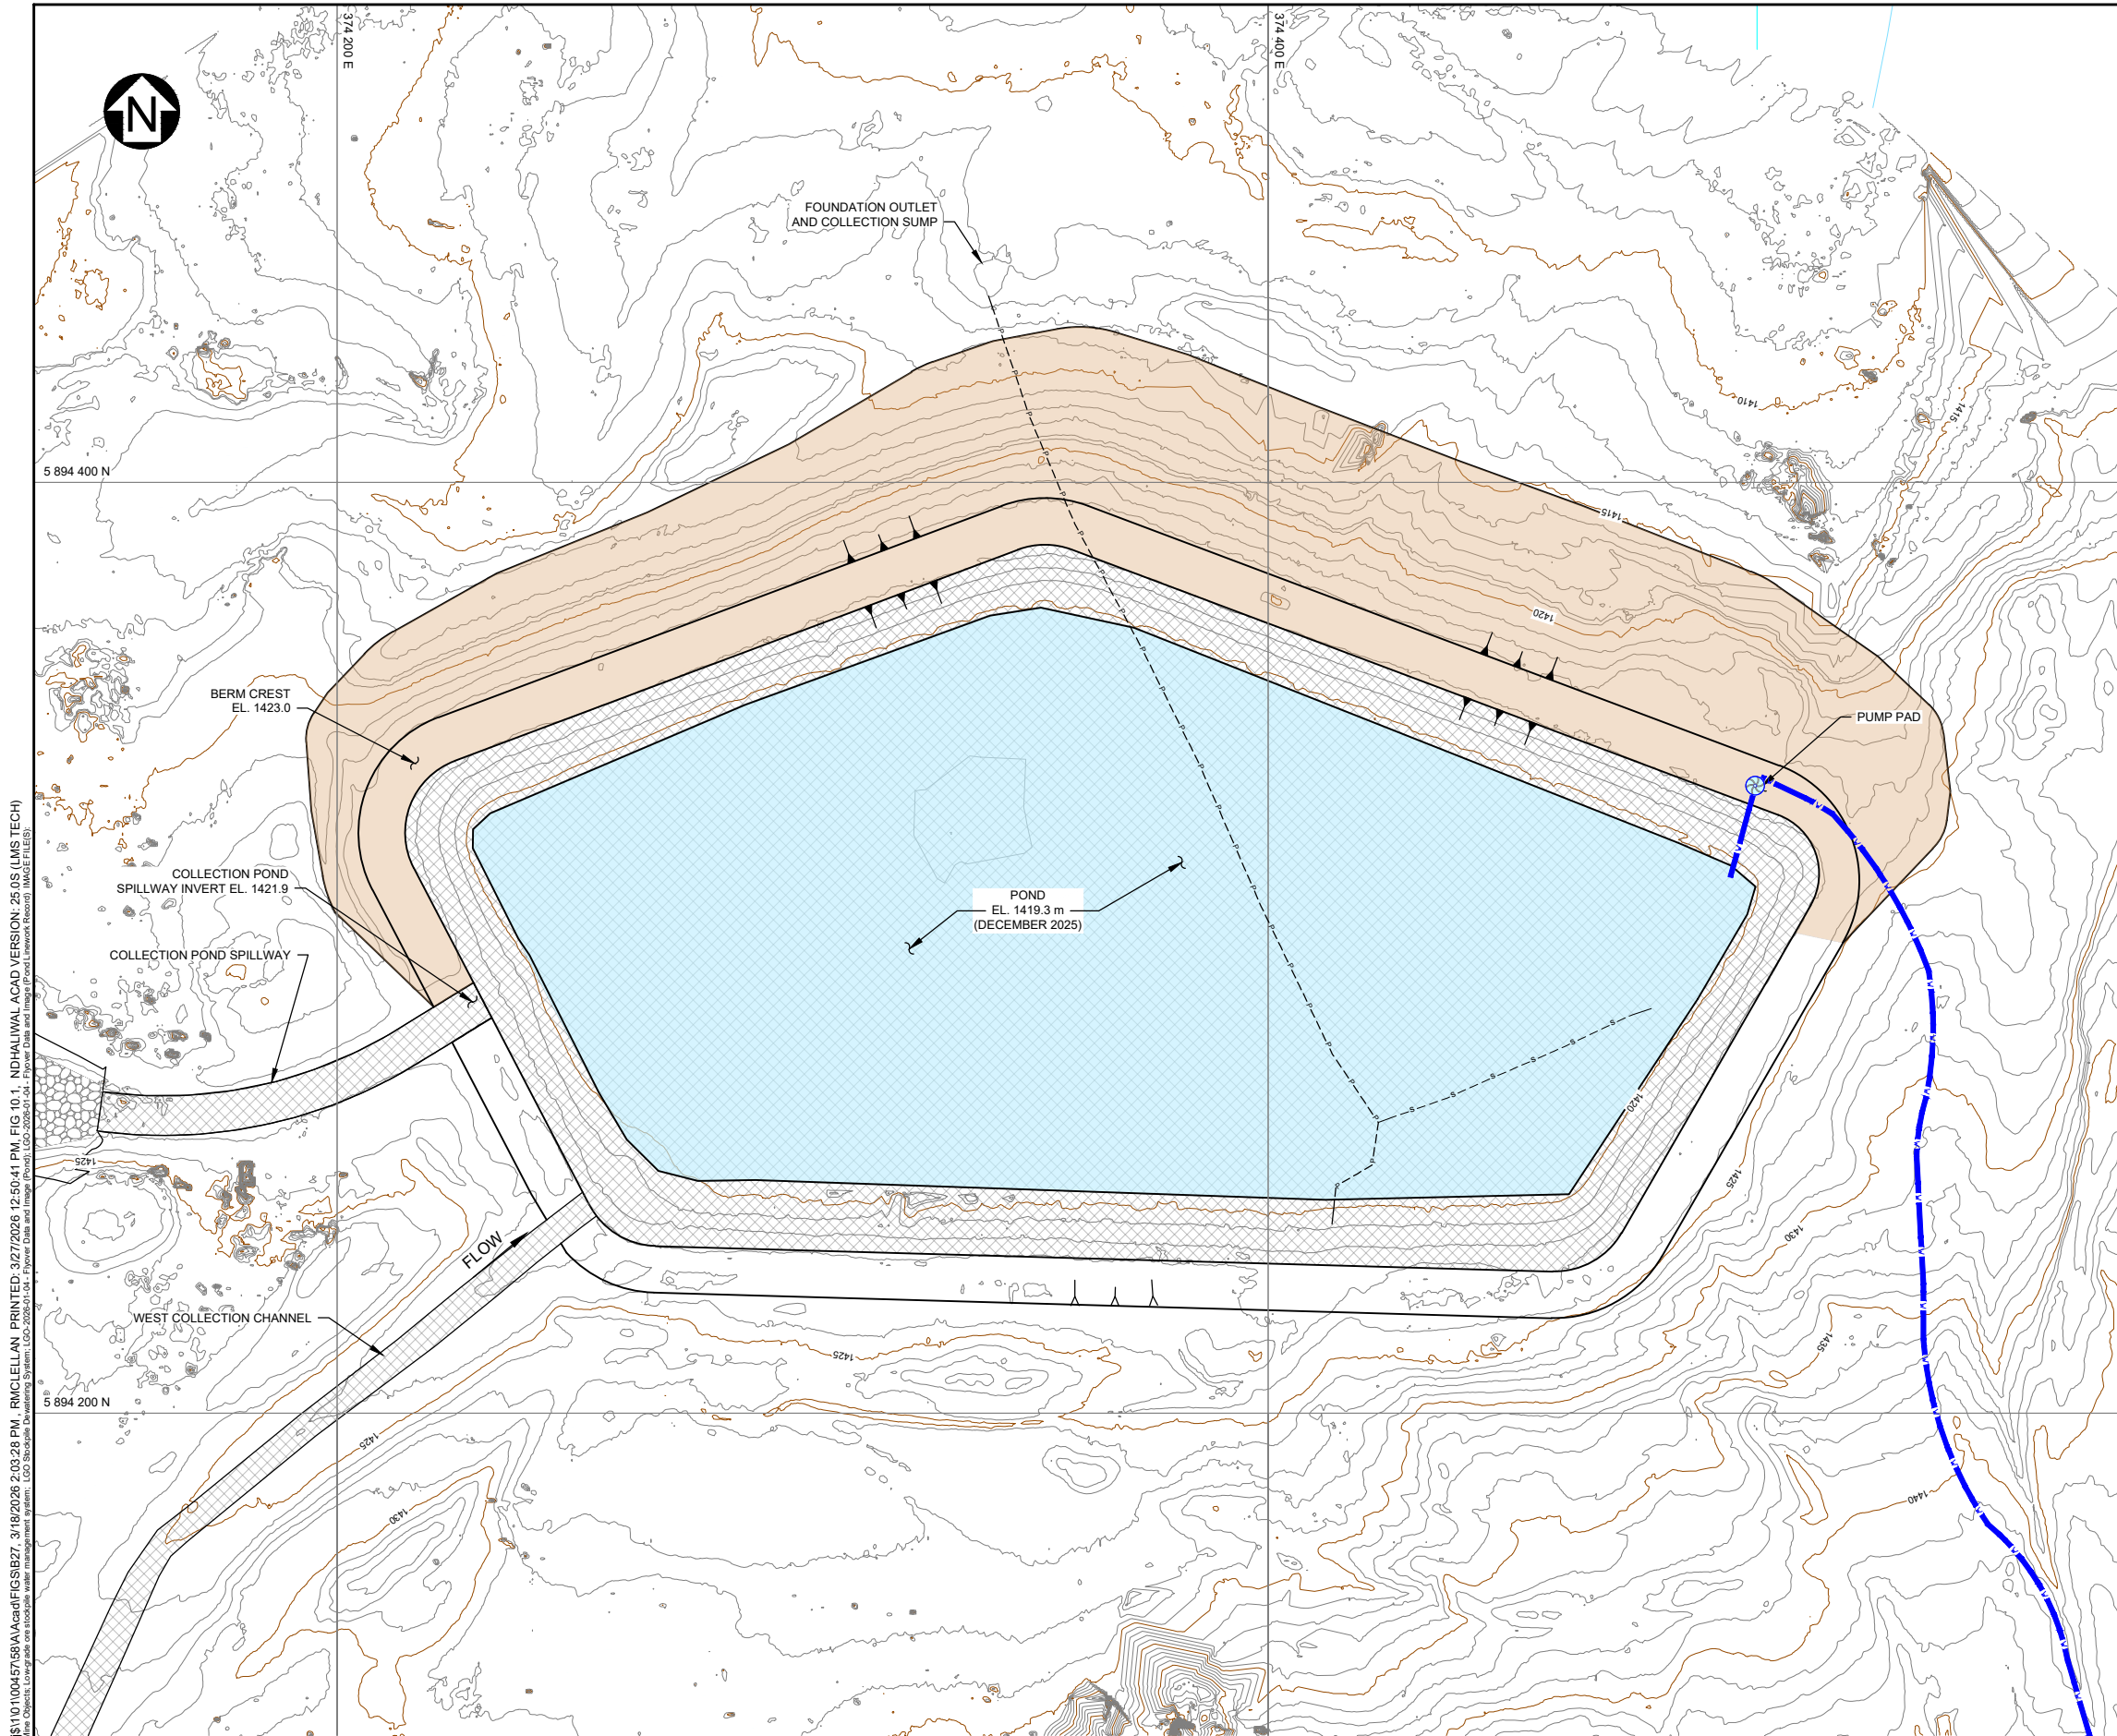
- LEGEND:**
- EMBANKMENT FILL
 - MINE WATER
 - RIPRAP
 - HDPE LINER
 - LGO PIPELINE
 - PUMP STATION
 - PRIMARY FOUNDATION DRAIN
 - SECONDARY FOUNDATION DRAIN

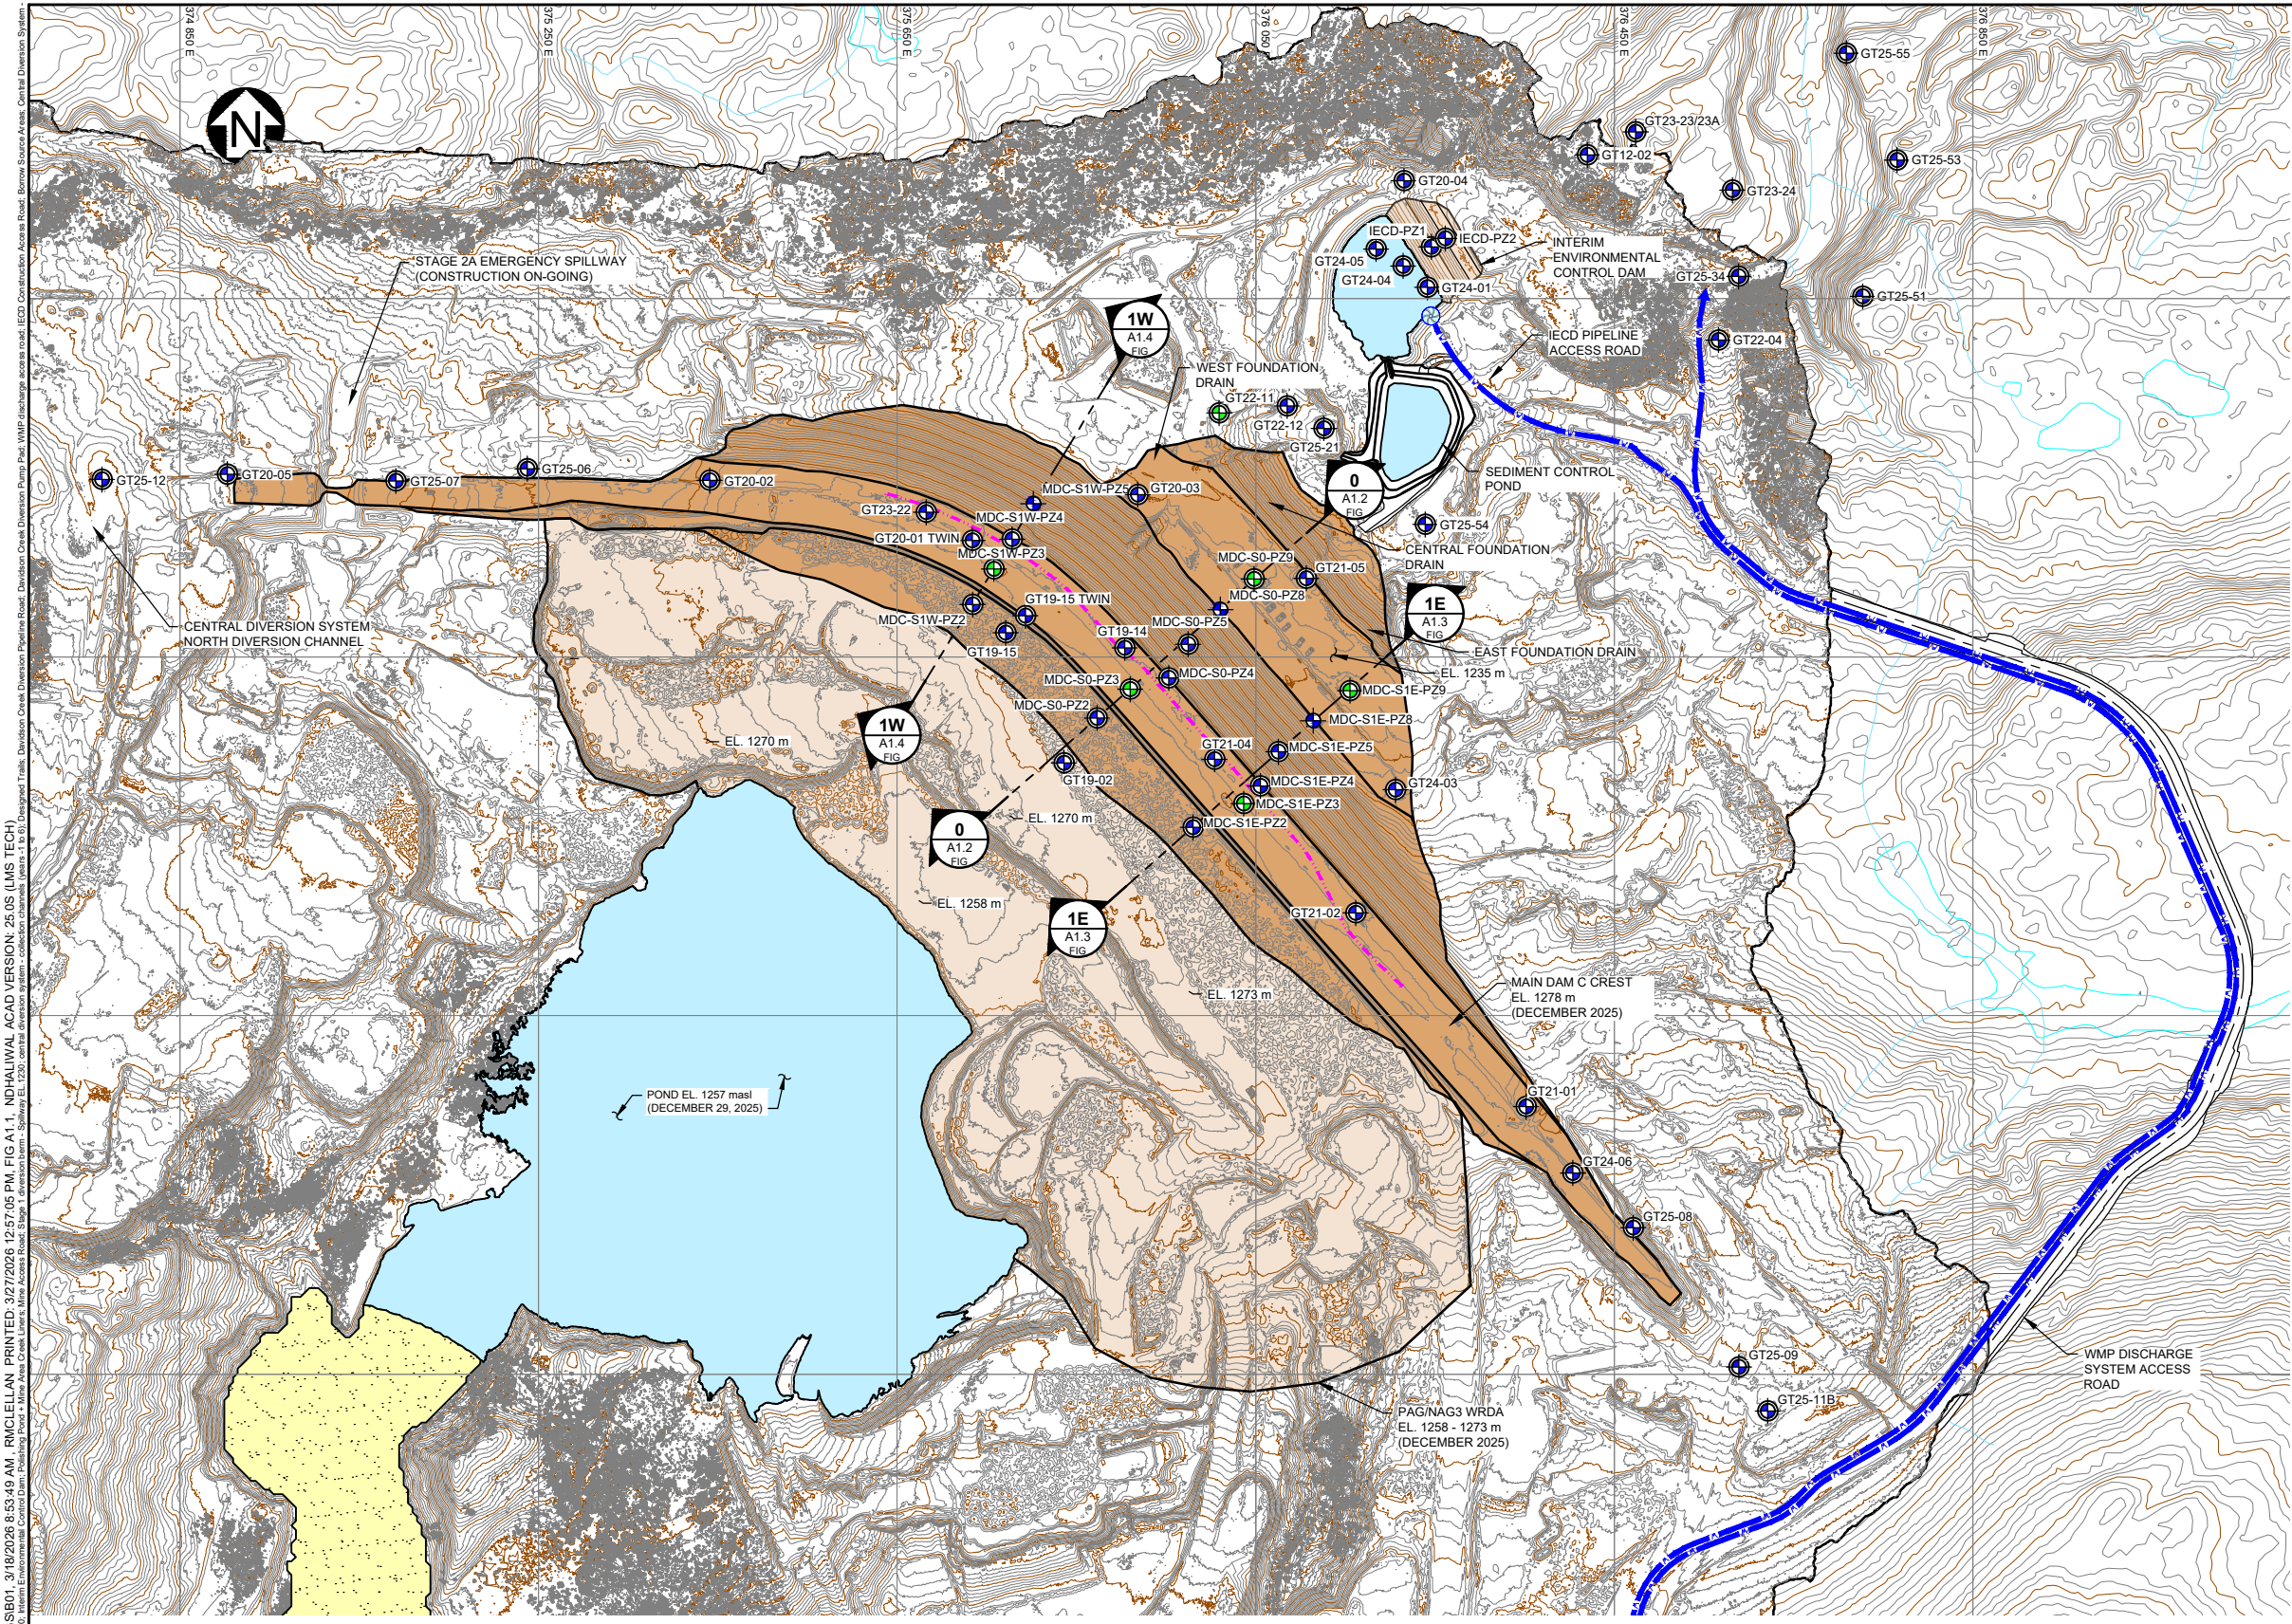
- LEGEND:**
- MINE WATER
 - EMBANKMENT FILL
 - PAG WASTE ROCK
 - TAILINGS BEACH
 - EXISTING ACCESS TRAILS
 - WATER MANAGEMENT PIPELINES
 - CHIMNEY DRAIN
 - PUMP STATION
 - DRILLHOLE WITH VWP
 - DRILLHOLE WITH VWP AND INCLINOMETER CASING
 - VWP EMBEDDED IN FILL

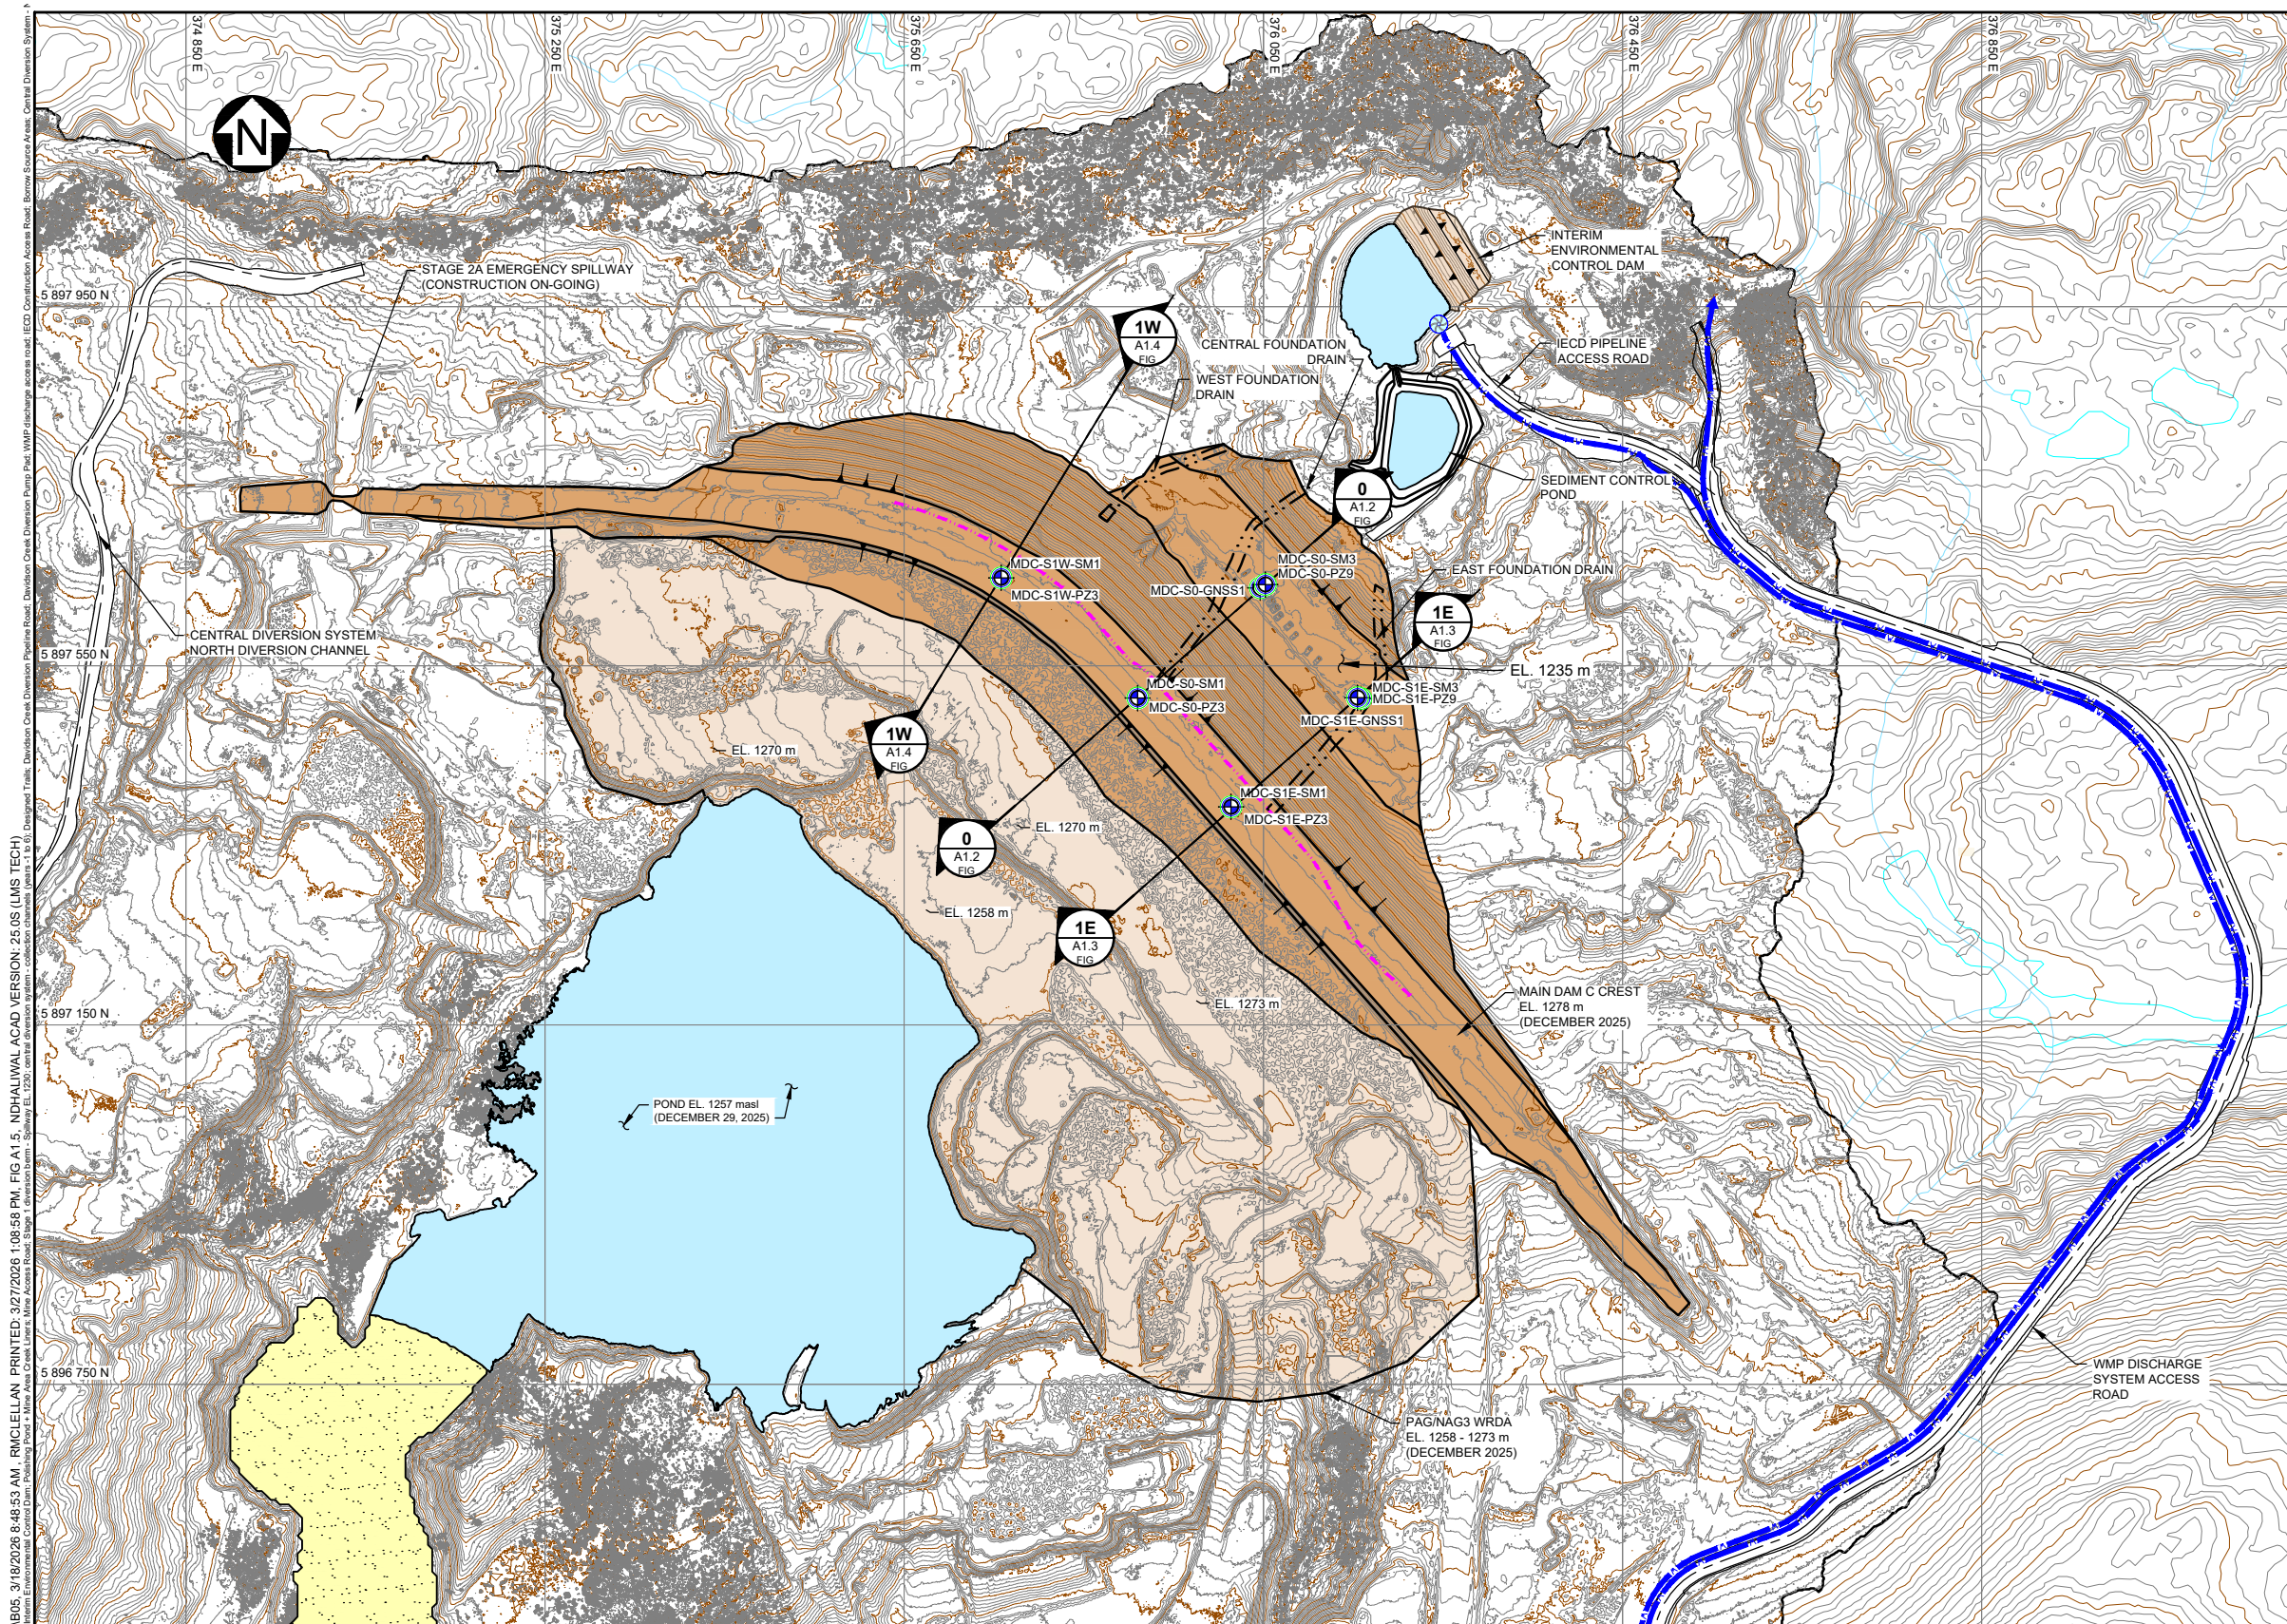
- LEGEND:**
- MINE WATER
 - EMBANKMENT FILL
 - PAG WASTE ROCK
 - TAILINGS BEACH
 - EXISTING ACCESS TRAILS
 - WATER MANAGEMENT PIPELINES
 - CHIMNEY DRAIN
 - PUMP STATION
 - SLOPE INCLINOMETER AND GNSS SURVEY - MONUMENT
 - DGPS SURVEY - MONUMENT
