Prepared for
BW Gold Ltd.
3083-595 Burrard Street
Vancouver, British Columbia V7X 1L3
Canada

Prepared by
Knight Piésold Ltd.
1400-750 West Pender Street
Vancouver, British Columbia V6C 2T8
Canada

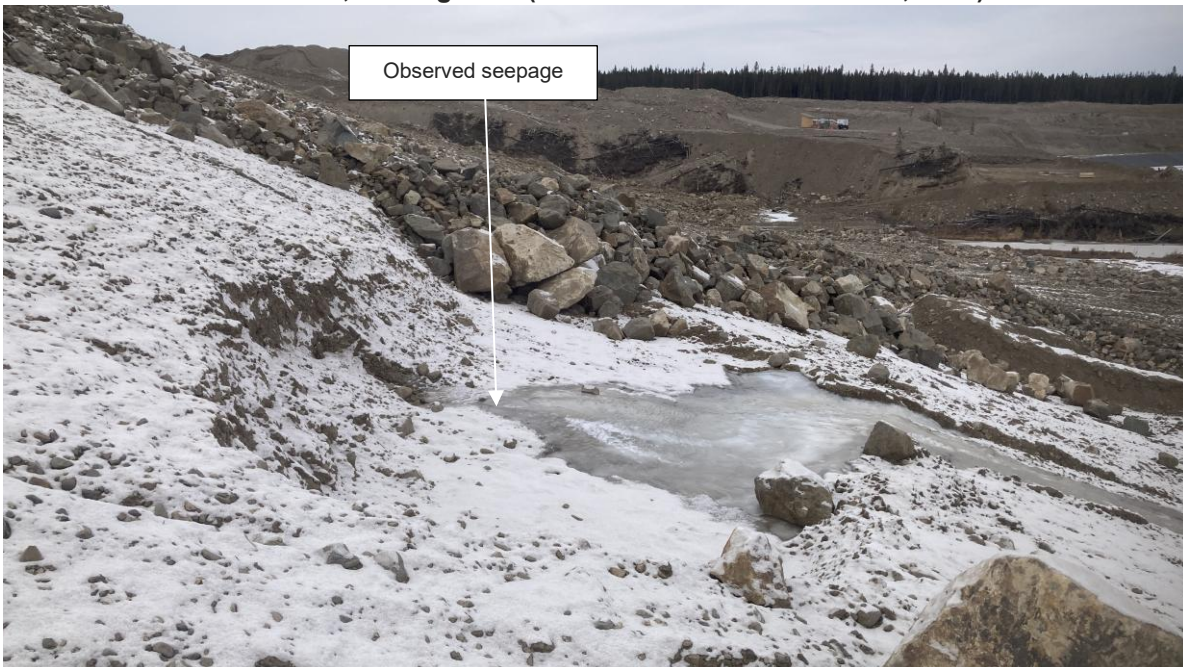
PHOTO 24 – Observed perched seepage discharging along the downstream slope of the buttress, looking northwest (Photo taken on November 28, 2025)

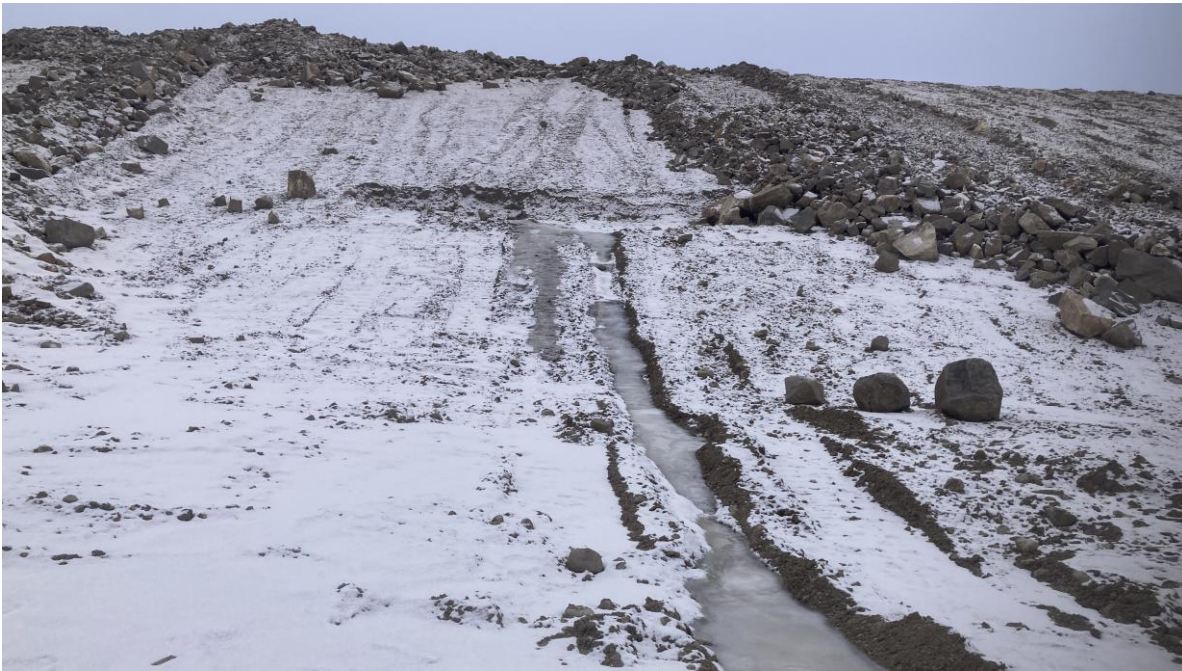
PHOTO 25 – Drainage channel excavated to convey the seepage downstream towards the east foundation drain, looking southwest (Photo taken on November 28, 2025)

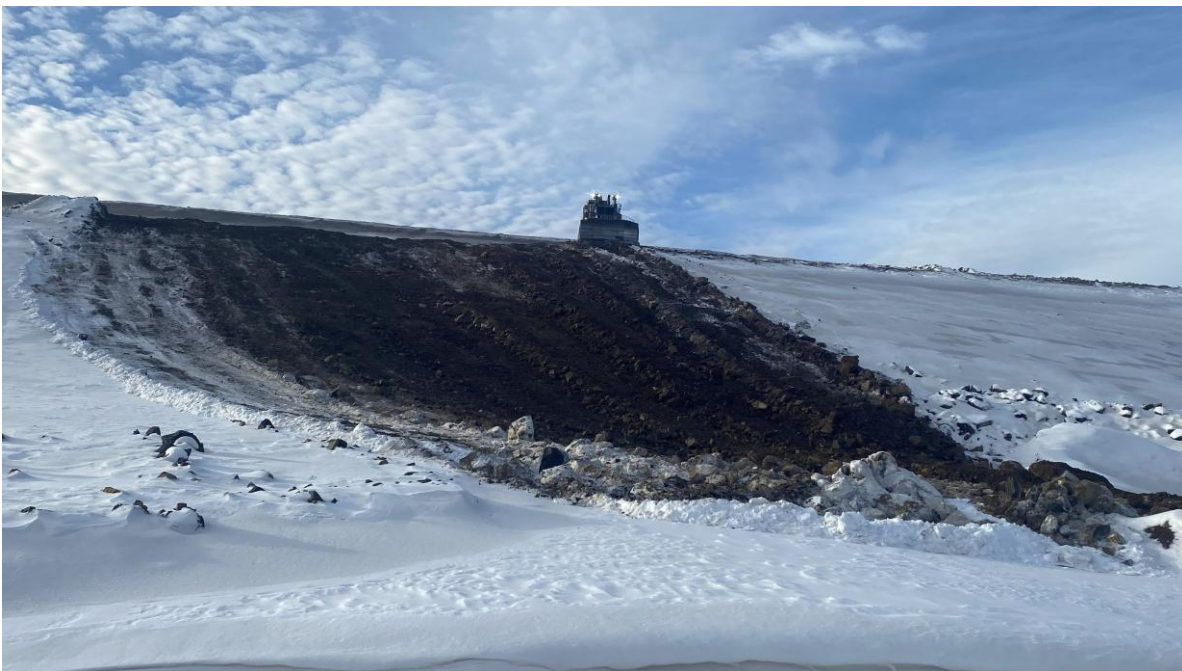
PHOTO 26 – Ongoing remediation and backfill of observed seepage area with NAG waste rock, looking west (December 31, 2025)

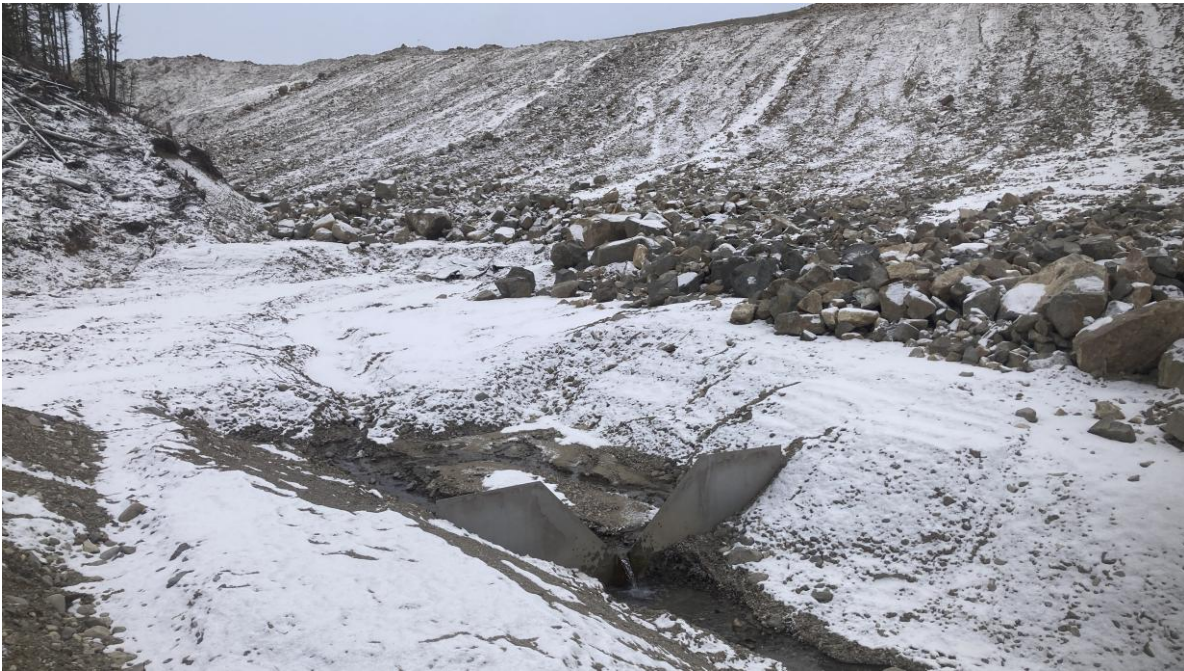
PHOTO 27 – East foundation drain and weir, looking east (Photo taken on November 28, 2025)

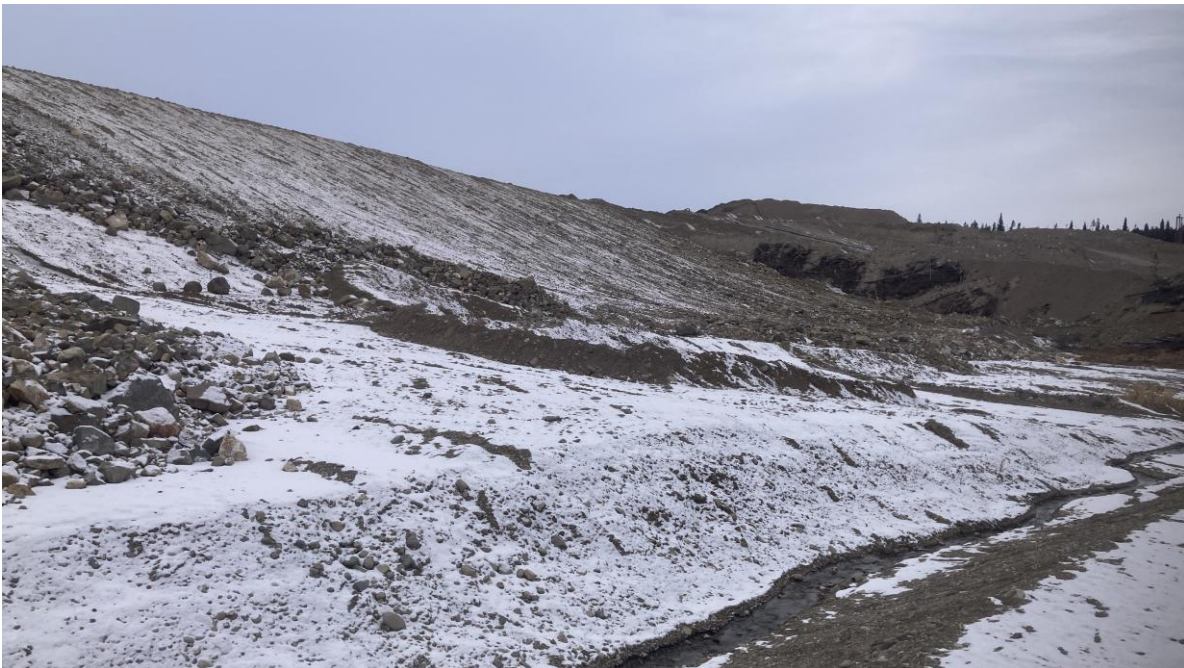
PHOTO 28 – East foundation drain flow towards the TSF SCP, looking northwest (Photo taken on November 28, 2025)

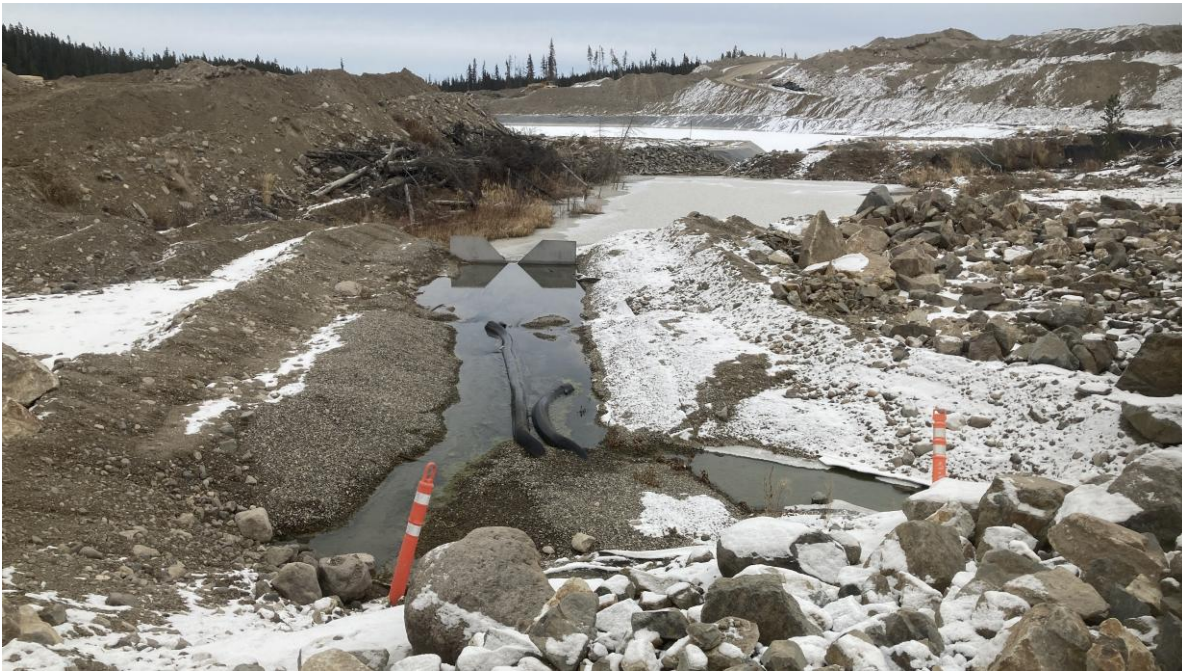
PHOTO 29 – Central foundation drain and collection sump upstream of the TSF SCP inlet, looking northeast (Photo taken on November 28, 2025)

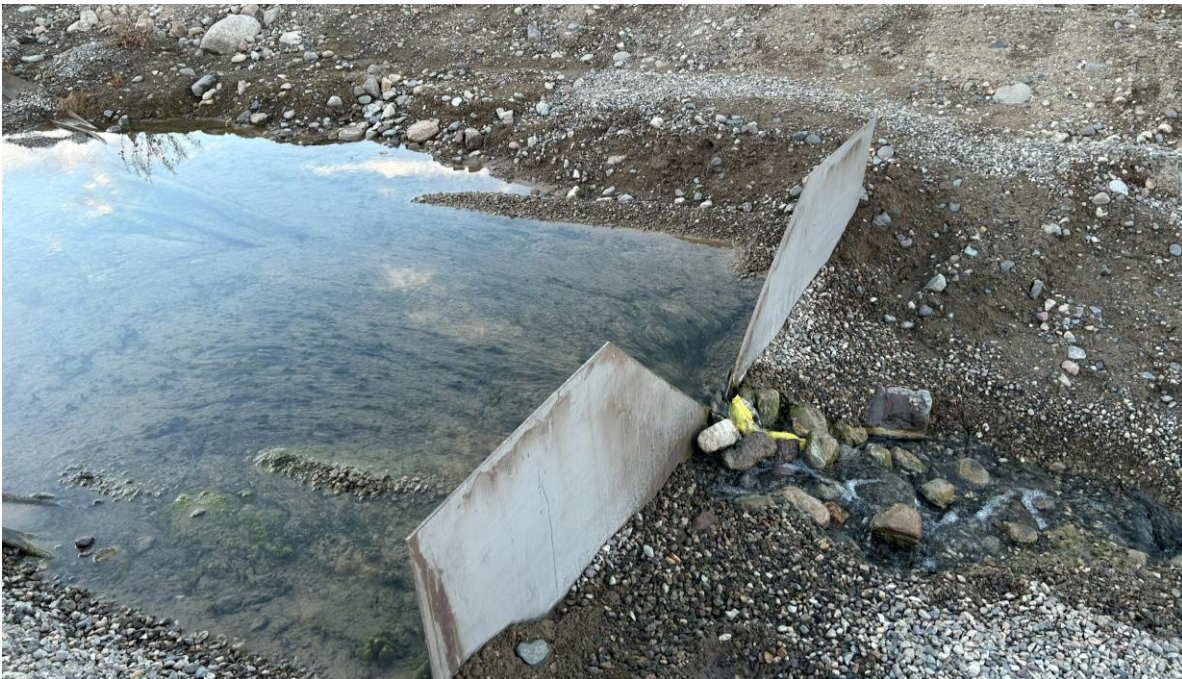
PHOTO 30 – Central foundation drain weir and organic growth (Photo taken on November 3, 2025)

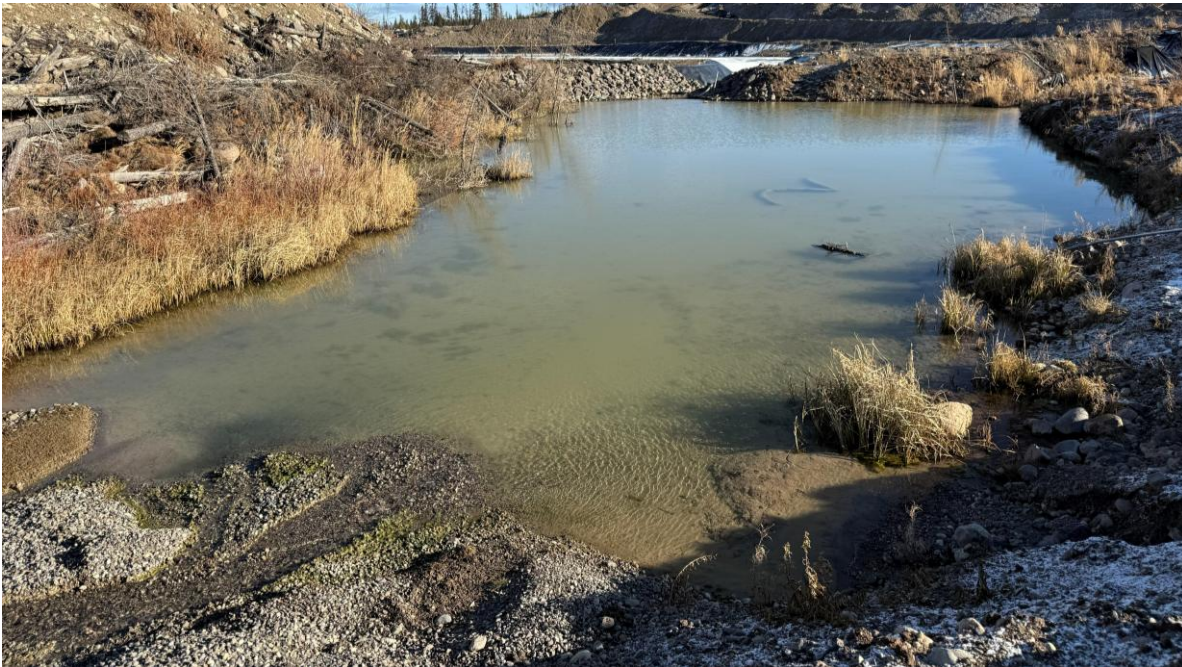
**PHOTO 31 – Seepage collection sump upstream for the TSF SCP inlet, looking northeast
(Photo taken on November 11, 2025)**

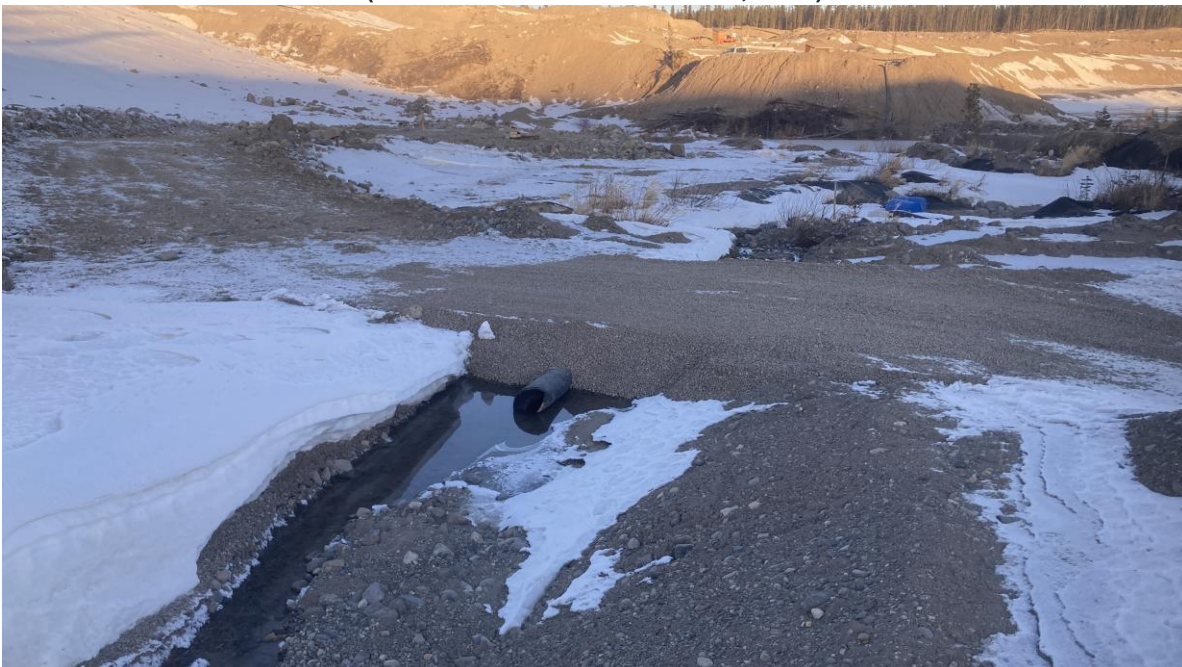
**PHOTO 32 – Culvert crossing over the east foundation drain outlet channel (Photo taken on
January 24, 2026)**

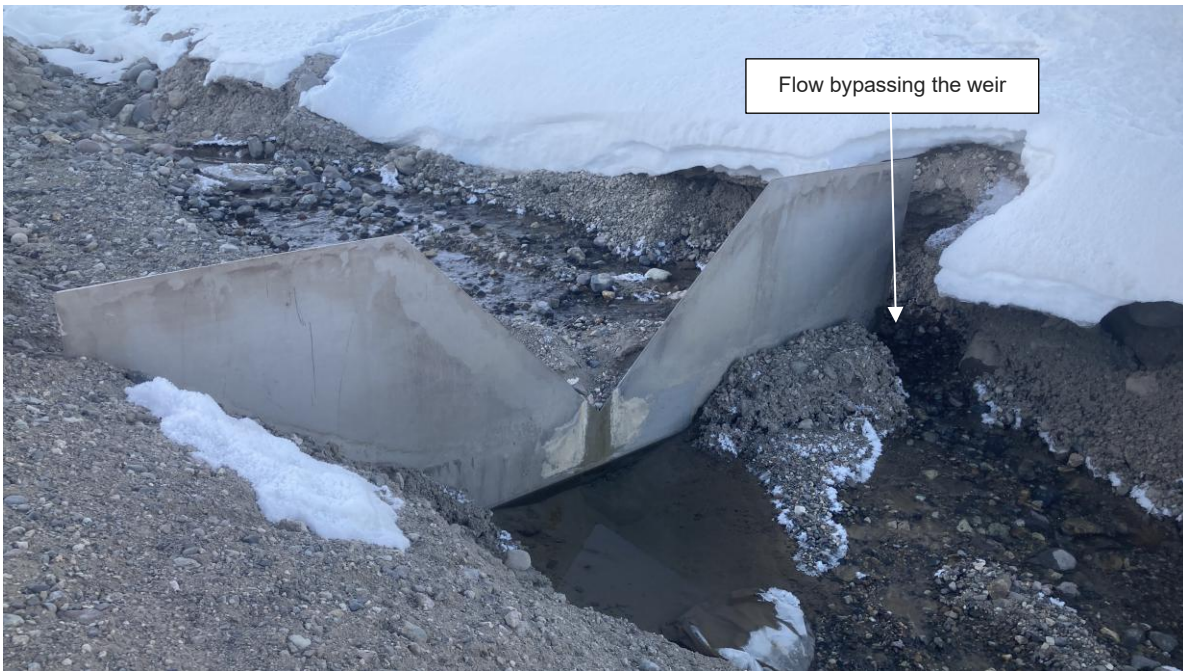
PHOTO 33 – Seepage flow bypassing the east foundation drain weir (Photo taken on January 24, 2026)

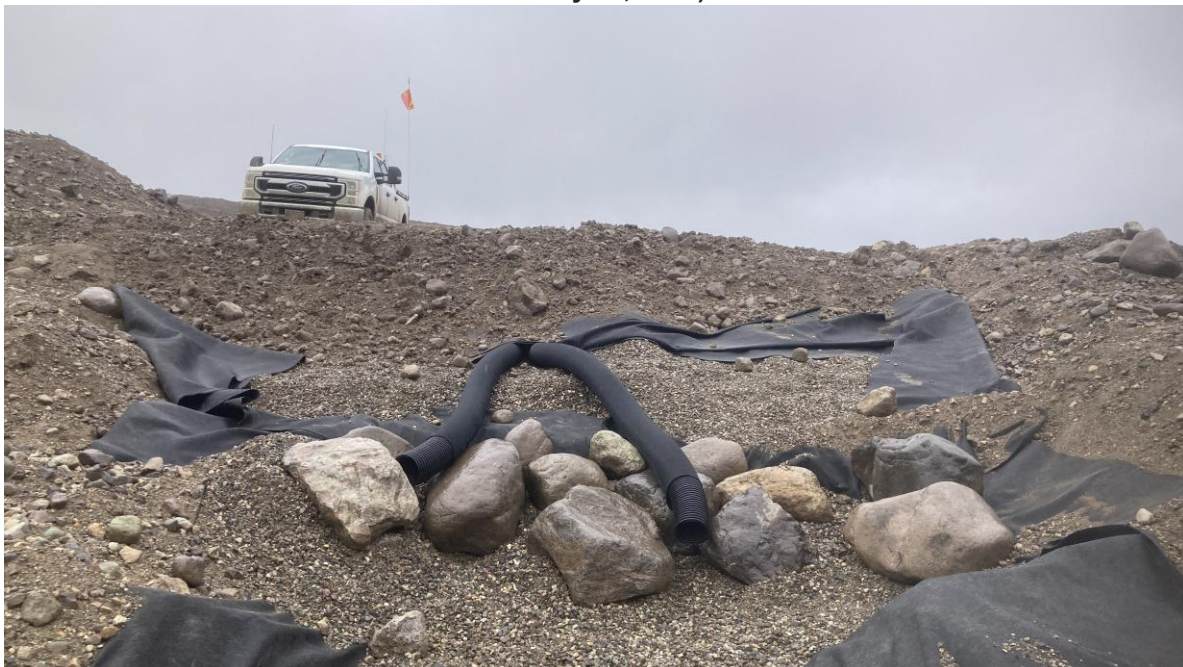
PHOTO 34 – West foundation drain outlet (Photo taken on May 17, 2025)

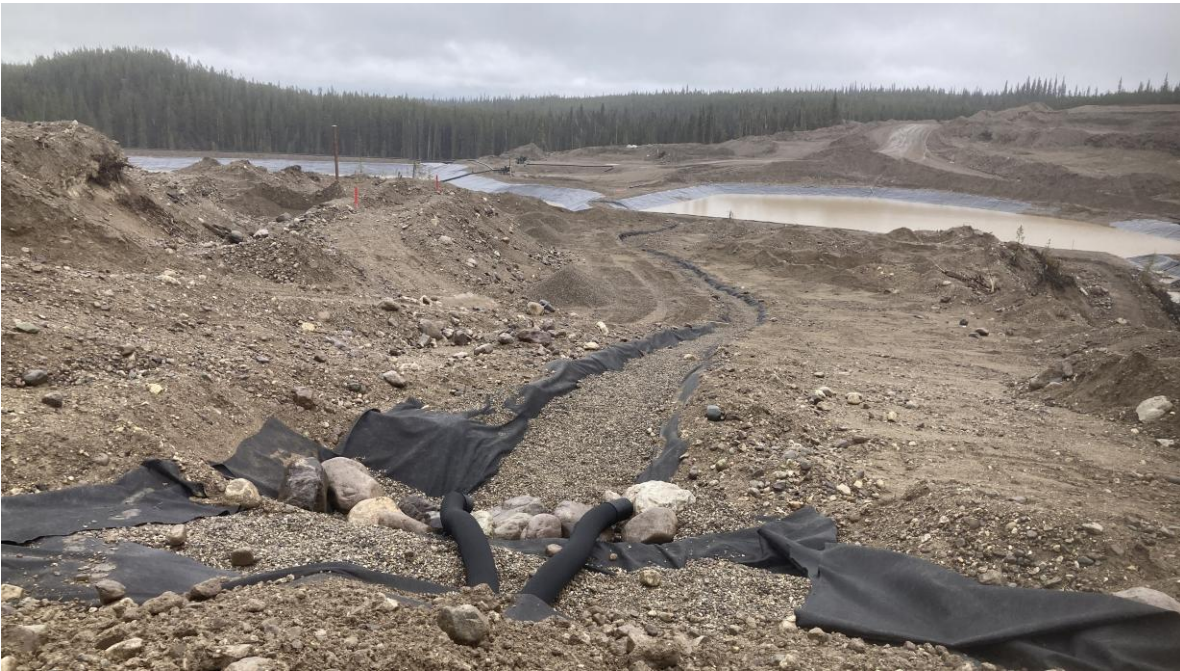
PHOTO 35 – Downstream channel of the west foundation drain outlet towards the IECD, looking northeast (Photo taken on May 17, 2025)

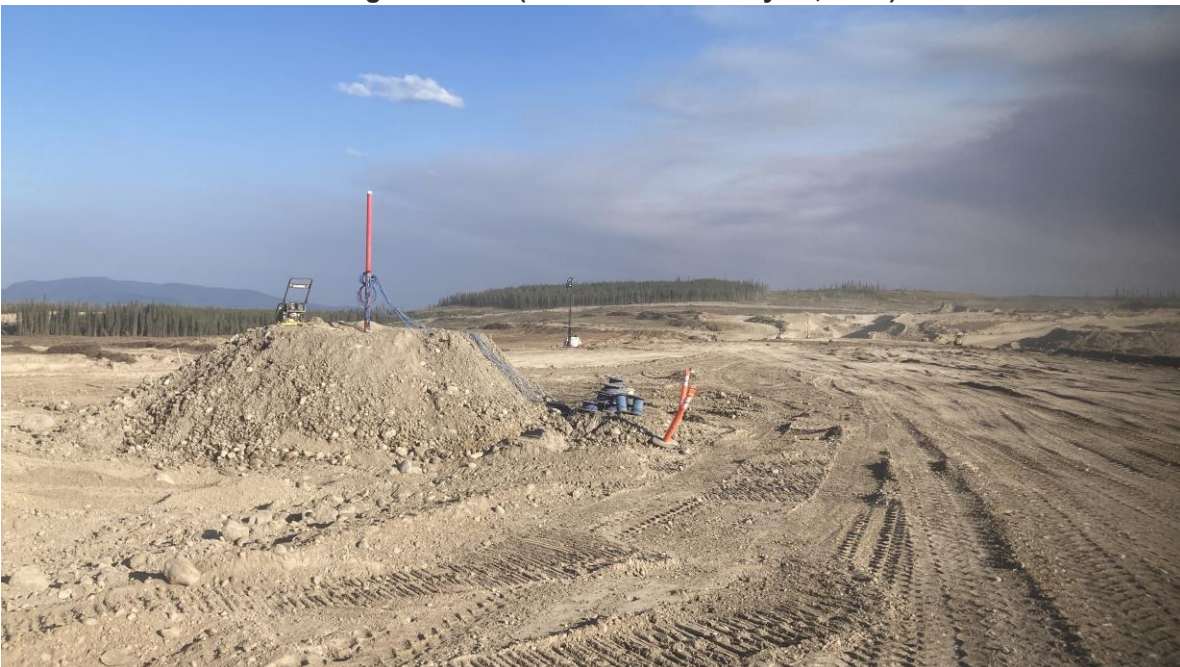
PHOTO 36 – MDC-S0-PZ3 inclinometer being raised during active crest construction (Photo taken on September 7, 2025)

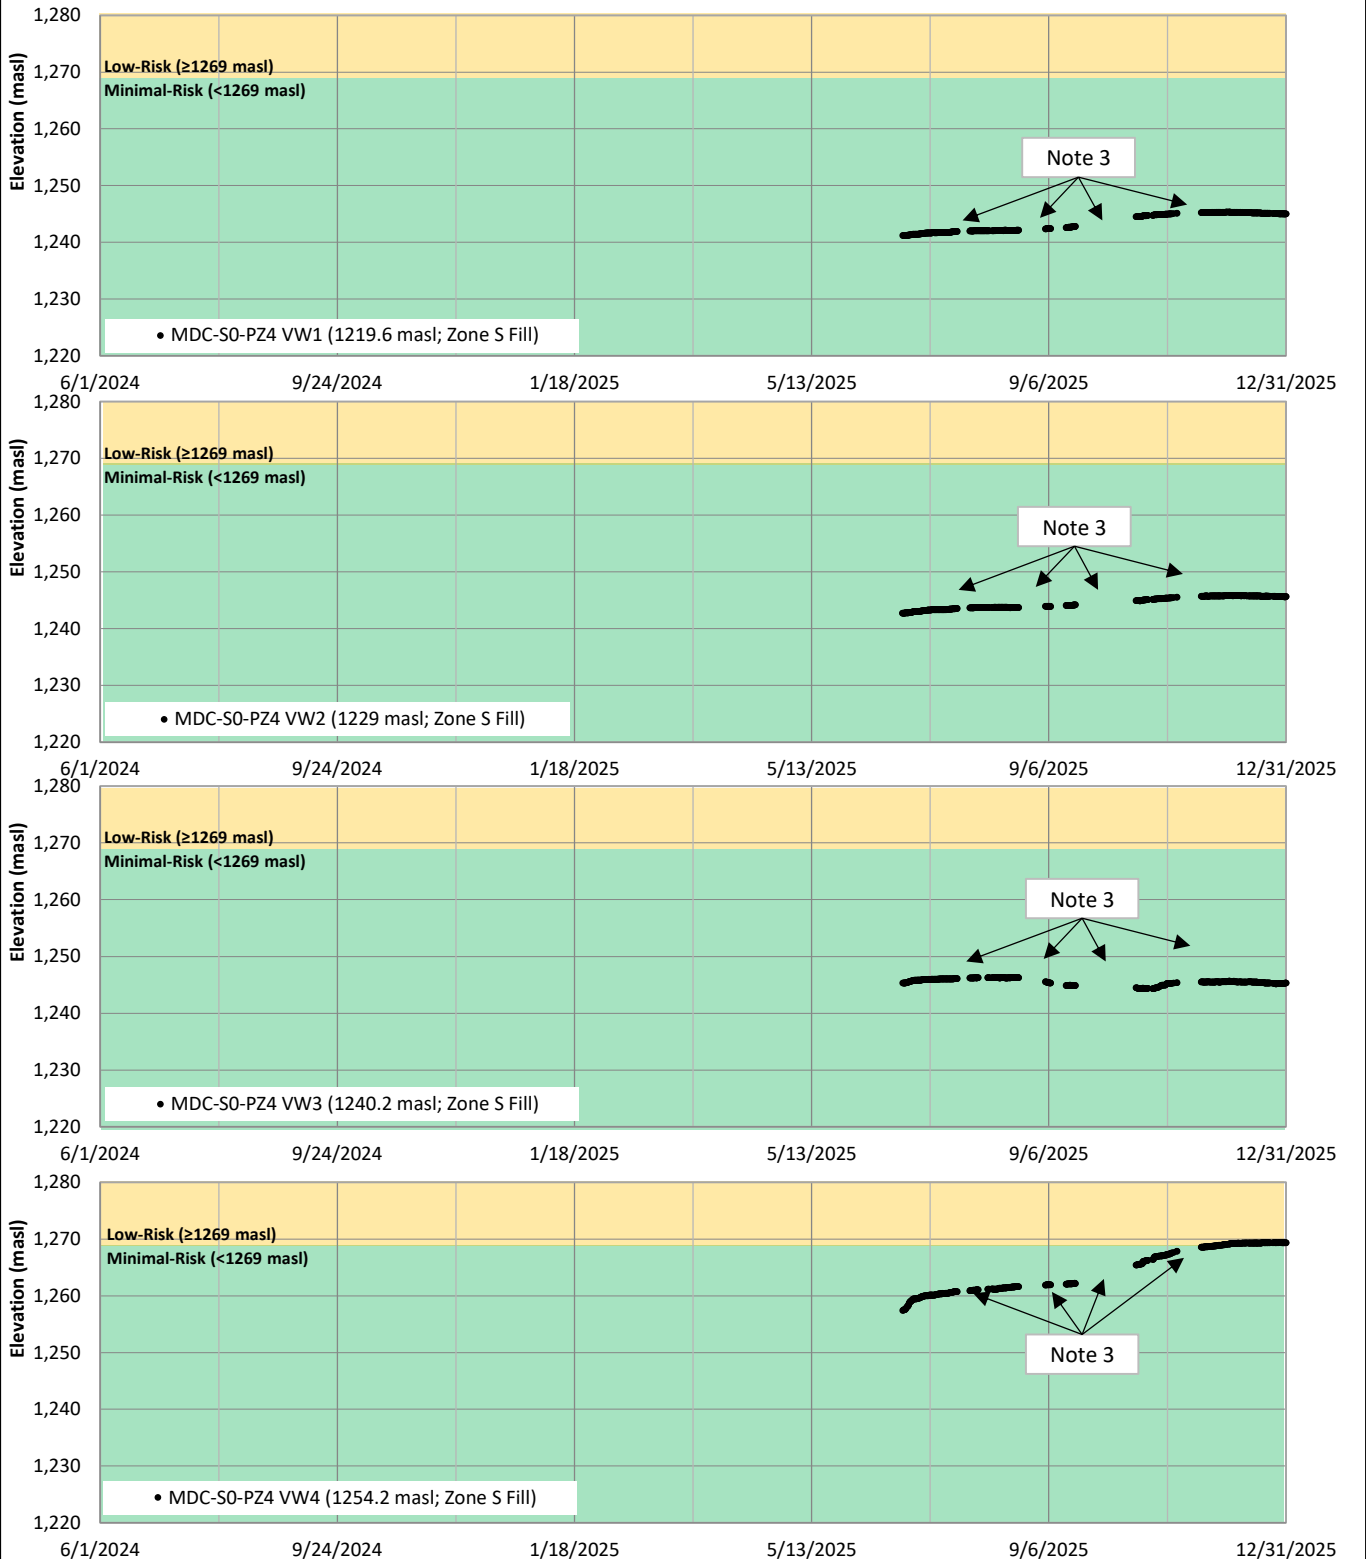
- NOTES:**
- VWP DATA WERE DOWNLOADED FROM RST AFFINITY GATEWAY ON DECEMBER 31, 2025.
 - QPO THRESHOLDS FOR EACH SENSOR ARE BASED ON THE VALUES PRESENTED IN VA25-02076 TABLE C.2.
 - NO DATA WERE AVAILABLE FROM ALL MDC-S0-PZ4 VWP SENSORS WHILE THE DATALOGGER WAS DISCONNECTED DUE TO CONSTRUCTION ACTIVITY.

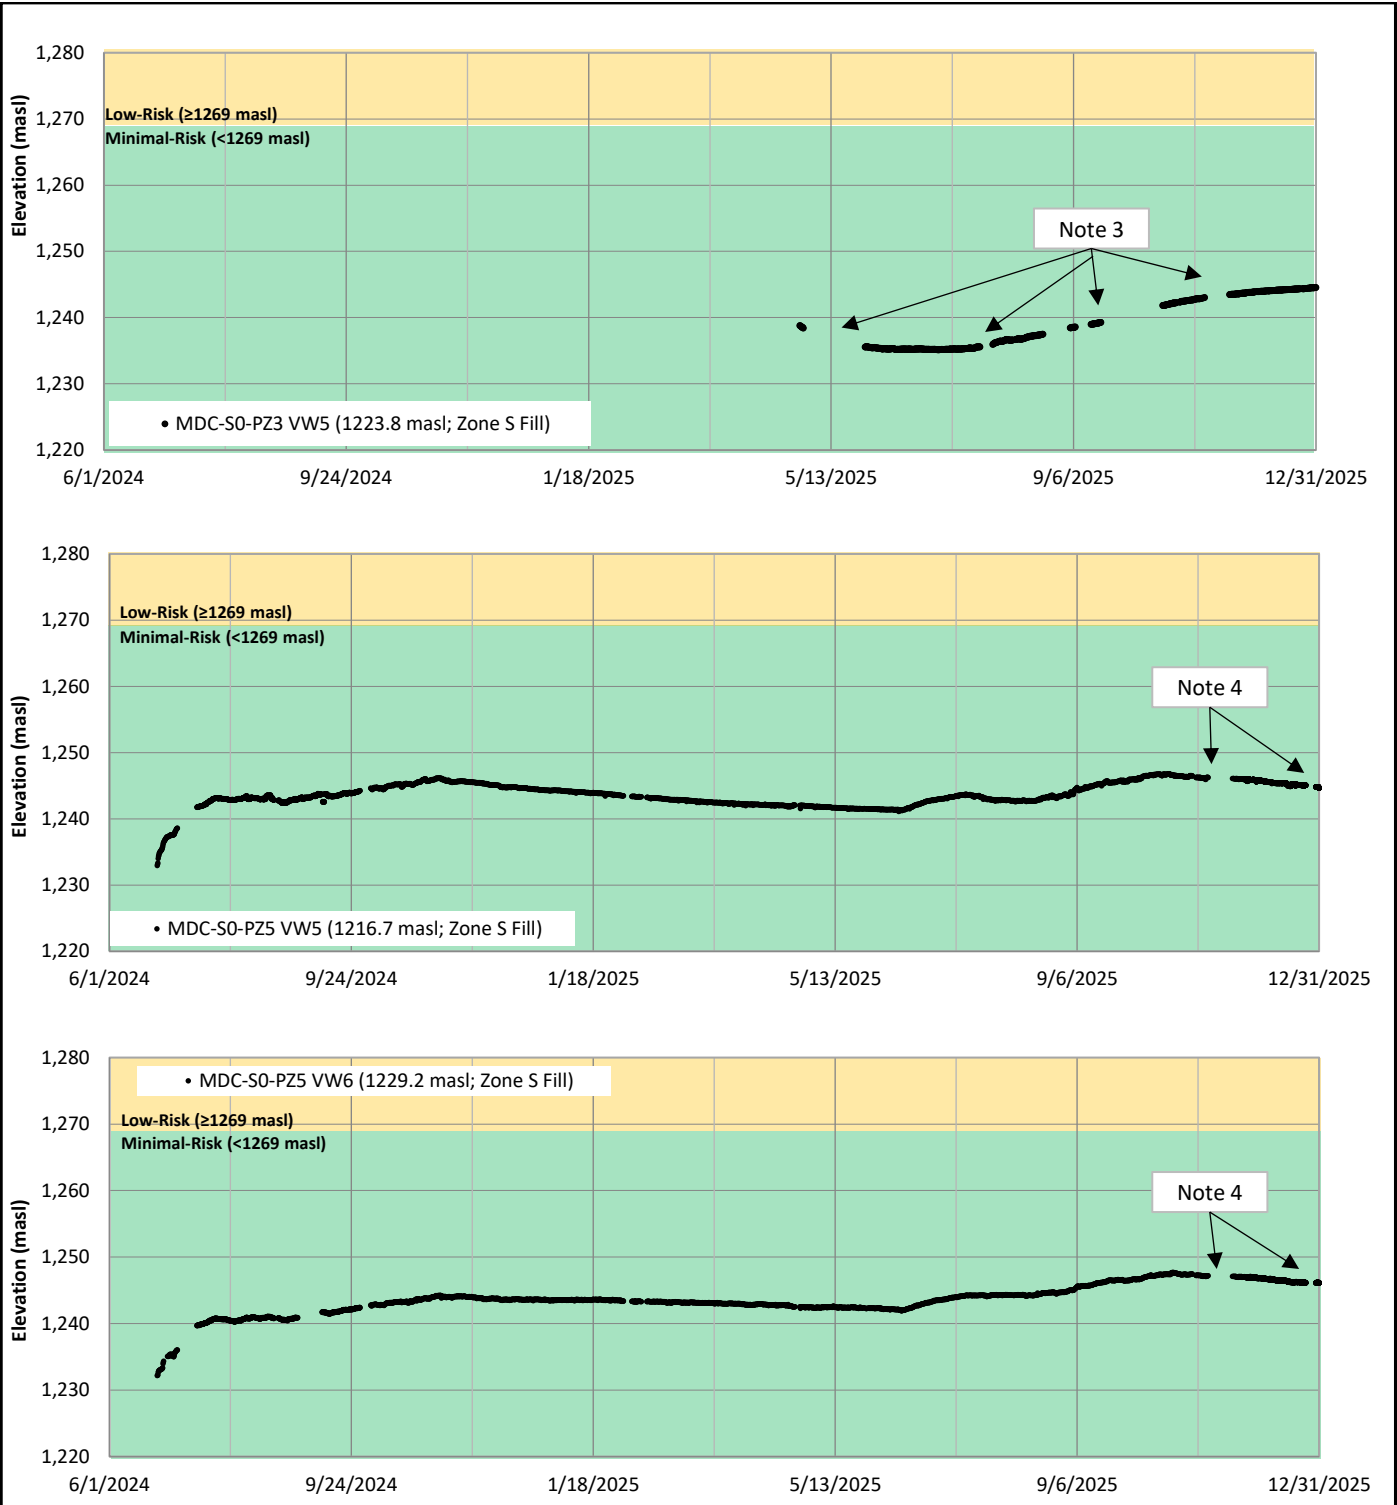
0	27MAR'26	ISSUED WITH REPORT	SY3	KTD
REV	DATE	DESCRIPTION	PREP'D	RWW'D

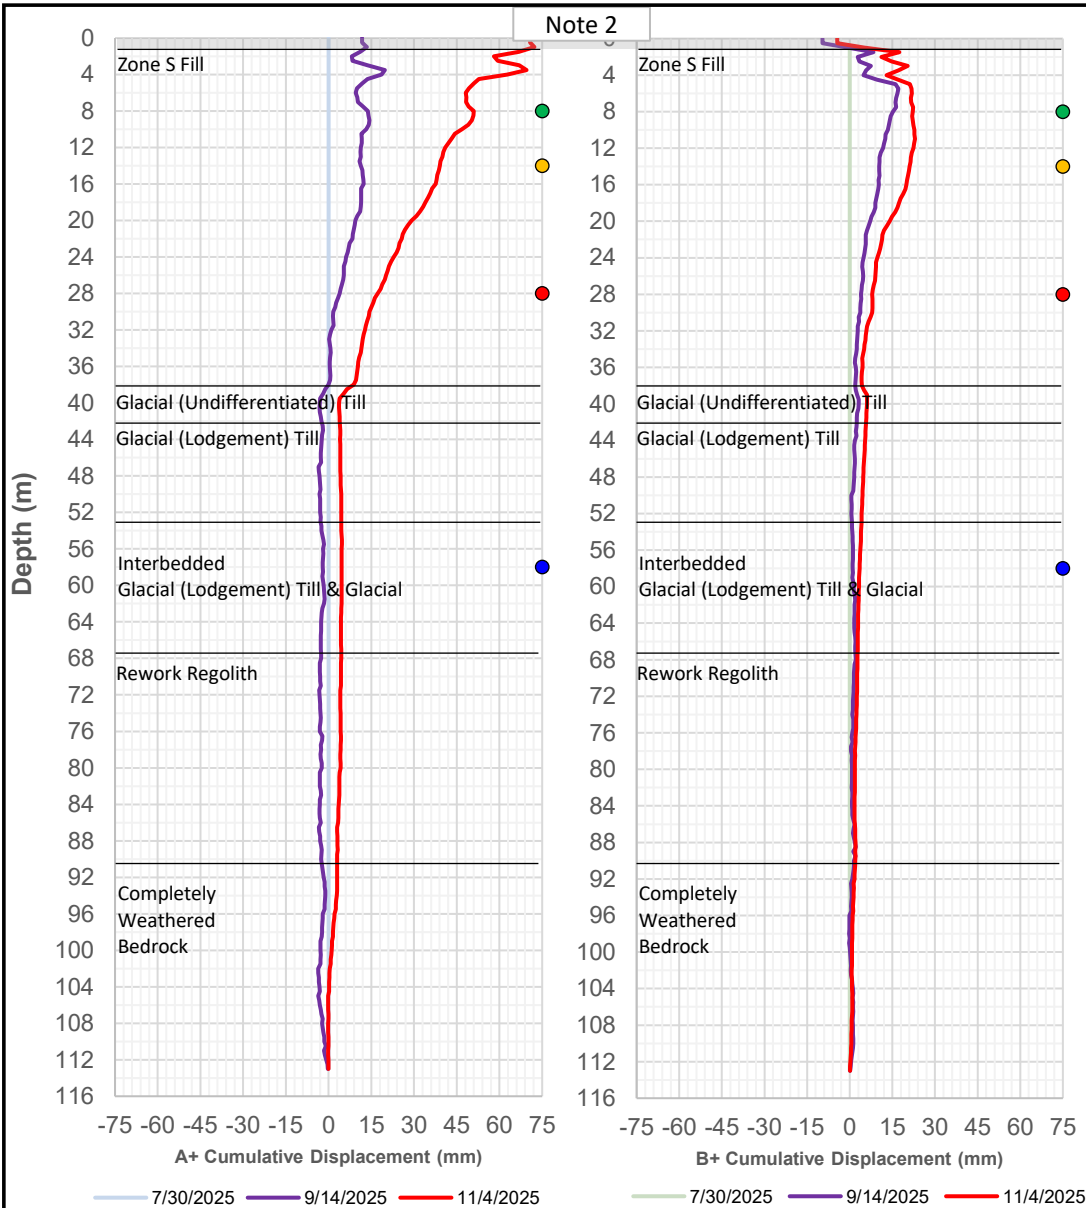
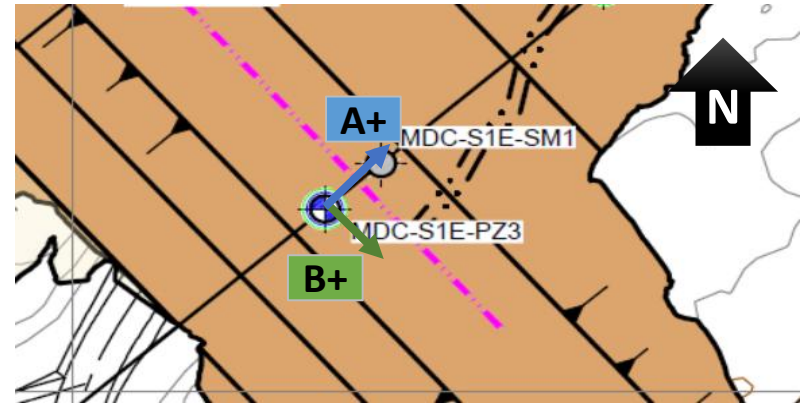
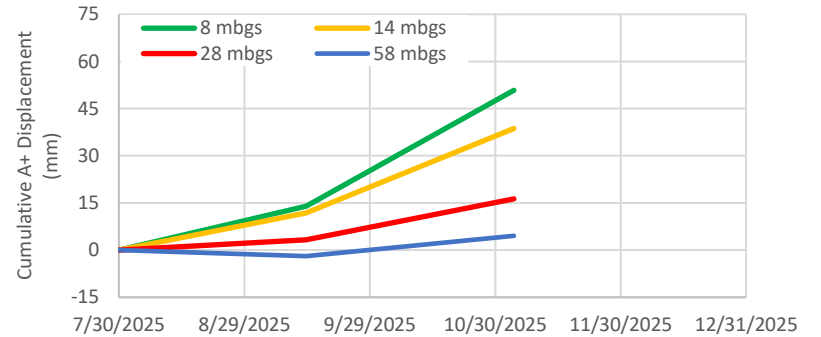
0	27MAR'26	ISSUED WITH REPORT	SY3	KTD
REV	DATE	DESCRIPTION	PREP'D	RVW'D

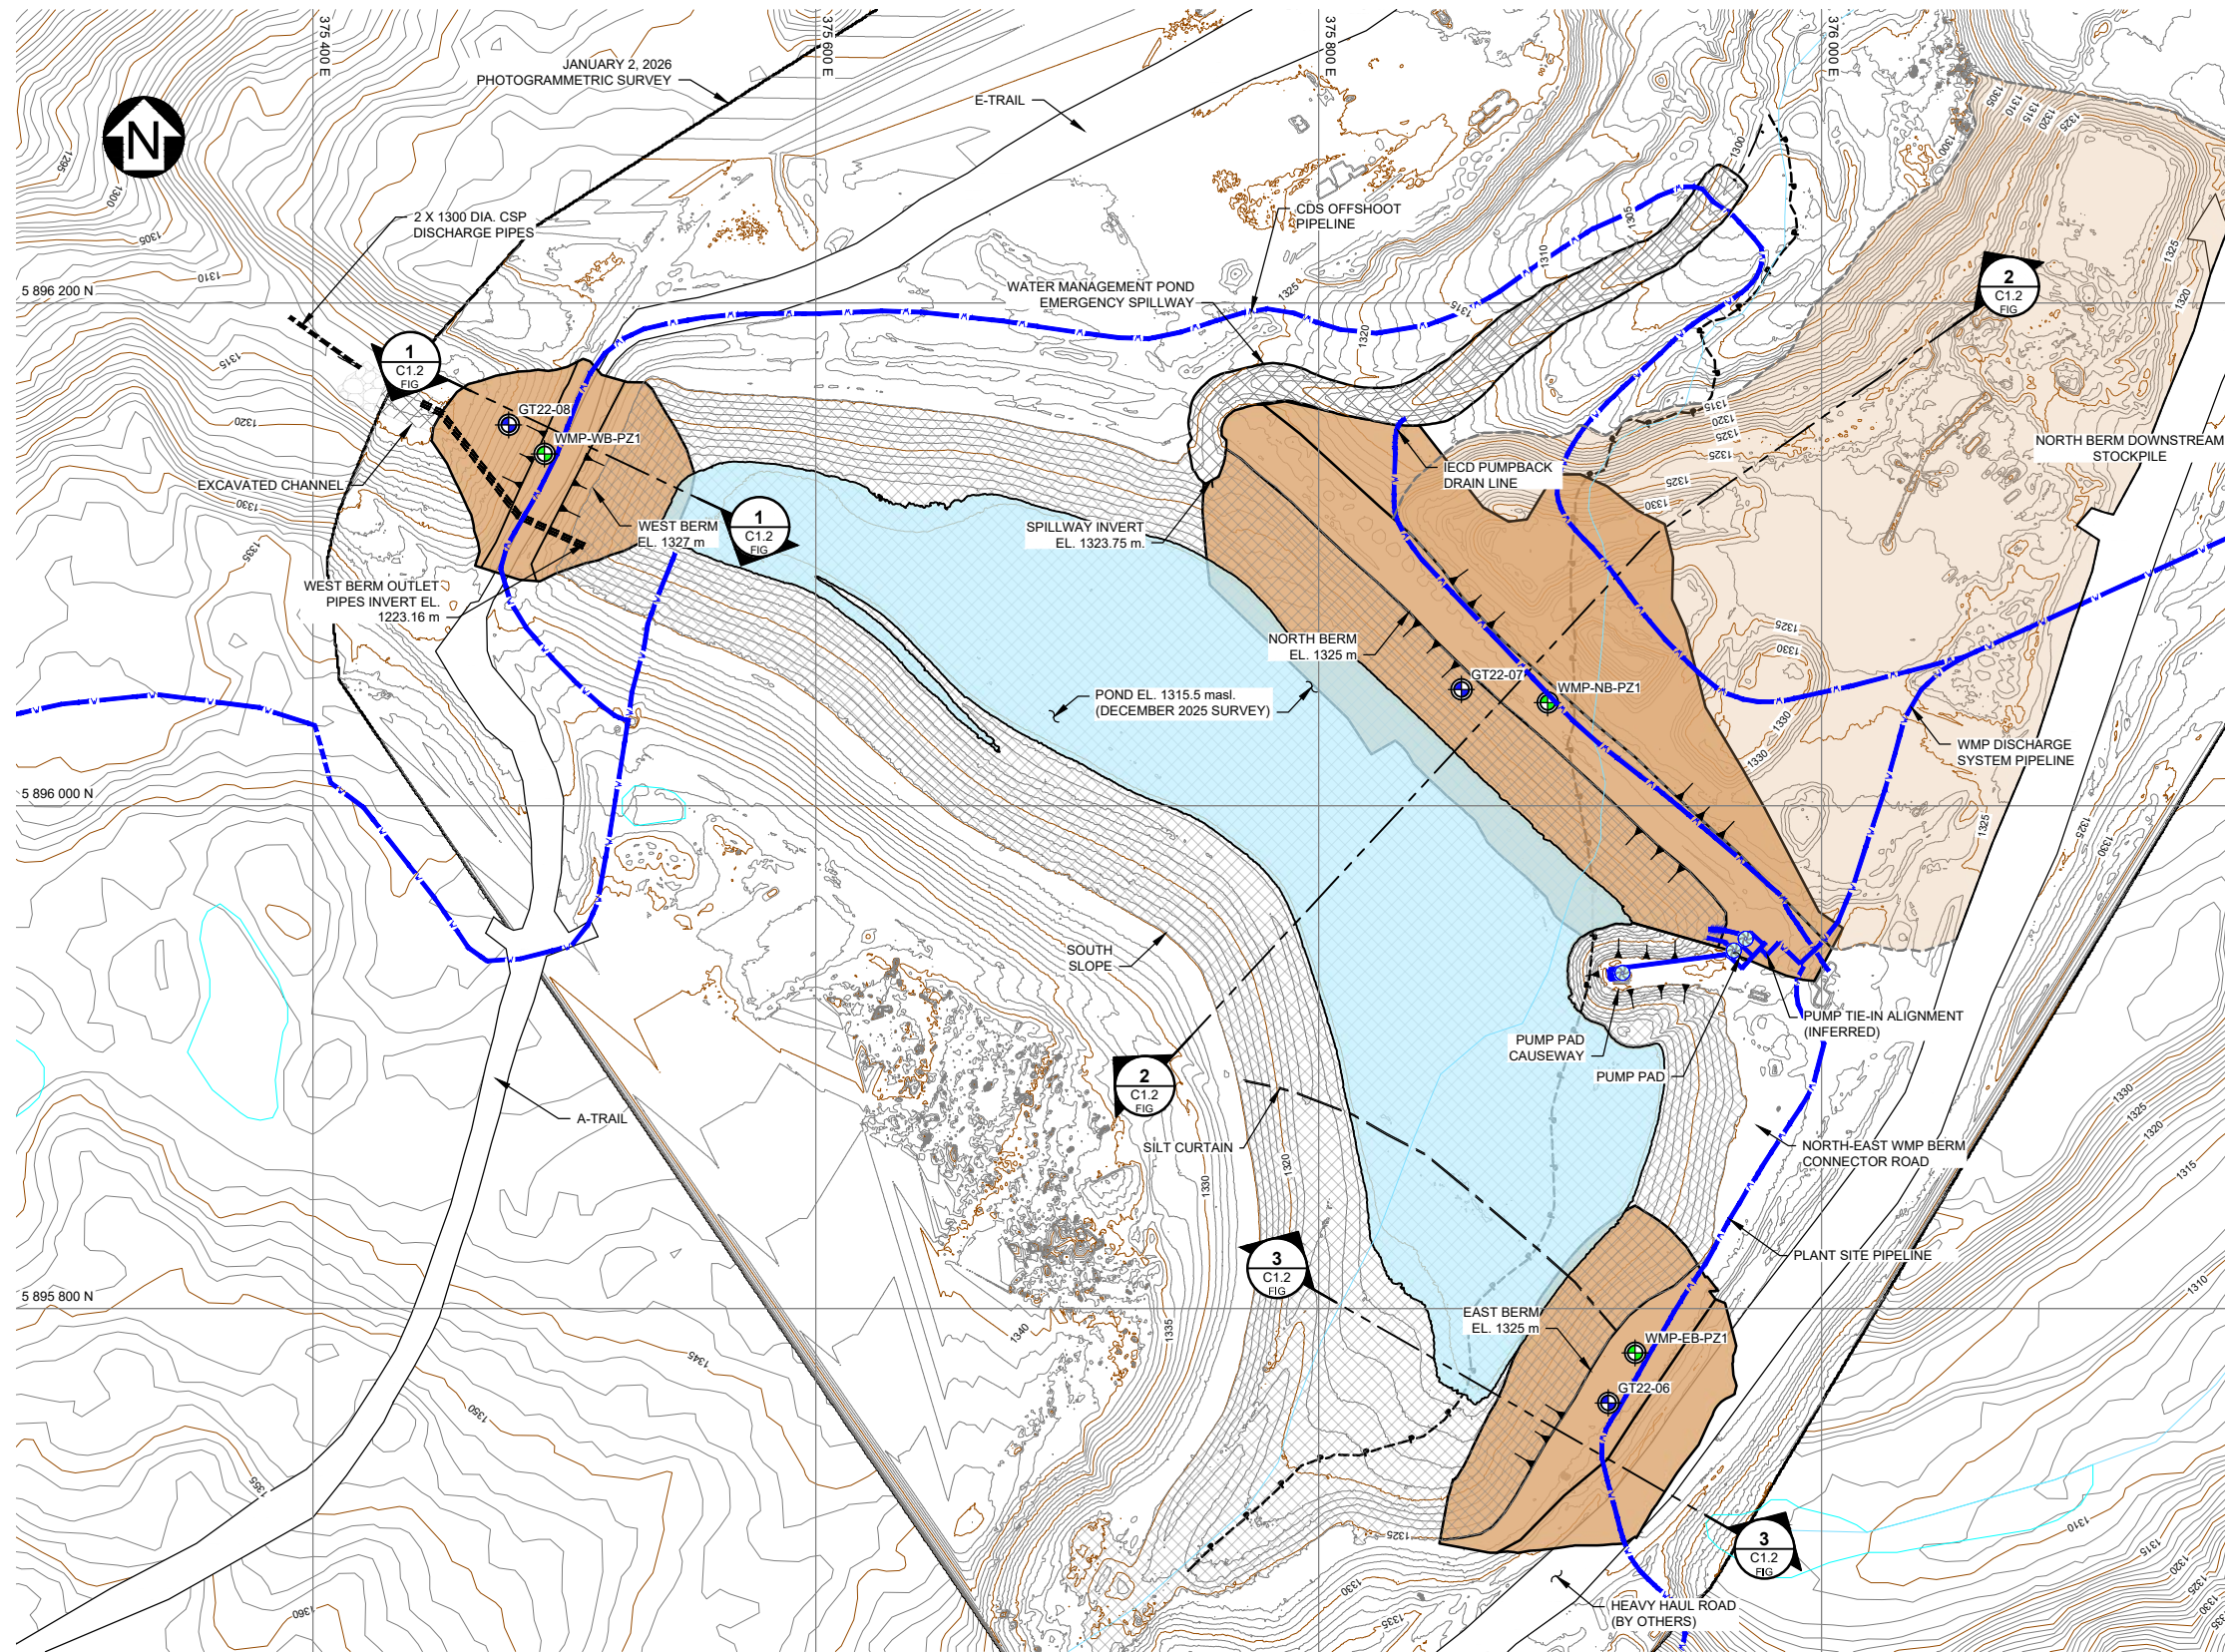
SAVED: W:\PIVA-PI\81101\004578\AA\CA\B\FIGS\B06_3182026 8:50:18 AM - RM\LELLAN PRINTED: 3/27/2026 11:12:18 PM - FIG B1.1 - NDHALIWA ACAD VERSION: 25.05 (LMS TECH)
 XREF FILES: Hydro; topo; tm; contours; Designated Trails; WMP; discharge access; road; Polishing Pond; Mine Area; Creek; Liners; WMP; Dore; Flyover; 2025-01-12; WMP ASB; Spillway; CPO; DORE; FLYOVER; 2024-01-02; Water Management Pond; IMAGE FILES;
