Prepared for
BW Gold Ltd.
3083-595 Burrard Street
Vancouver, British Columbia V7X 1L3
Canada

Prepared by
Knight Piésold Ltd.
1400-750 West Pender Street
Vancouver, British Columbia V6C 2T8
Canada

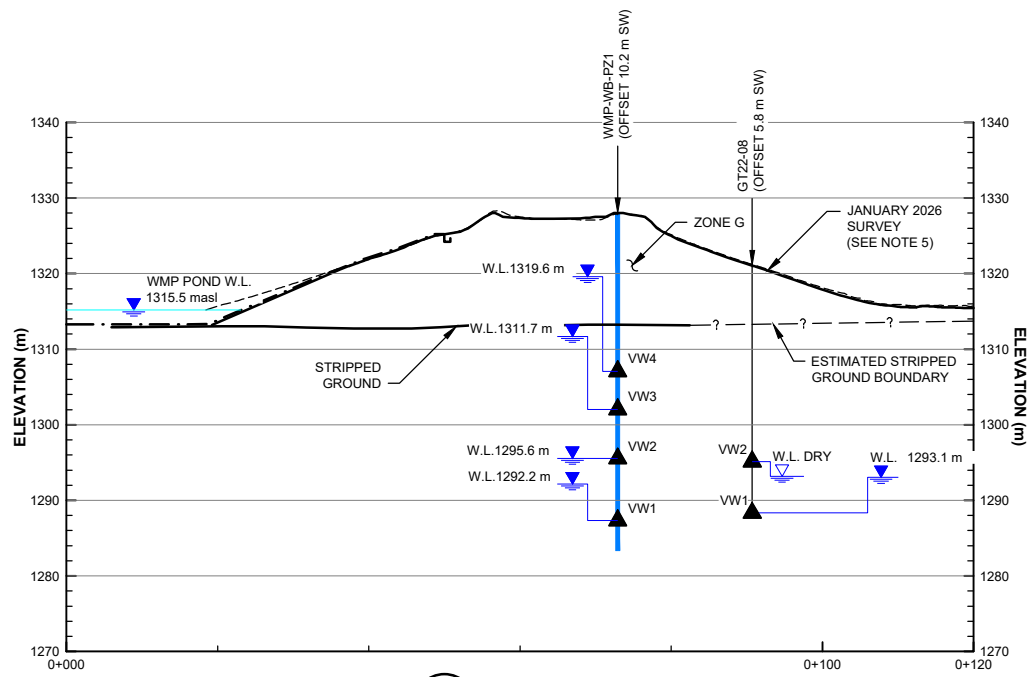
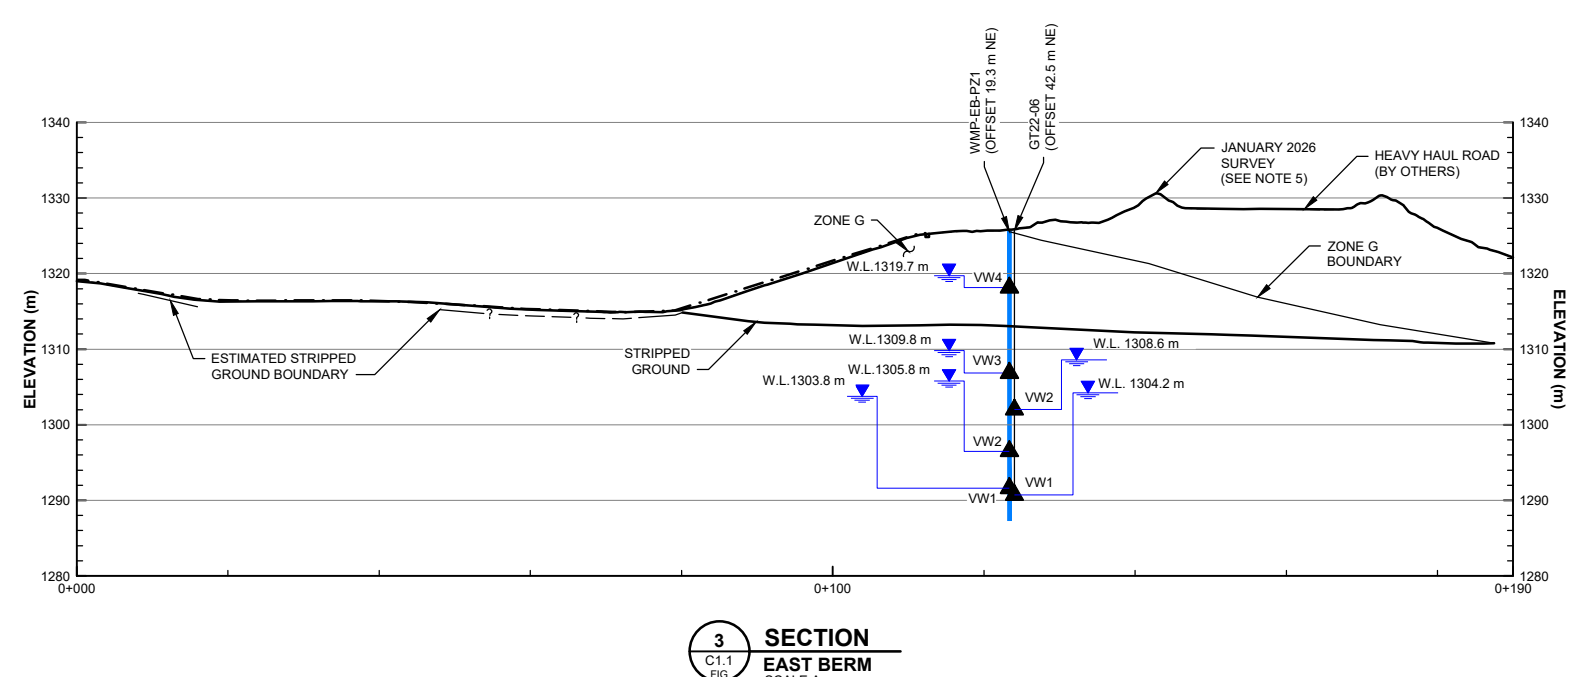
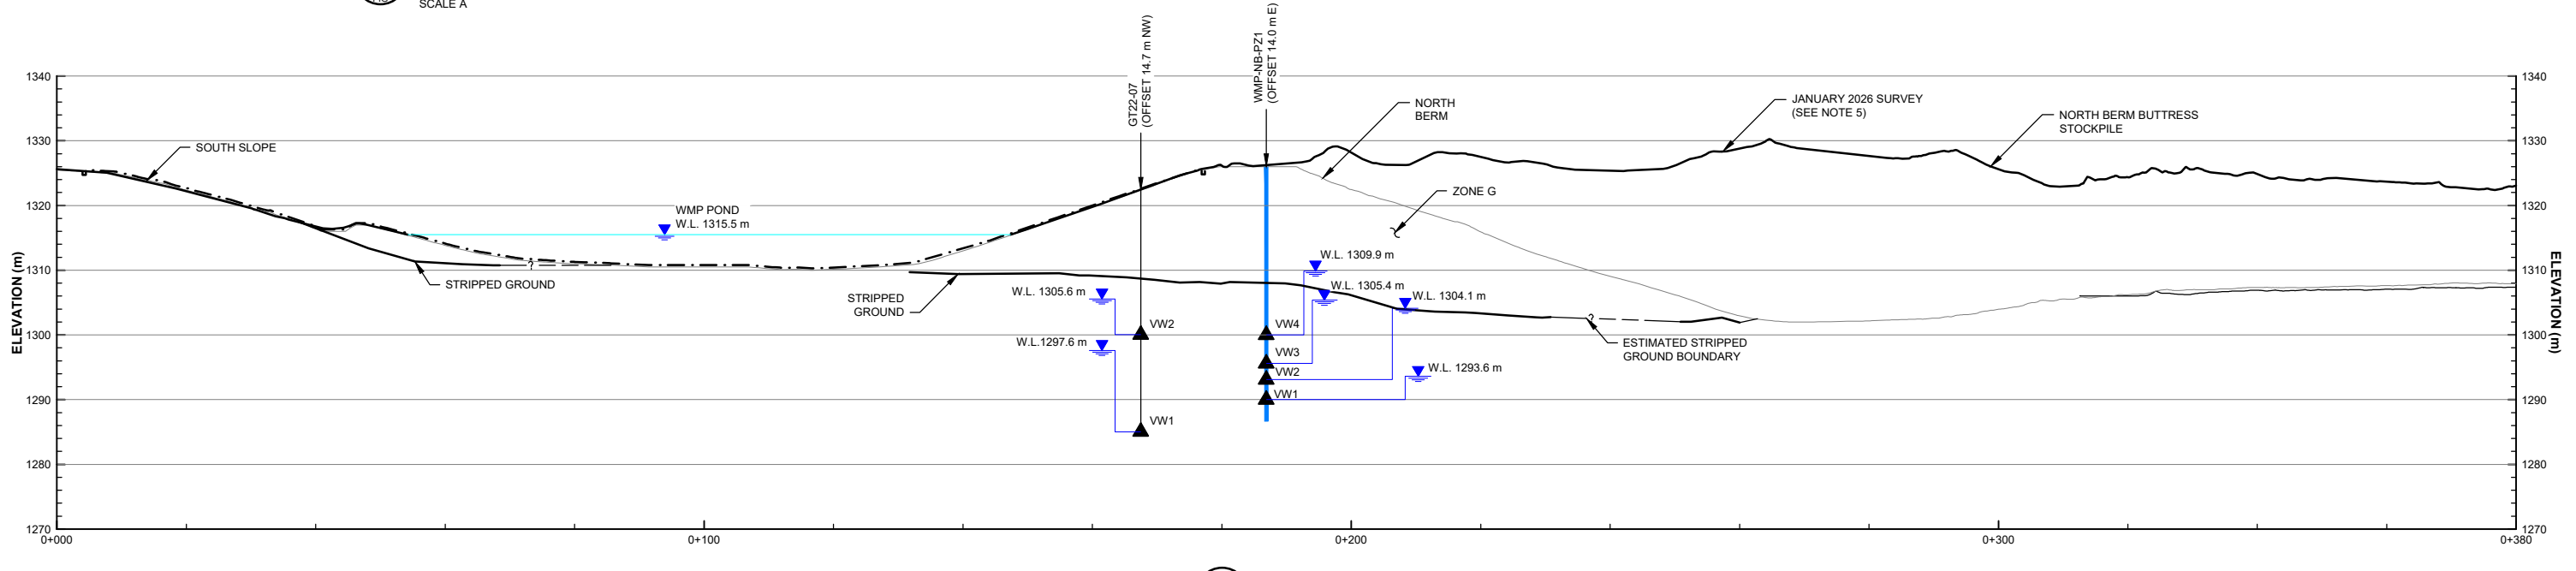
- LEGEND:**
- GENERAL FILL / ZONE G
 - VIBRATING WIRE PIEZOMETER (VWP)
 - W.L. XXX PIEZOMETRIC ELEVATION (m)
 - HDPE LINER
 - INCLINOMETER CASING

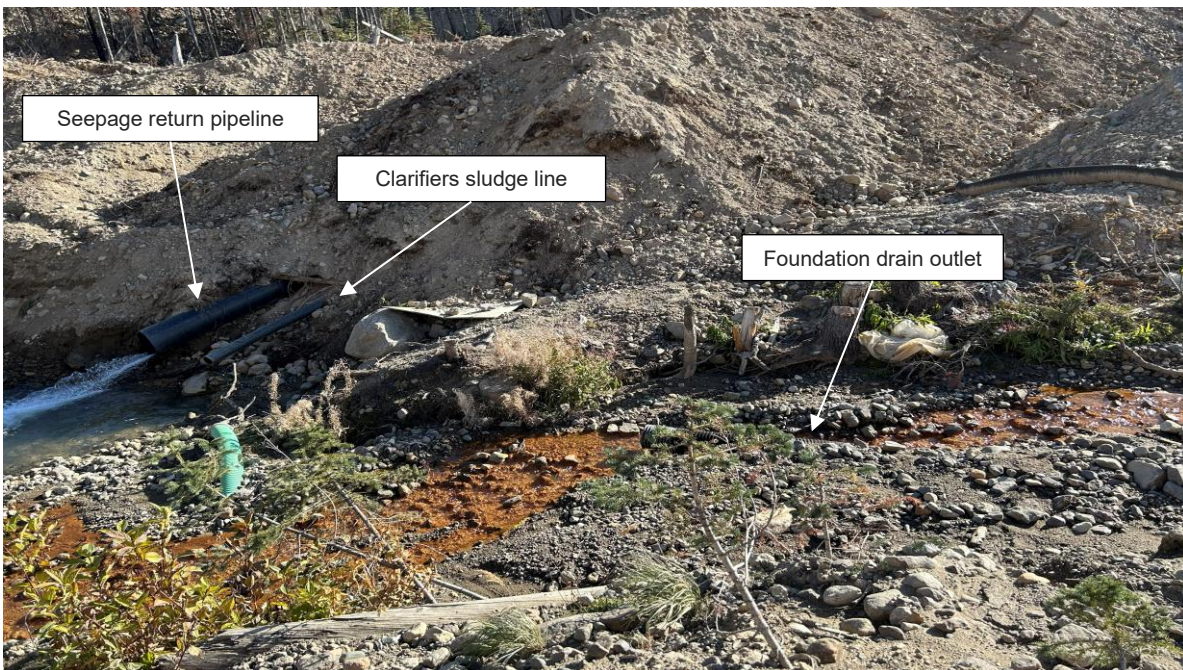
PHOTO 10 – North Berm foundation drain, seepage return pipeline, and clarifiers sludge line discharge downstream of spillway outlet, looking southeast (Photo taken on October 16, 2025)

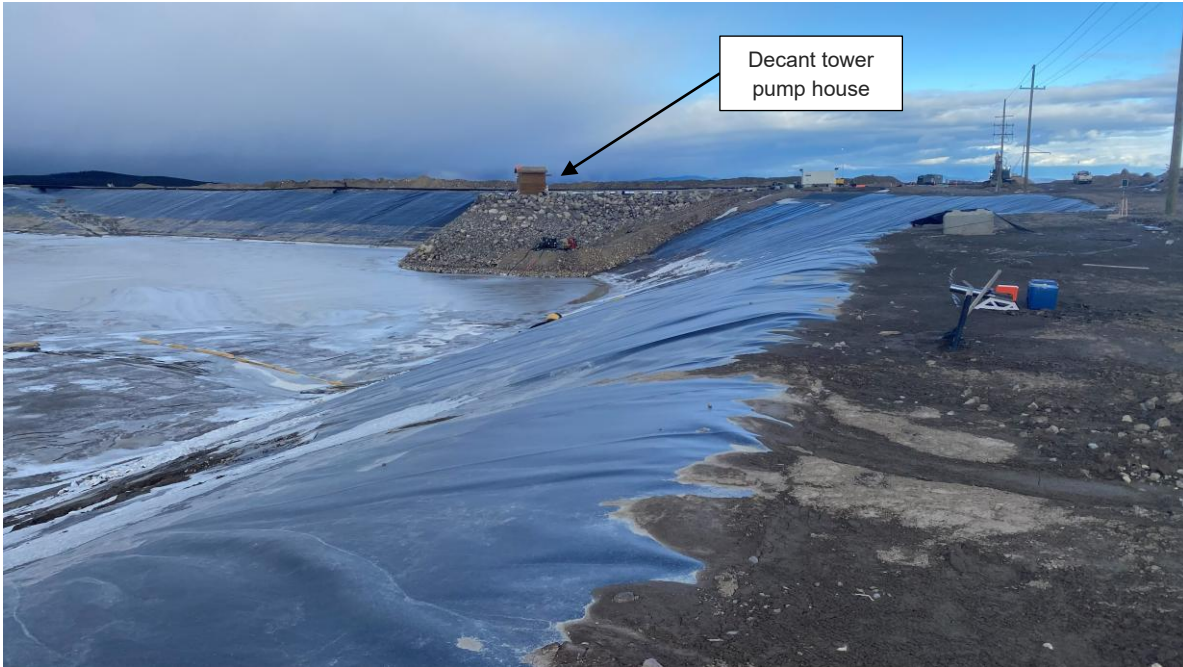
PHOTO 11 – Upstream slope of East Berm and decant tower causeway, looking north (Photo taken on October 13, 2024)

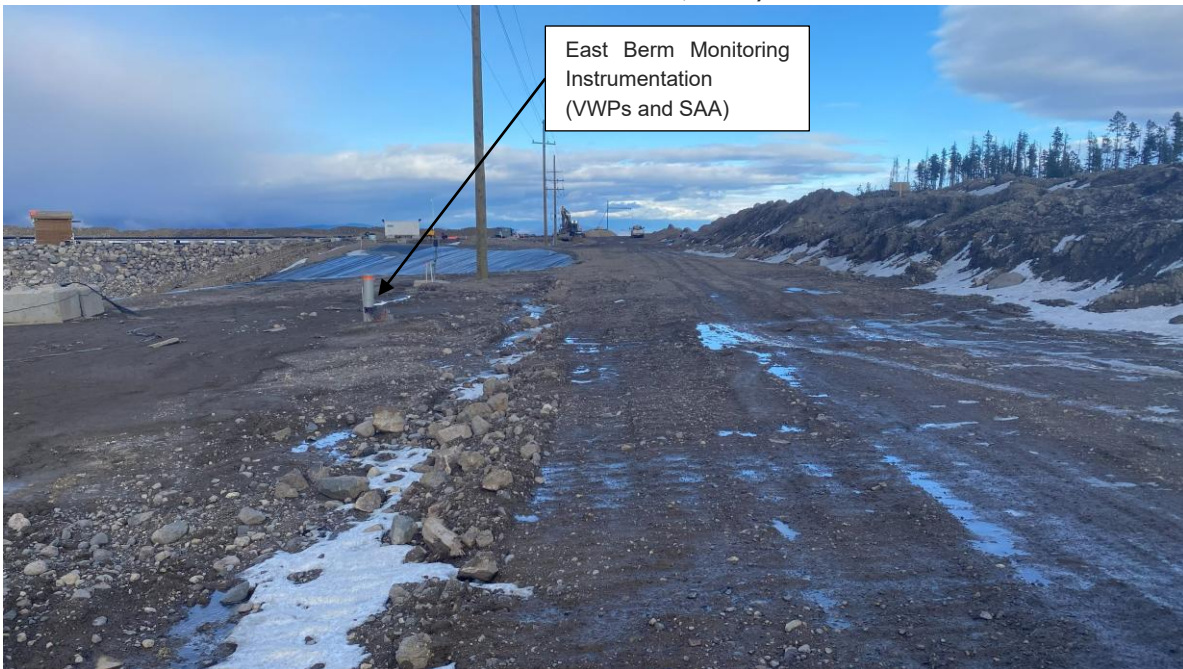
PHOTO 12 – East Berm crest, looking north (Photo taken on October 31, 2025)

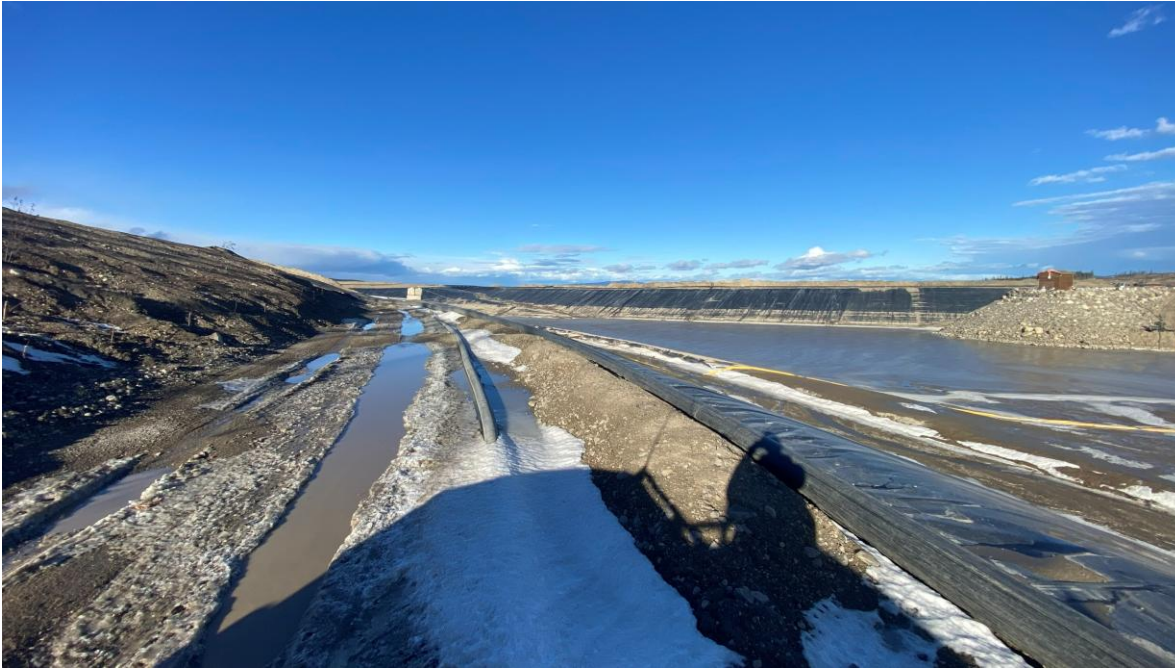
PHOTO 17 – Erosion and minor ponding in vehicle ruts observed on the South slope and bench, respectively, looking north (Photo taken on October 31, 2025)

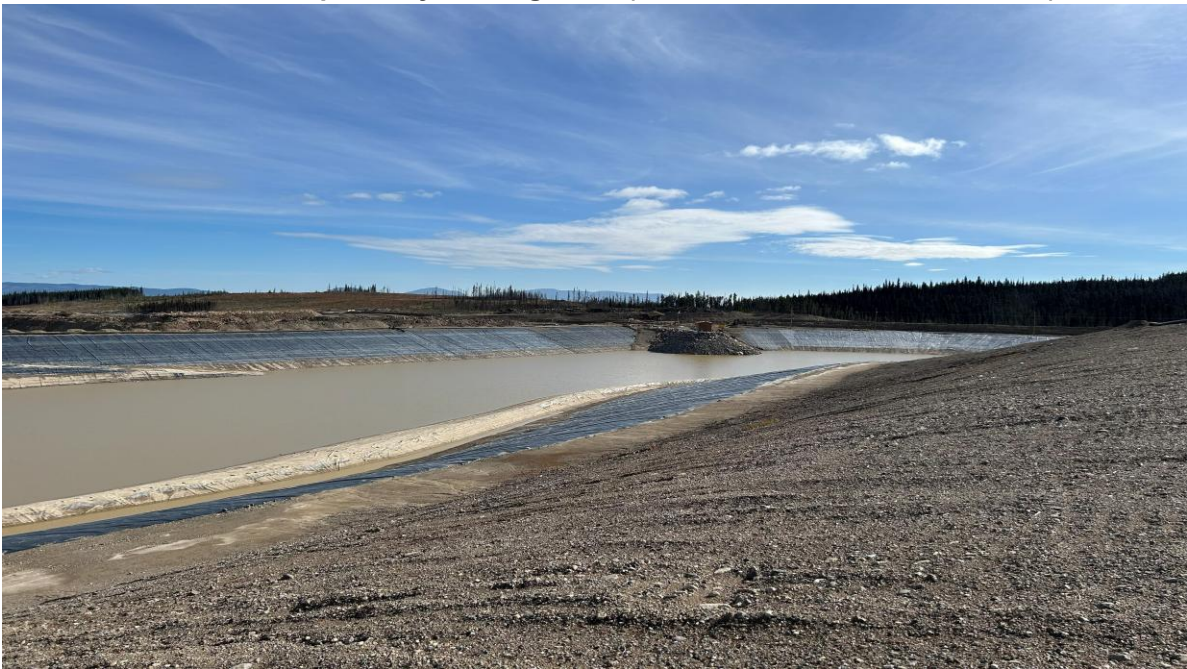
PHOTO 18 – South slopes, looking east to the decant tower causeway (Photo taken on September 19, 2025)

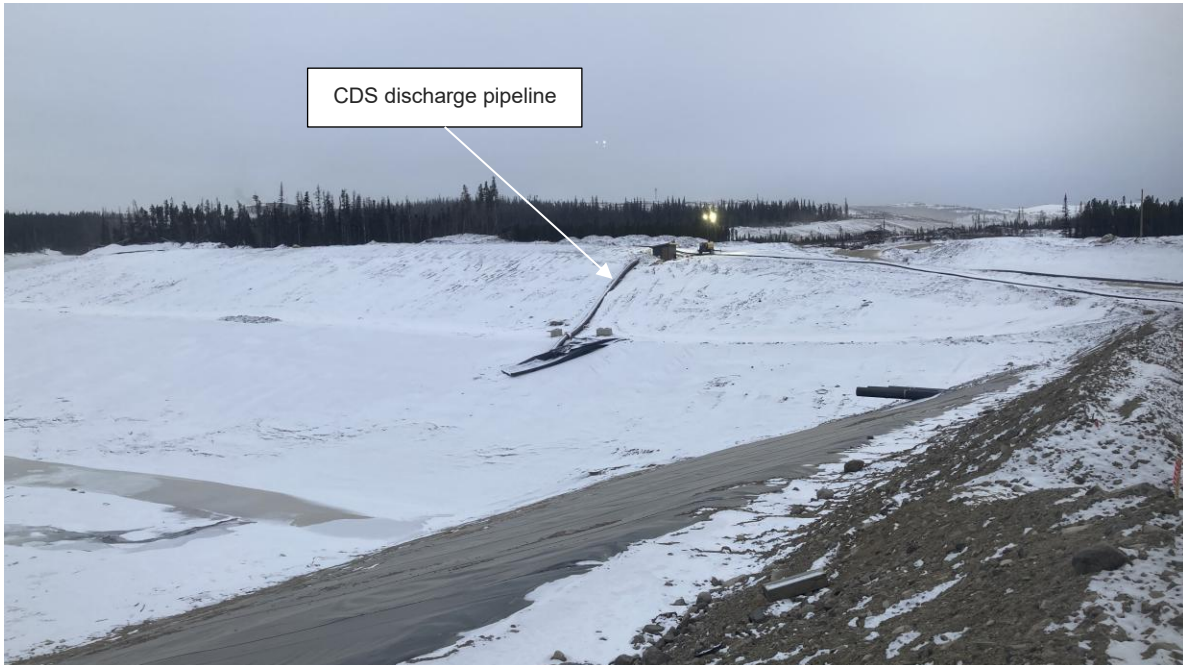
PHOTO 19 – CDS discharge pipeline, looking south (Photo taken on September 19, 2025)

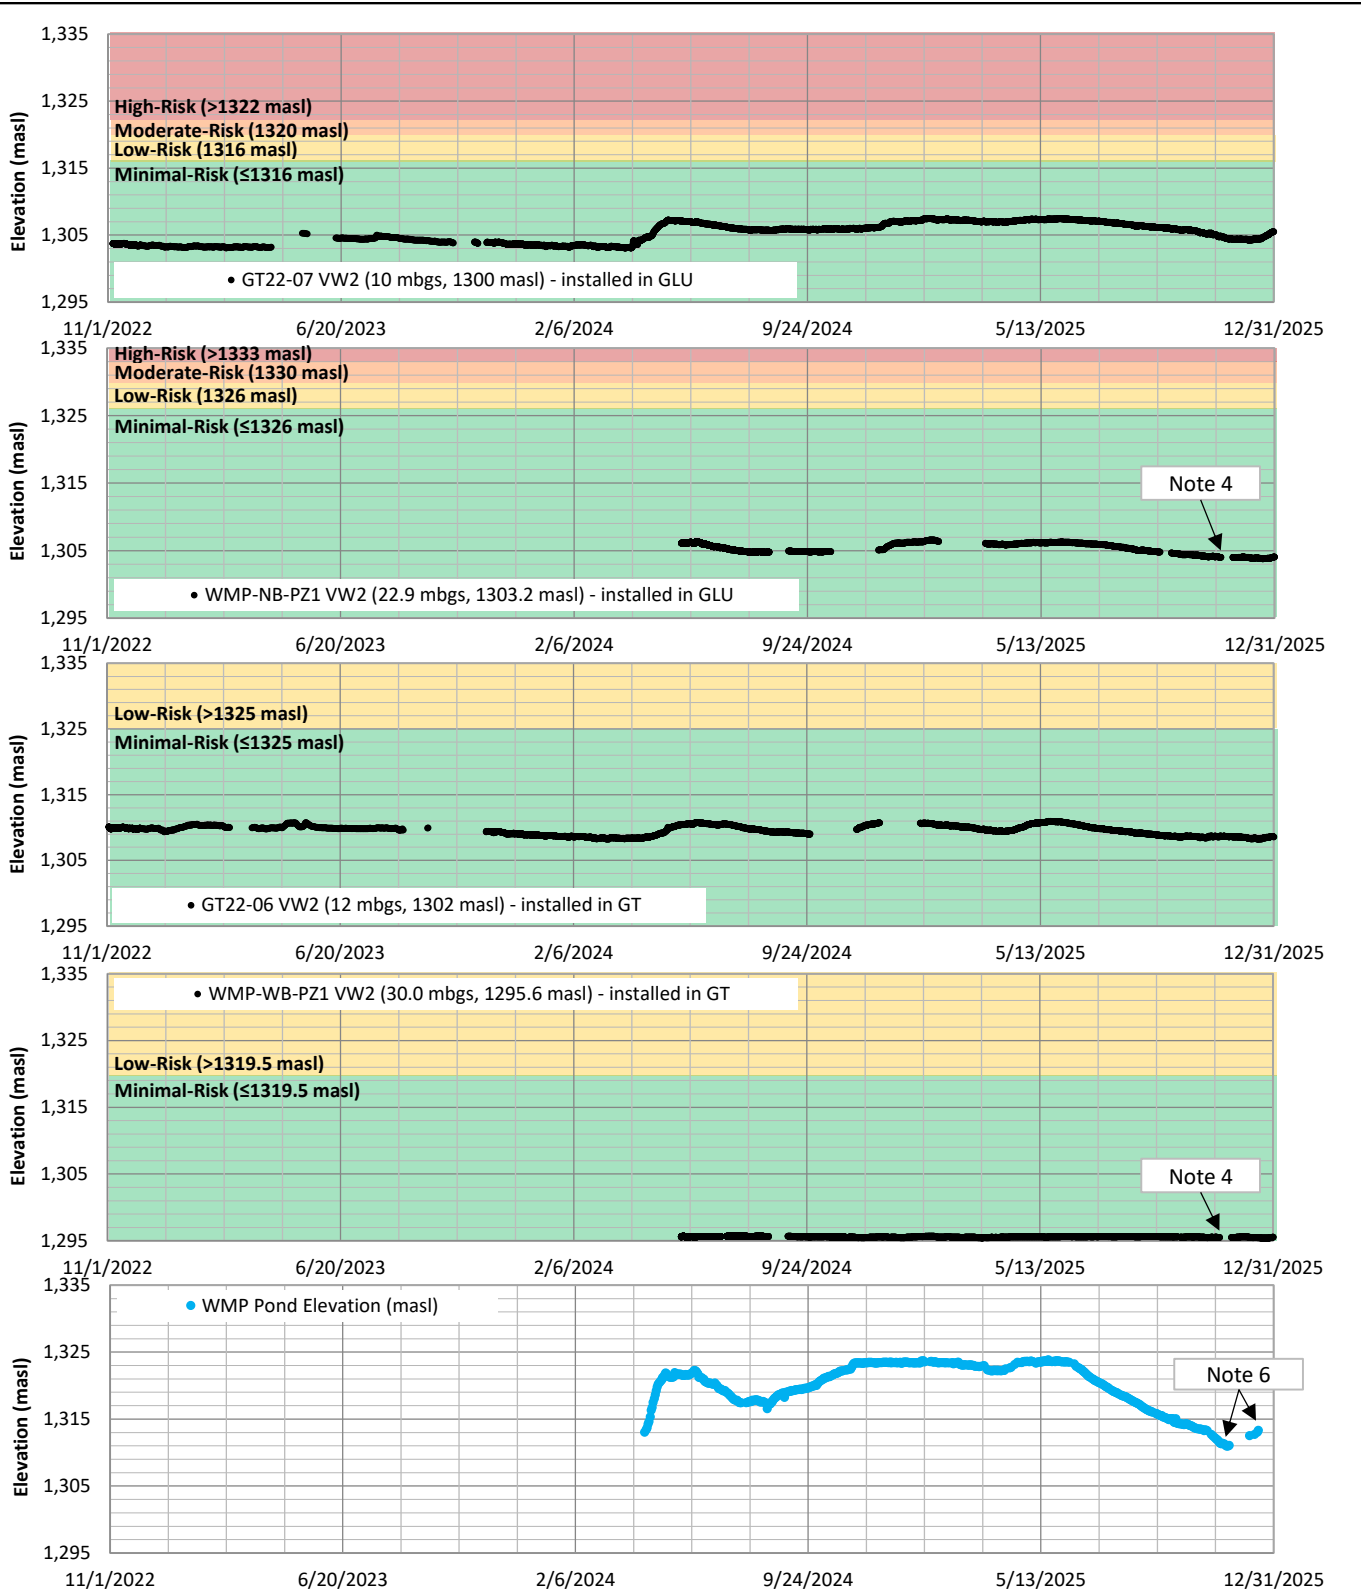
- NOTES:**
1. WMP DATA WERE MANUALLY DOWNLOADED FROM THE DATALOGGER ON DECEMBER 31, 2025.
 2. SENSOR DEPTHS SHOWN IN LEGEND ARE VERTICAL DEPTHS BELOW THE DRILLHOLE COLLAR.
 3. QPO THRESHOLDS FOR EACH SENSOR ARE BASED ON THE VALUES PRESENTED IN VA23-01592 TABLE C.3.
 4. NO DATA WERE AVAILABLE BETWEEN NOVEMBER 7 AND NOVEMBER 19 AS THE DATALOGGER EXPERIENCED CONNECTIVITY ISSUES.
 5. GLU = GLACIOLACUSTRINE; GT = GLACIAL TILL
 6. WMP WATER LEVELS AFTER NOVEMBER 23, 2025 WERE COLLECTED ONLY WHEN SAFE ACCESS TO THE WATER SURFACE WAS POSSIBLE.

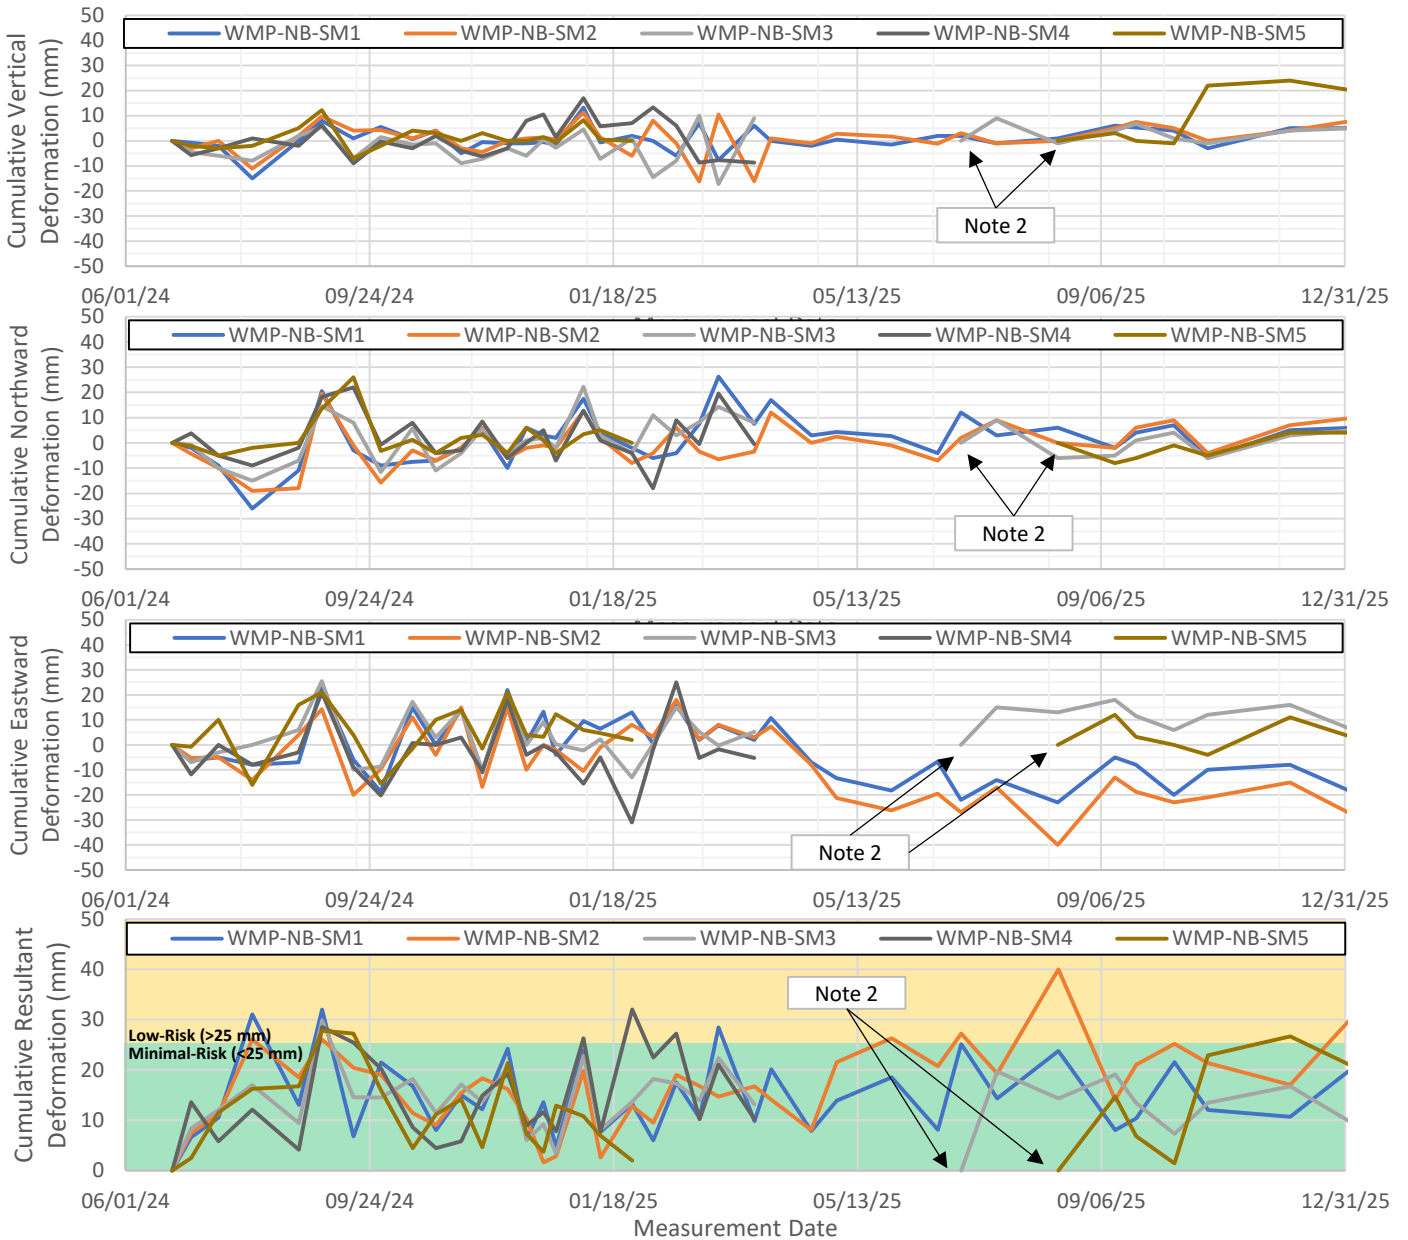
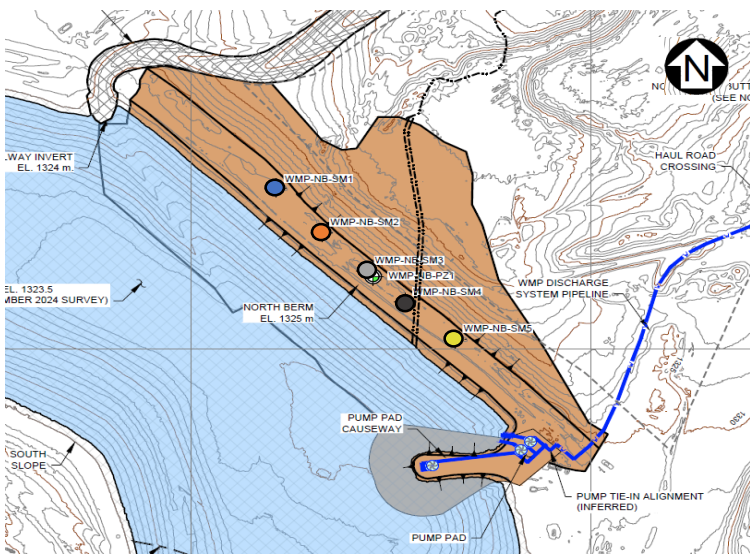
- NOTES:**
1. INSTRUMENT MEASUREMENT ACCURACY FOR TRIMBLE DGPS IS UNDERSTOOD TO BE +/- 0.02 m.
 2. DGPS SURVEY MONUMENTS WERE DAMAGED OR COVERED DURING NEARBY CONSTRUCTION ACTIVITIES. MONUMENTS HAVE BEEN RE-ESTABLISHED AND DATA HAVE BEEN RE-BASELINED, IF NEEDED.
 3. GNSS INSTRUMENTATION HAS BEEN INSTALLED AT WMP-NB-SM3; HOWEVER, THE INSTRUMENTATION HAS BEEN OFFLINE SINCE INSTALLATION DUE TO CONNECTIVITY ISSUES. KP AND BWG ARE CURRENTLY TROUBLESHOOTING.

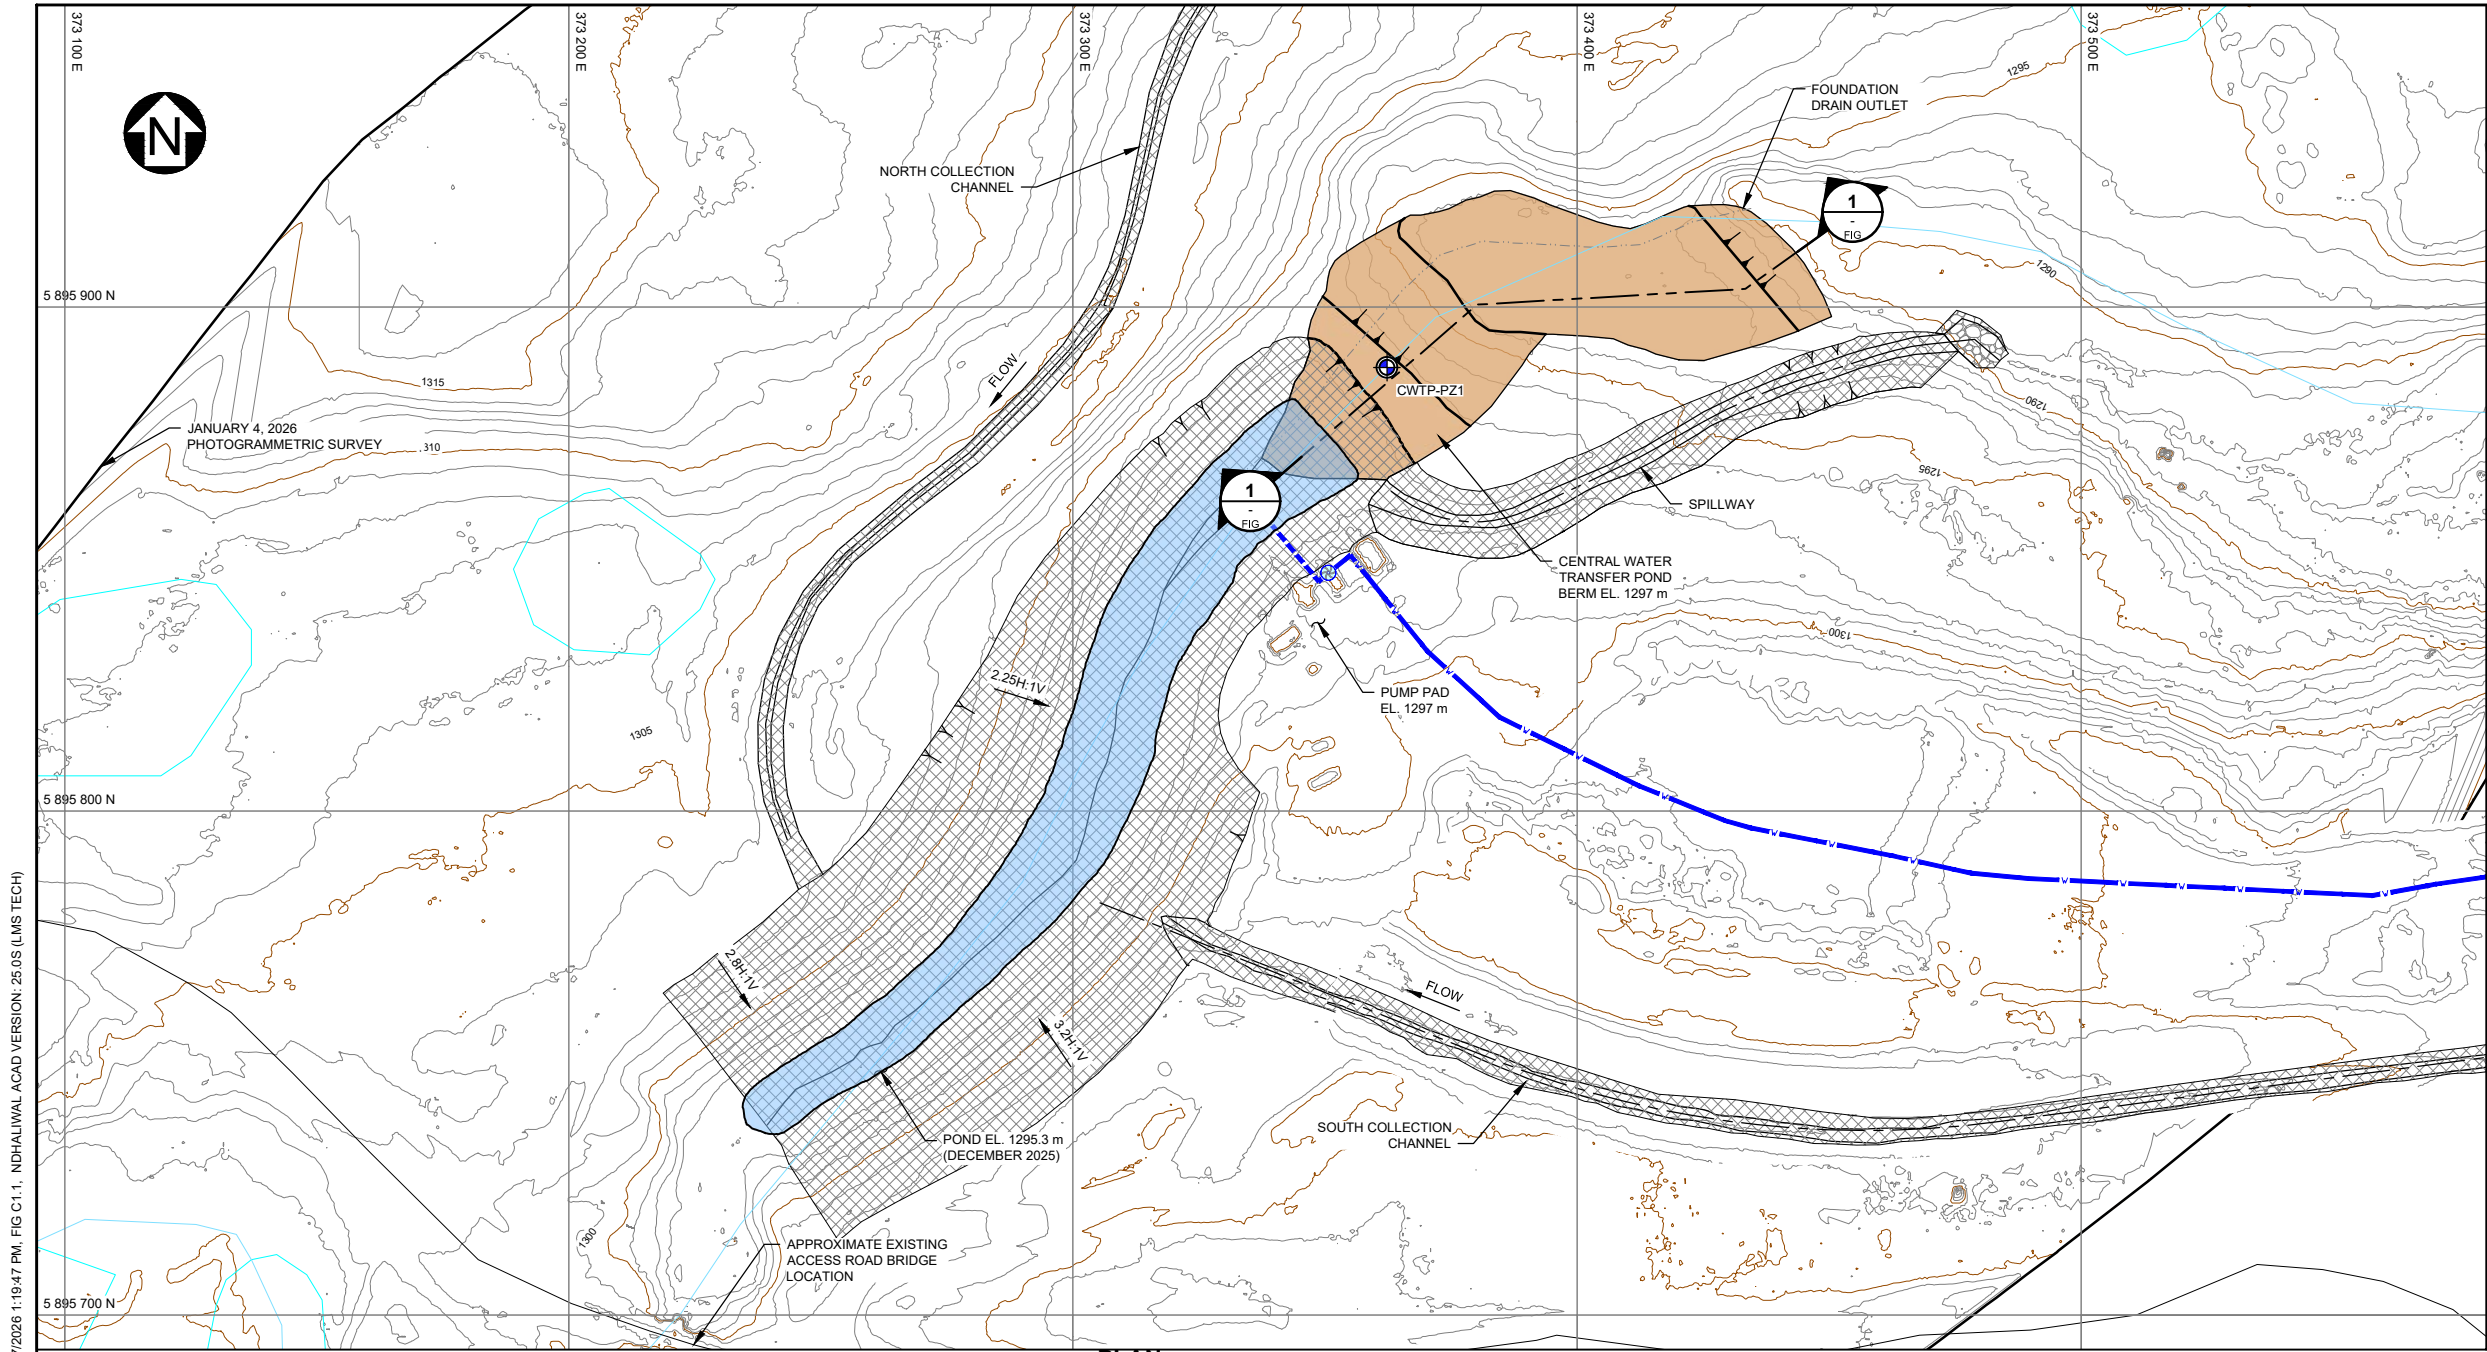
- LEGEND:**
- EMBANKMENT FILL
 - ZONE G
 - HDPE LINER
 - FRESH WATER
 - EXISTING ACCESS TRAILS
 - FOUNDATION DRAIN
 - CDS DISCHARGE PIPELINE (AS-BUILT)
 - + DRILLHOLE WITH VWP
 - ▲ VIBRATING WIRE PIEZOMETER (VWP)
 - ▼ W.L. XXX
PIEZOMETRIC ELEVATION (m)

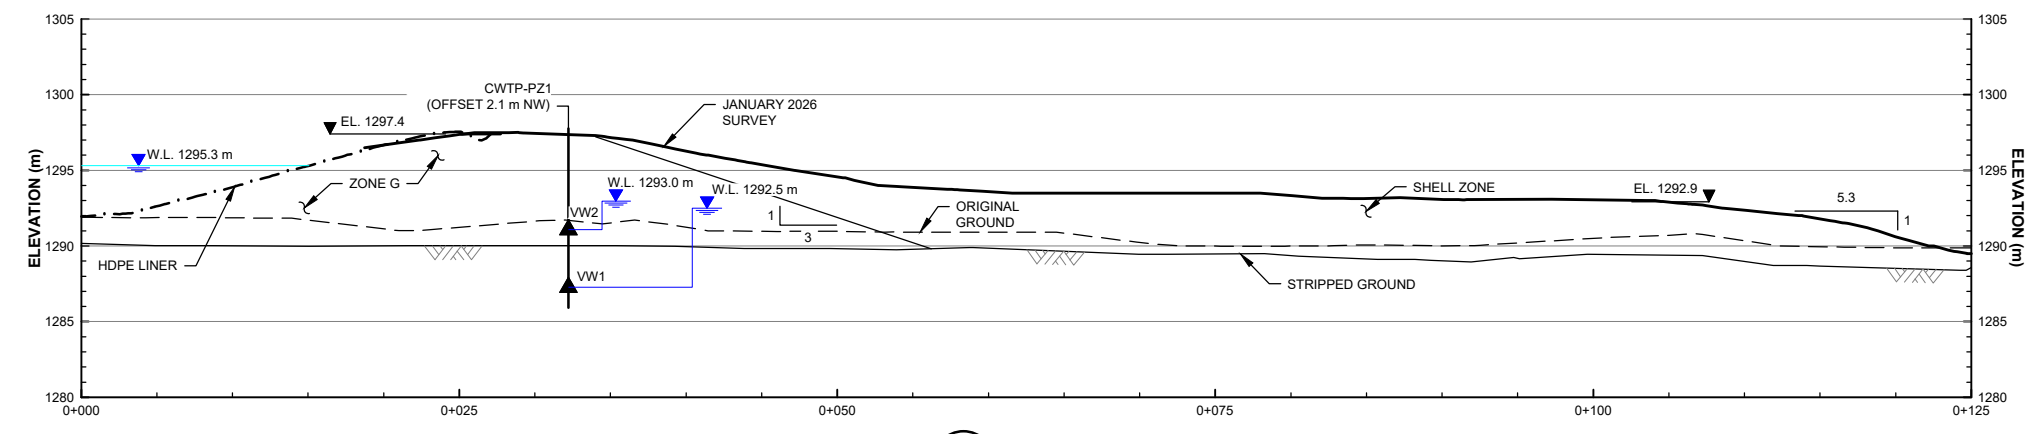
BW GOLD LTD.
BLACKWATER MINE
CENTRAL DIVERSION SYSTEM
CENTRAL WATER TRANSFER POND
PIEZOMETRIC MONITORING INSTRUMENTATION

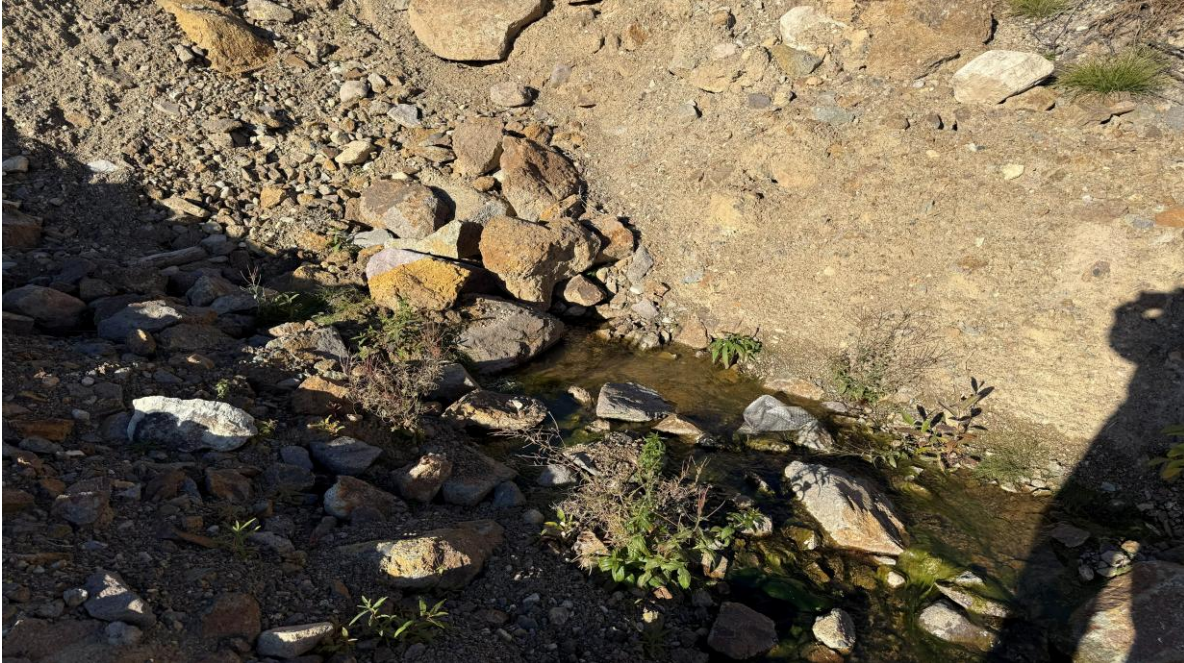
PHOTO 9 – CWTP foundation drain outlet (Photo taken on October 13, 2025)

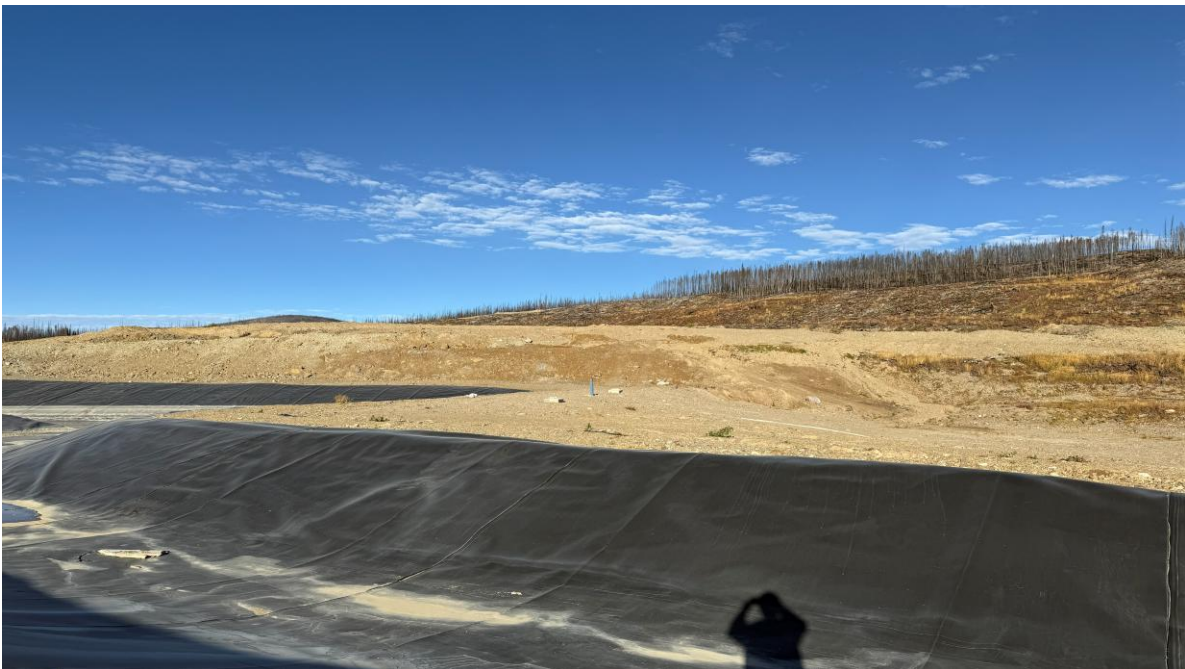
PHOTO 10 – CWTP spillway, looking northwest (Photo taken on October 13, 2025)

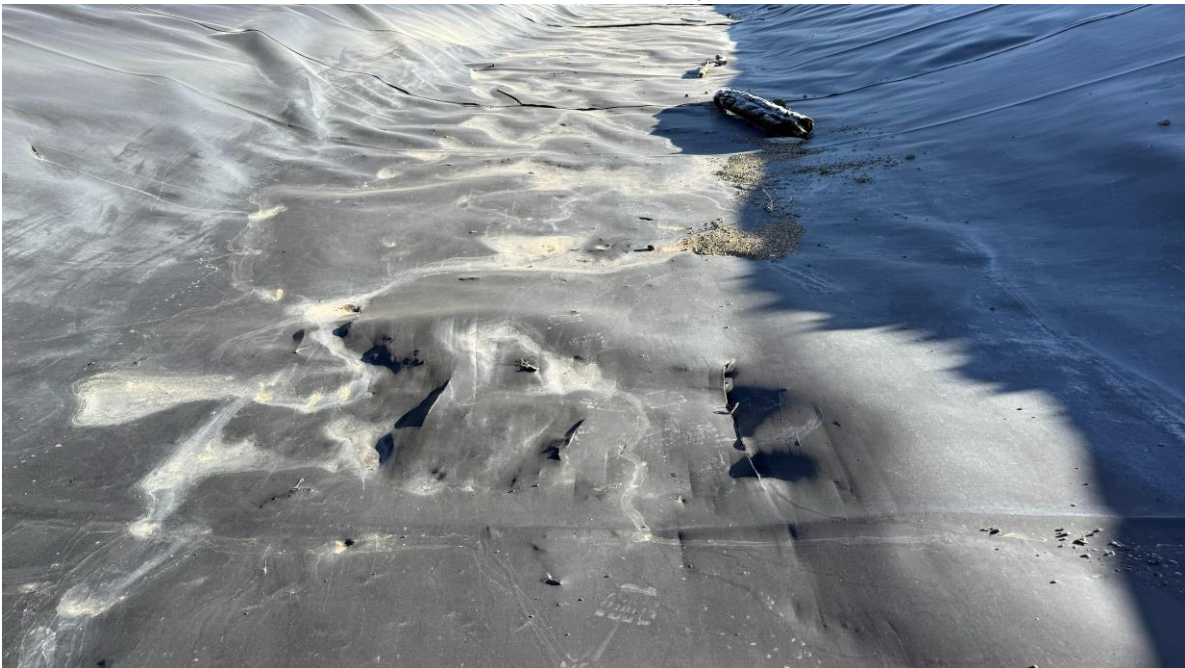
PHOTO 12 – CWTP spillway HDPE liner damage (Photo taken on October 13, 2025)

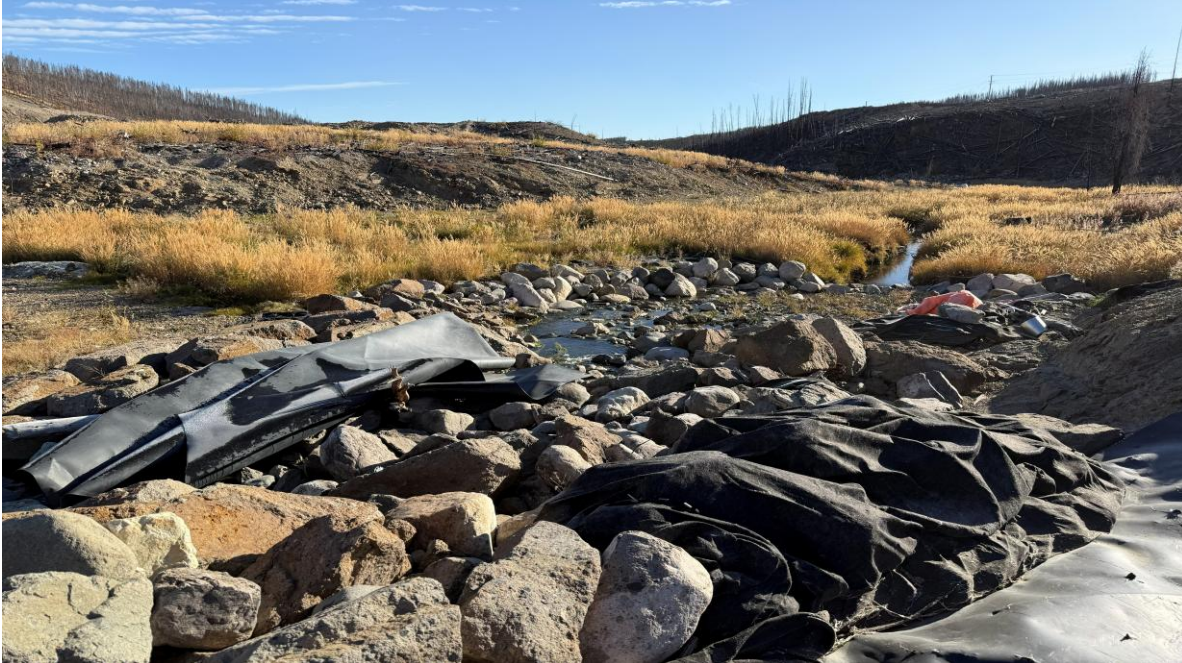
**PHOTO 13 – CWTP spillway stilling basin and deformed HDPE liner, looking northeast
(Photo taken on October 13, 2025)**

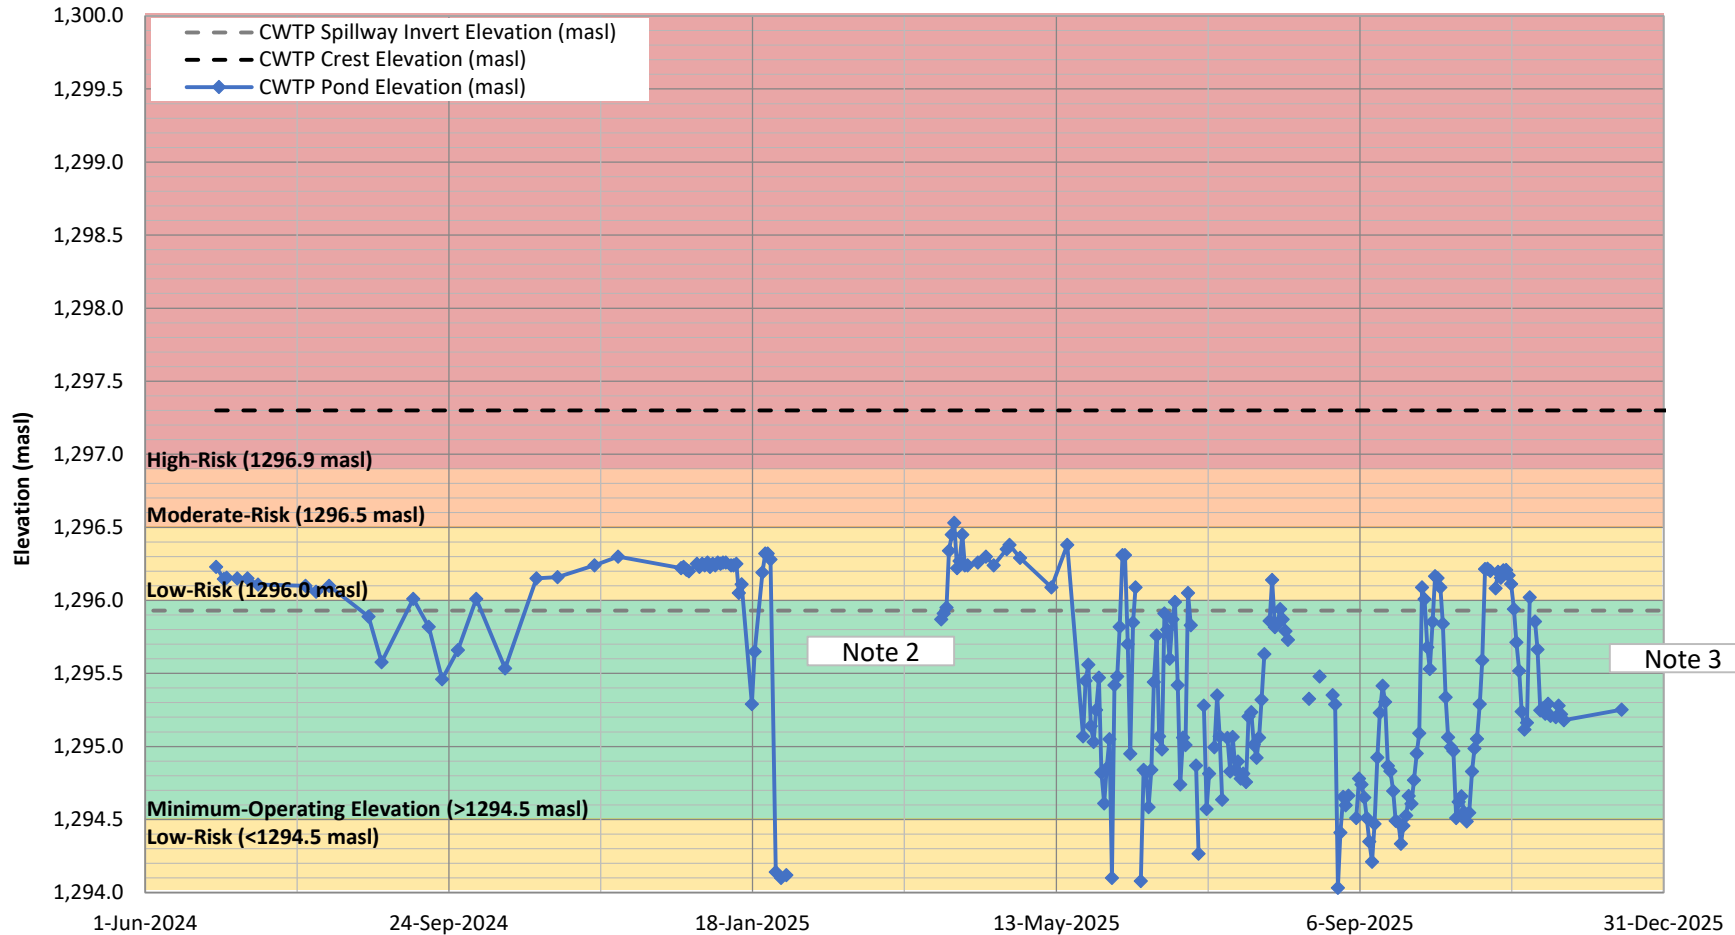
0	27MAR'26	ISSUED WITH REPORT VA101-457/58-1	SY3	KTD
REV	DATE	DESCRIPTION	PREP'D	RW'D
