Prepared for
BW Gold Ltd.
3083-595 Burrard Street
Vancouver, British Columbia V7X 1L3
Canada

Prepared by
Knight Piésold Ltd.
1400-750 West Pender Street
Vancouver, British Columbia V6C 2T8
Canada

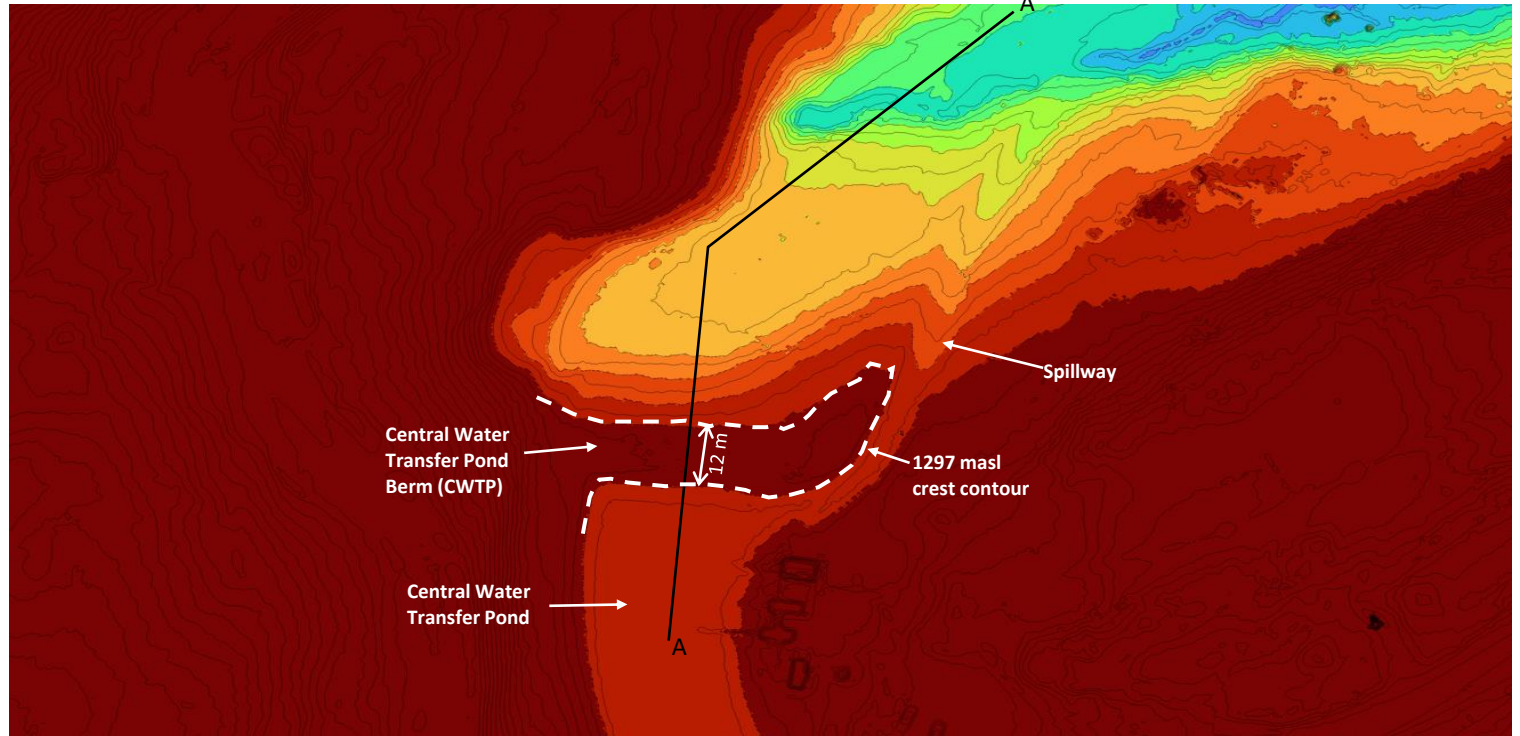
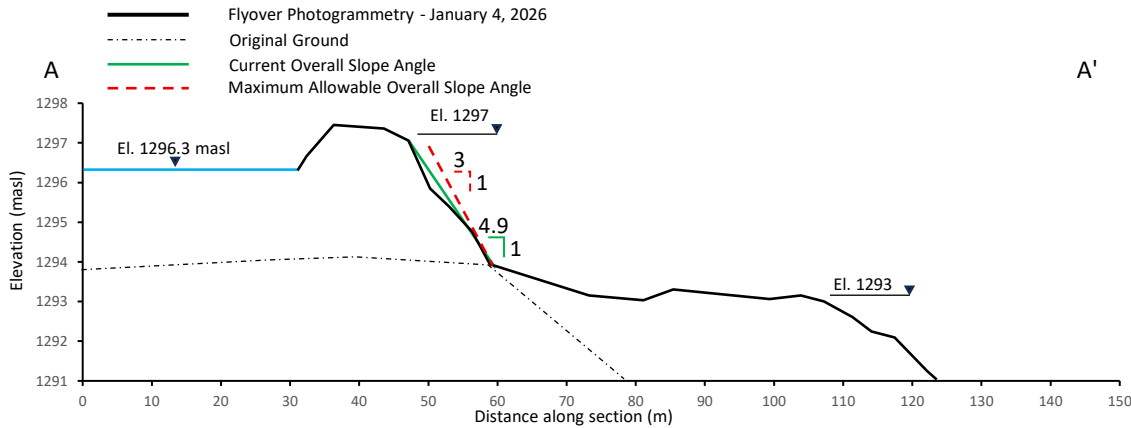
GROUND SURFACE
ELEVATION (masl)

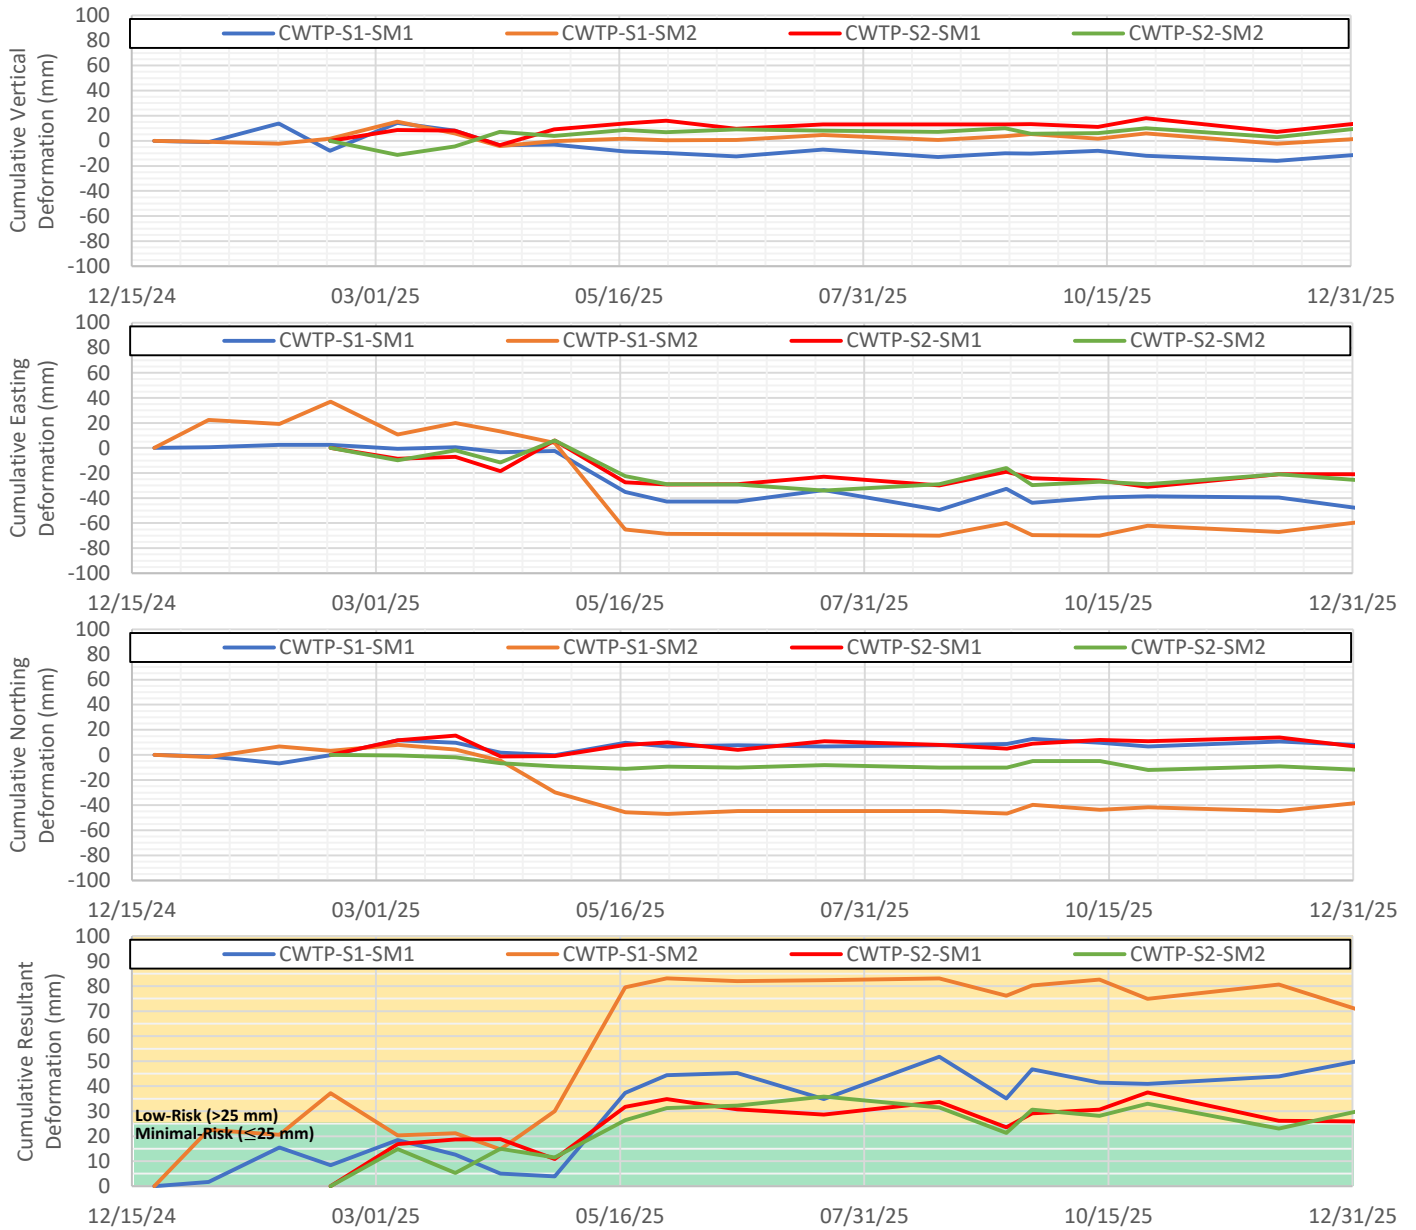
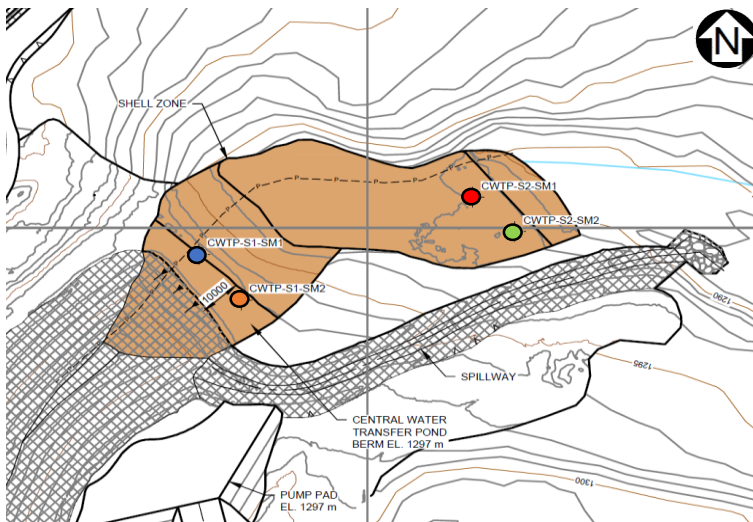
NOTES:
 1. INSTRUMENT MEASUREMENT ACCURACY FOR TRIMBLE DGPS IS UNDERSTOOD TO BE +/- 0.02 m.

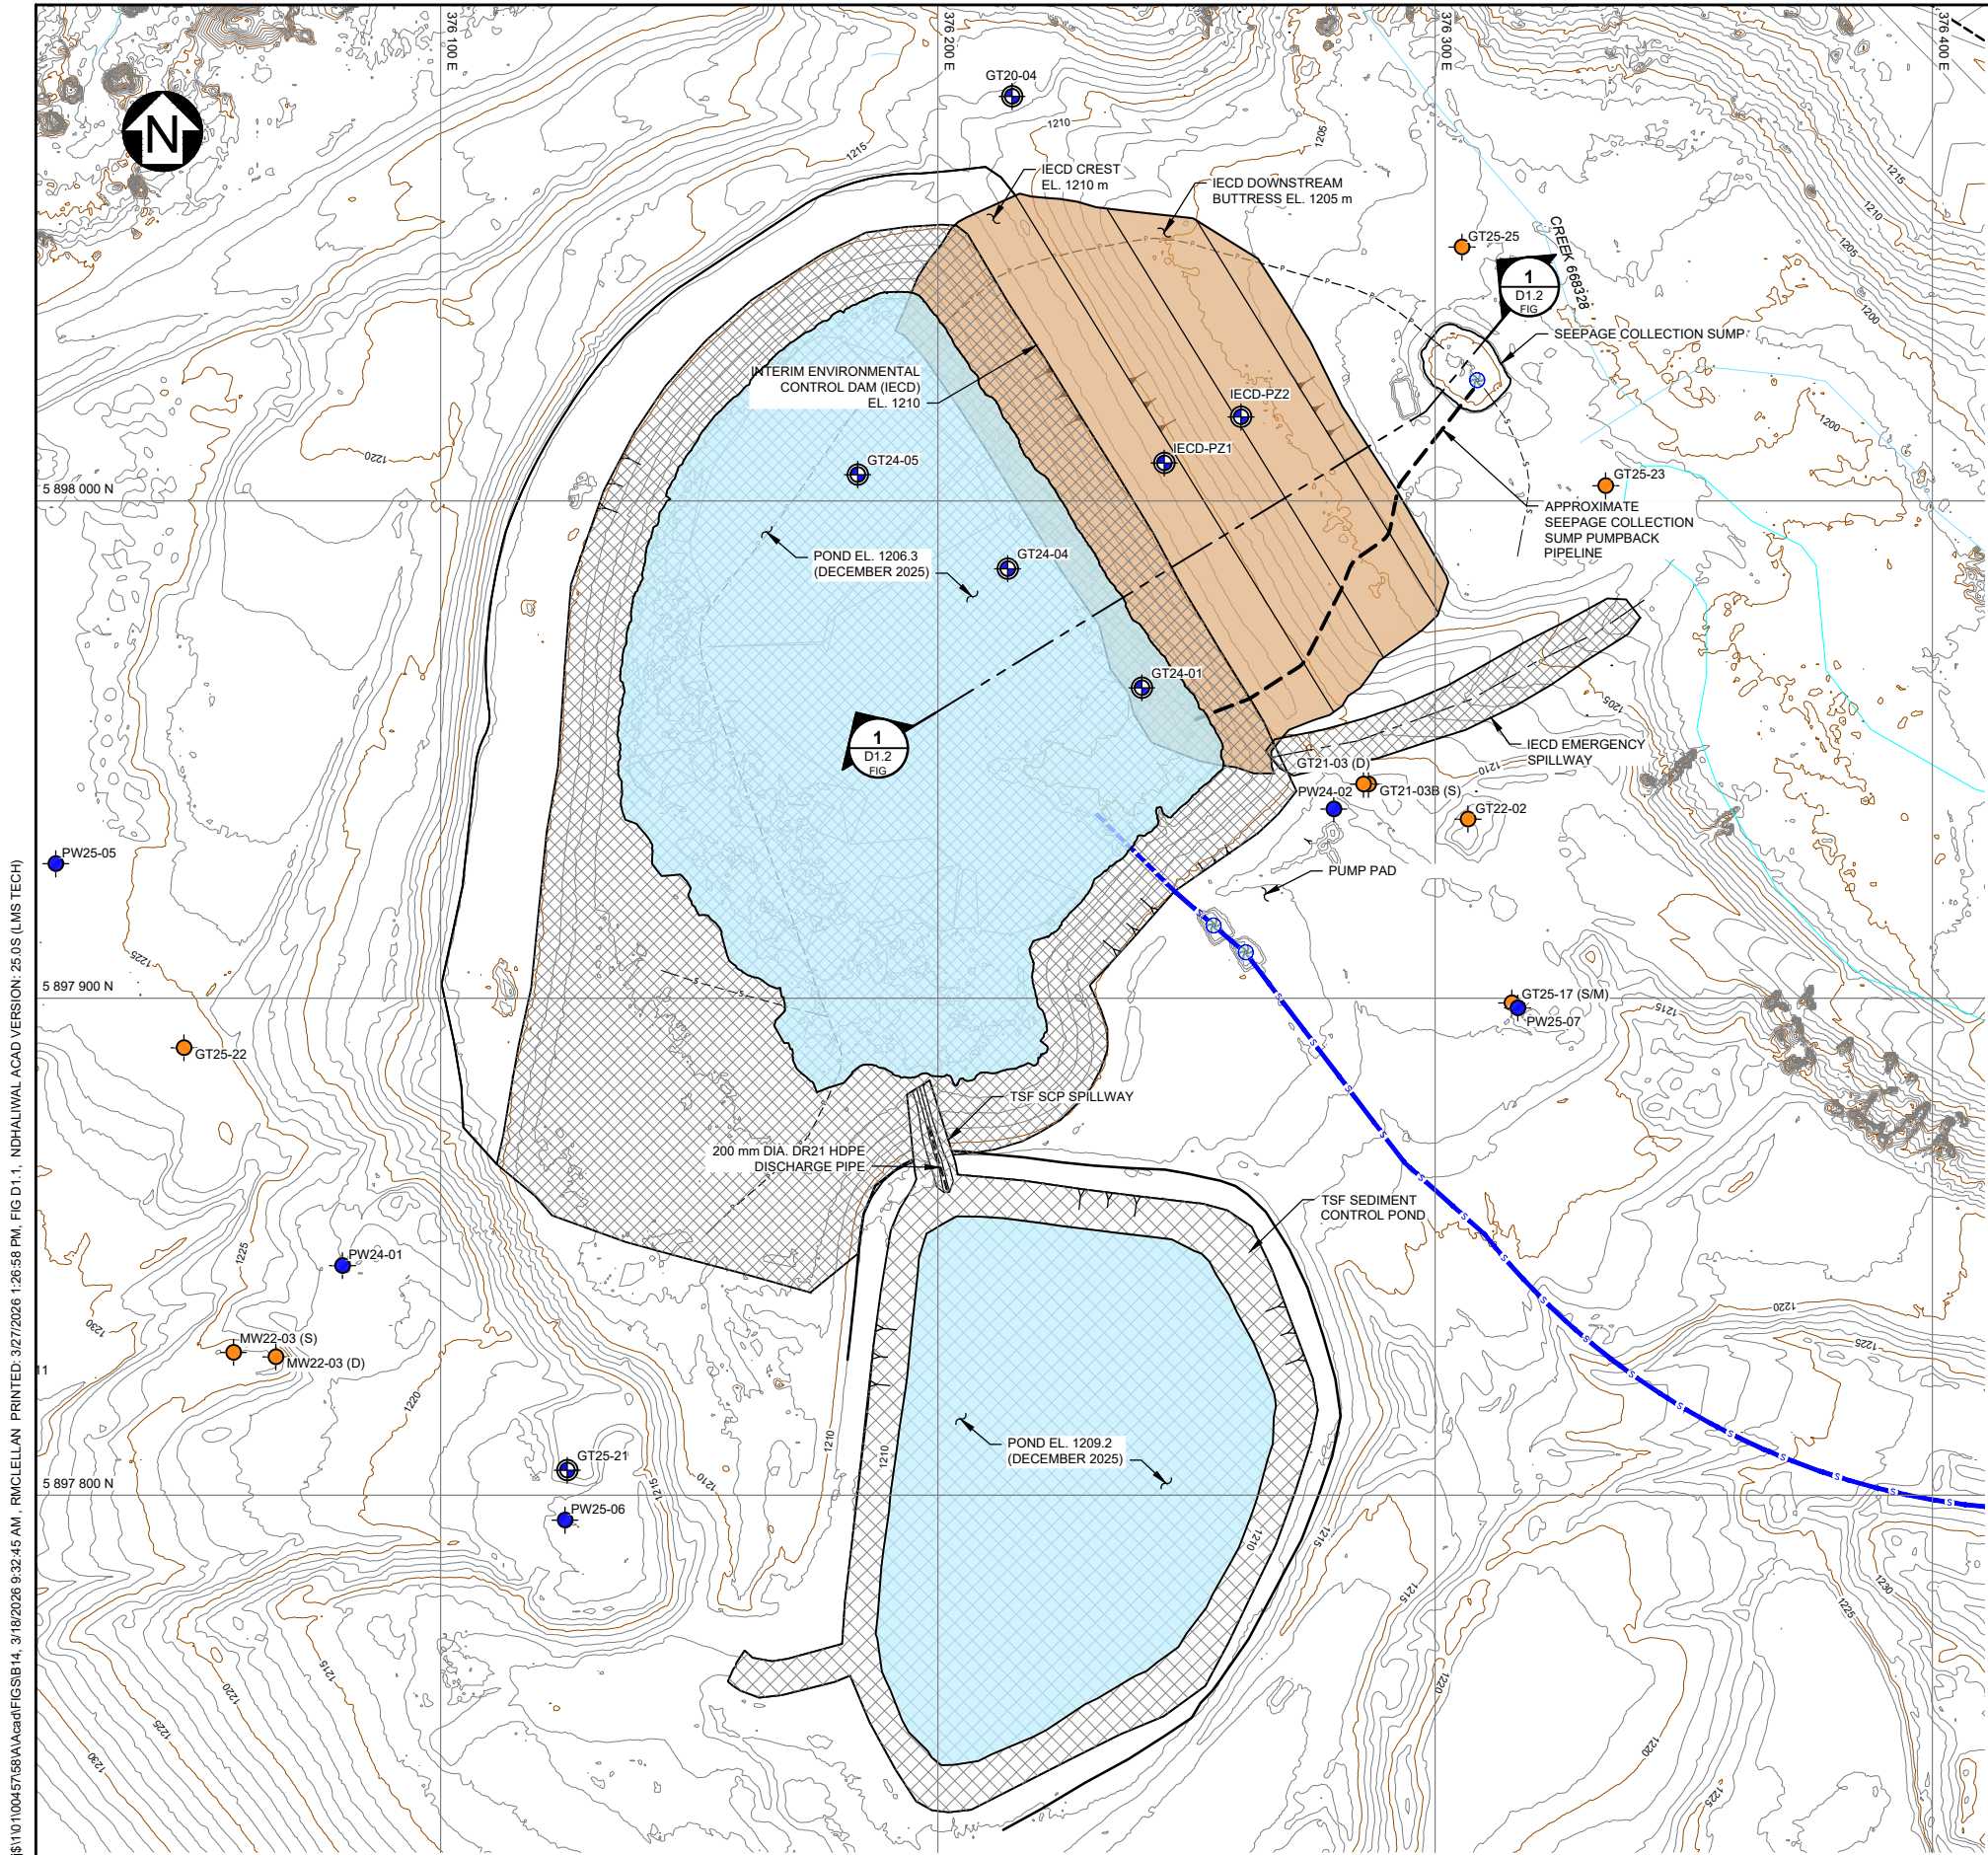
SAVED: \\KPL\VA-P\B\11010045758\A\Acad\FIGS\B14_3\18\2026 9:32:45 AM, RMCLELLAN PRINTED: 3/27/2026 1:26:58 PM, FIG D1.1, NDHALIWA ACAD VERSION: 25.05 (LMS TECH)

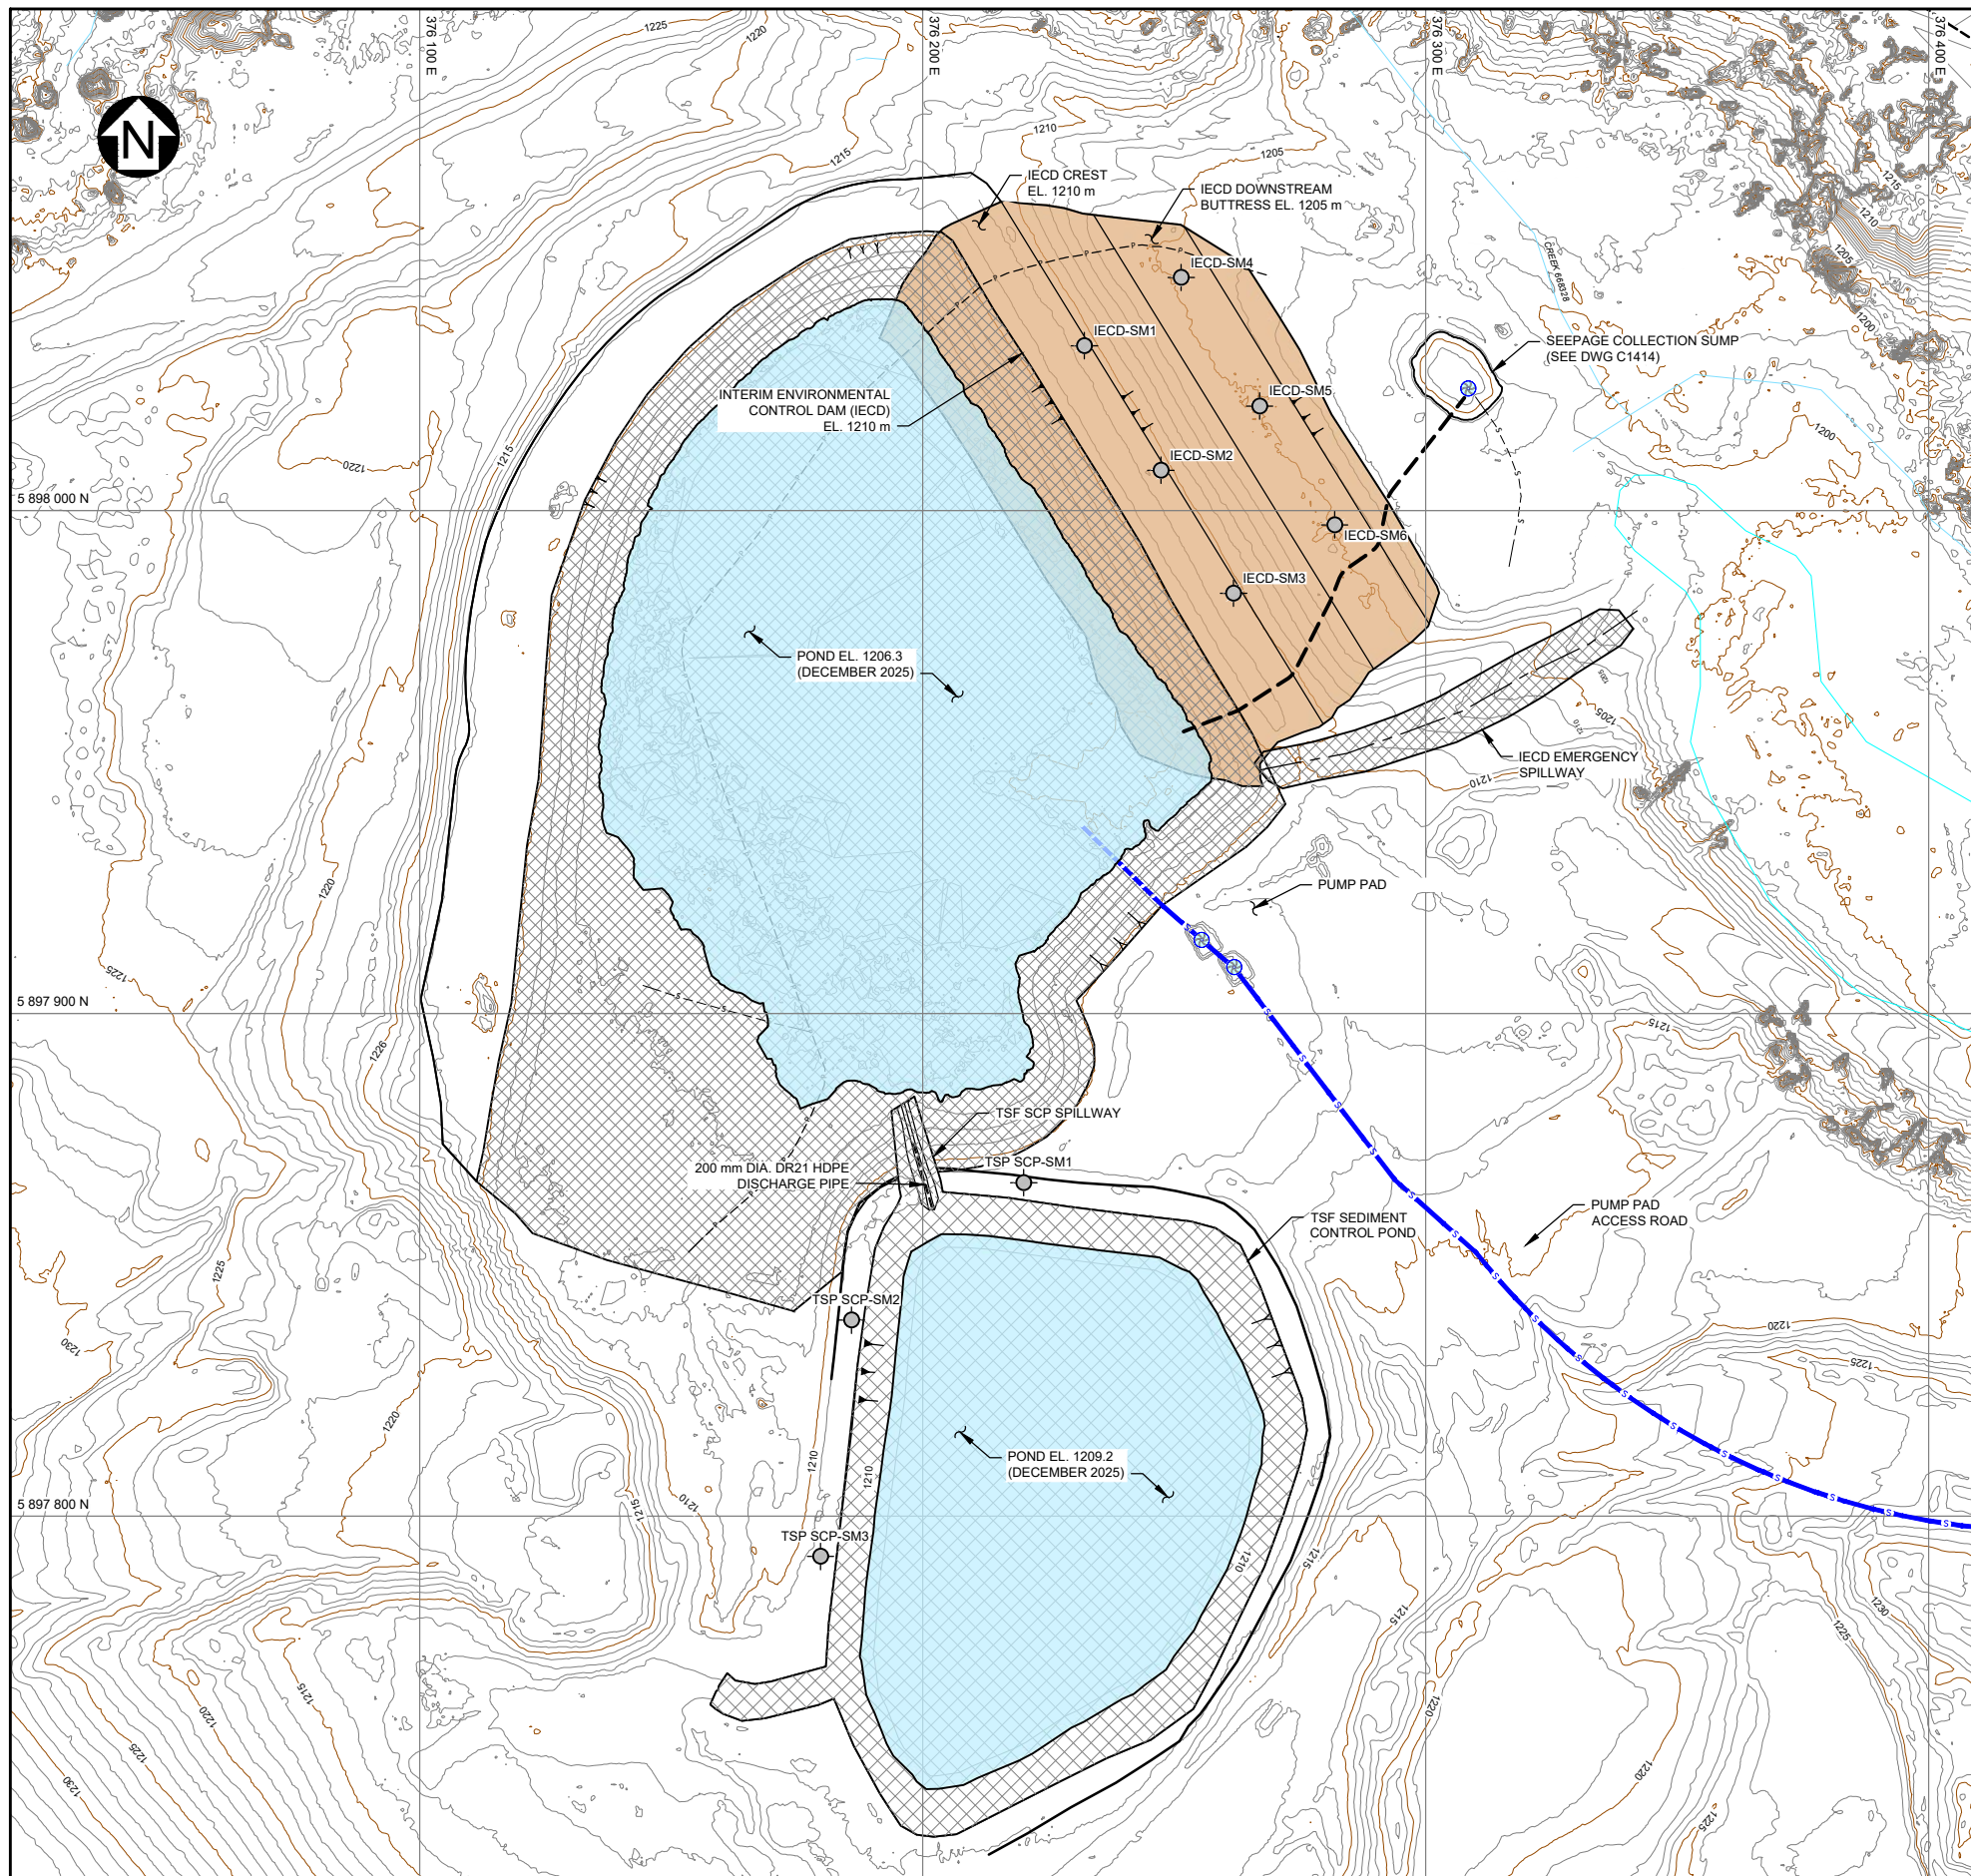
- LEGEND:**
- EMBANKMENT FILL
 - HDPE LINER
 - DGPS SURVEY - MONUMENT
 - PUMP
 - SEEPAGE PUMPBACK PIPELINE (DESIGN)
 - PRIMARY FOUNDATION DRAIN
 - SECONDARY FOUNDATION DRAIN
 - ACCESS ROAD

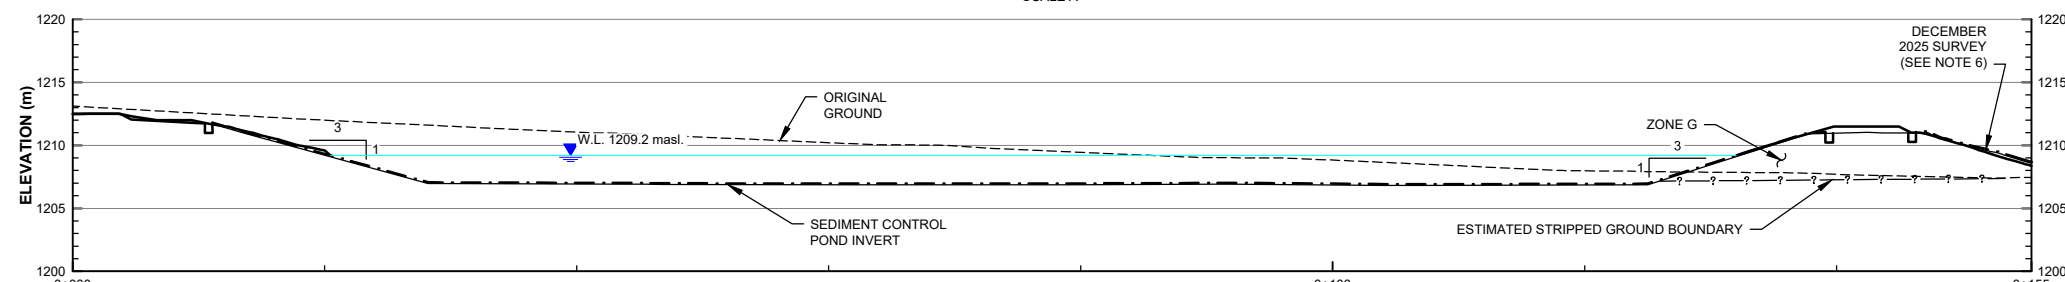
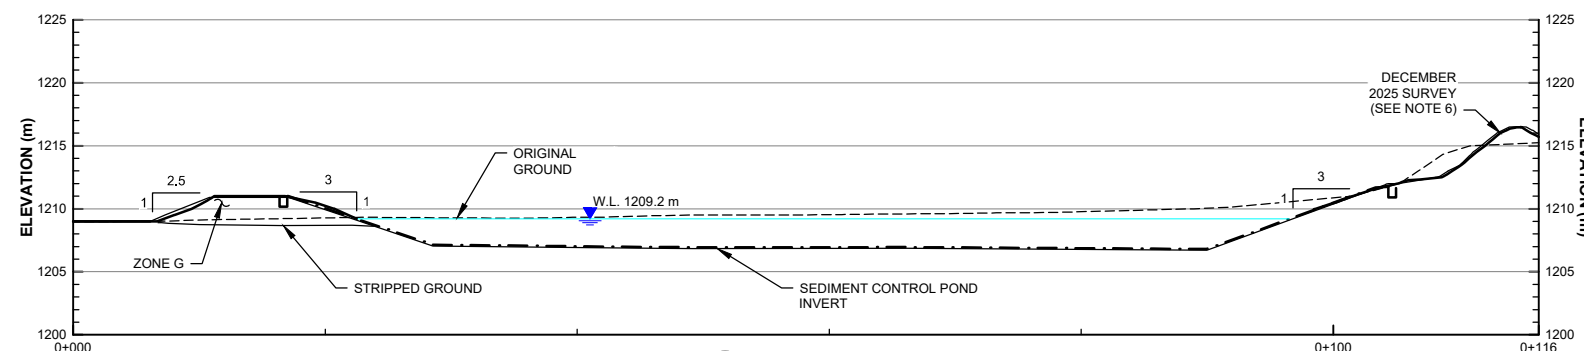
BW GOLD LTD.	
BLACKWATER MINE	
TSF C SEDIMENT CONTROL POND PLAN AND SECTIONS	
	P/A NO. VA101-457/58
FIGURE D1.4	
REF NO. 1	REV 0

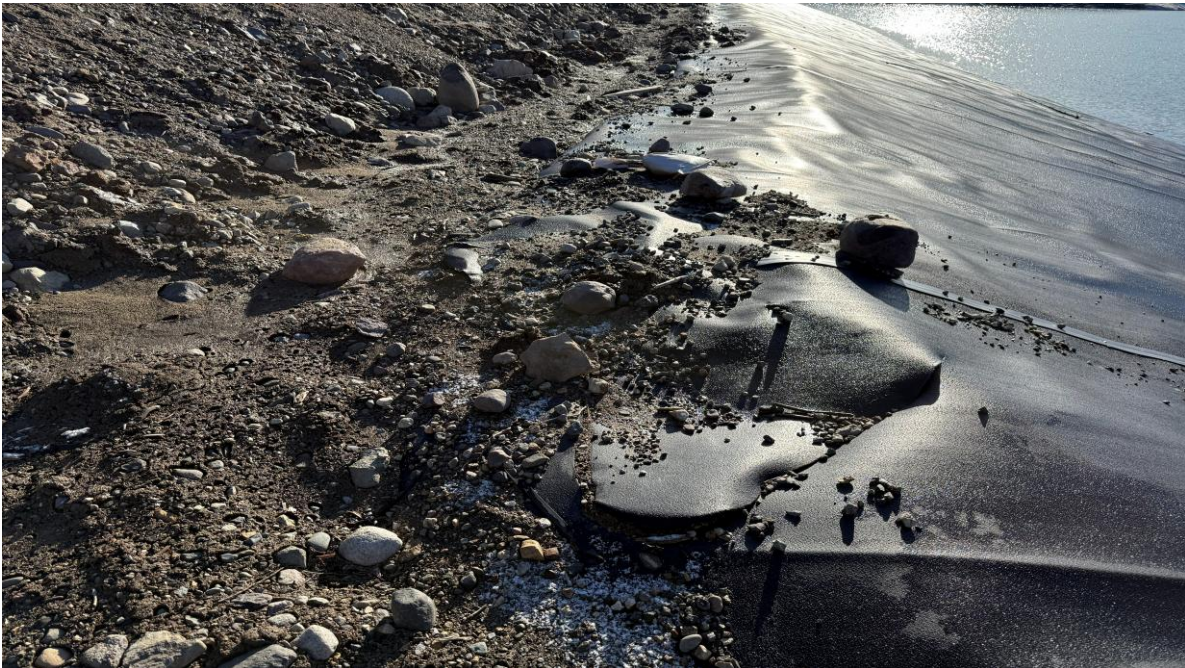
PHOTO 10 – IECD liner damage at the upstream crest, northwest corner (Photo taken on November 11, 2025)

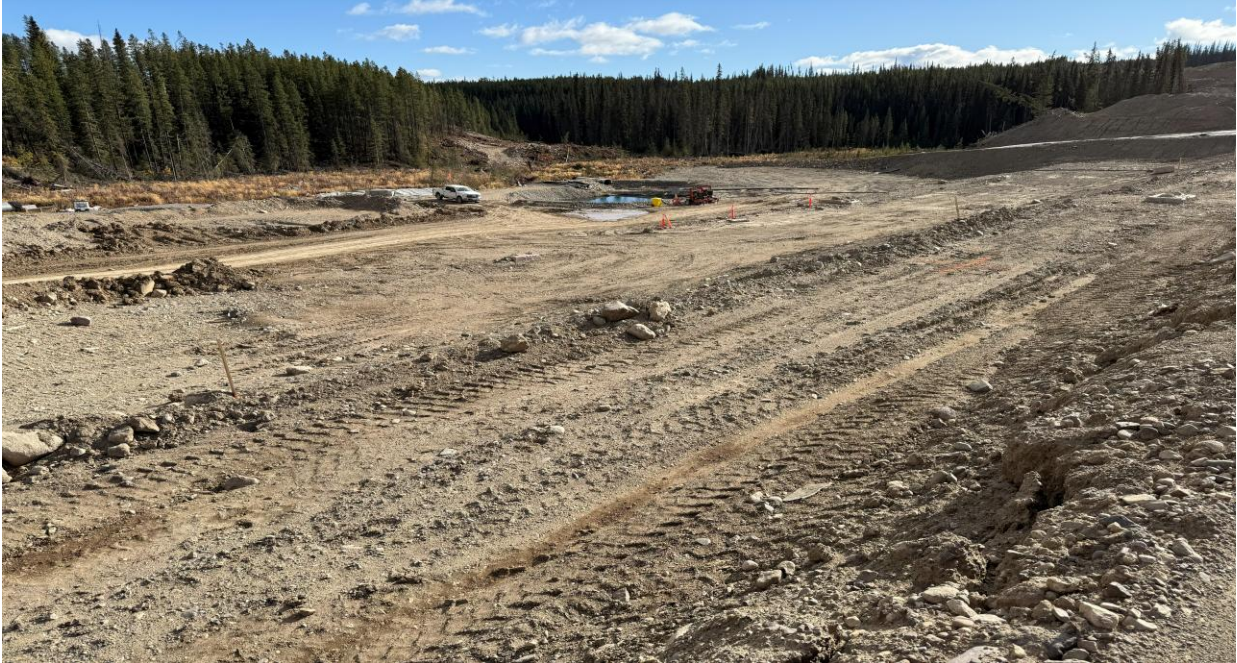
PHOTO 11 – IECD downstream bench, looking southeast (Photo taken on October 12, 2025)

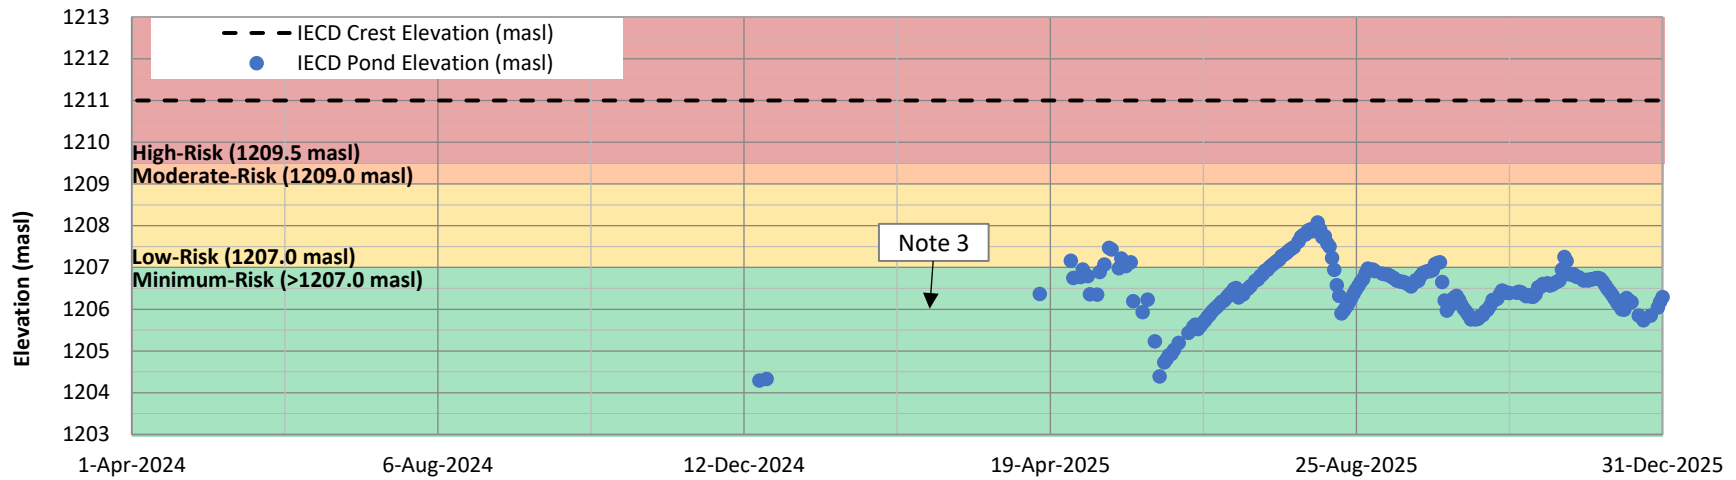
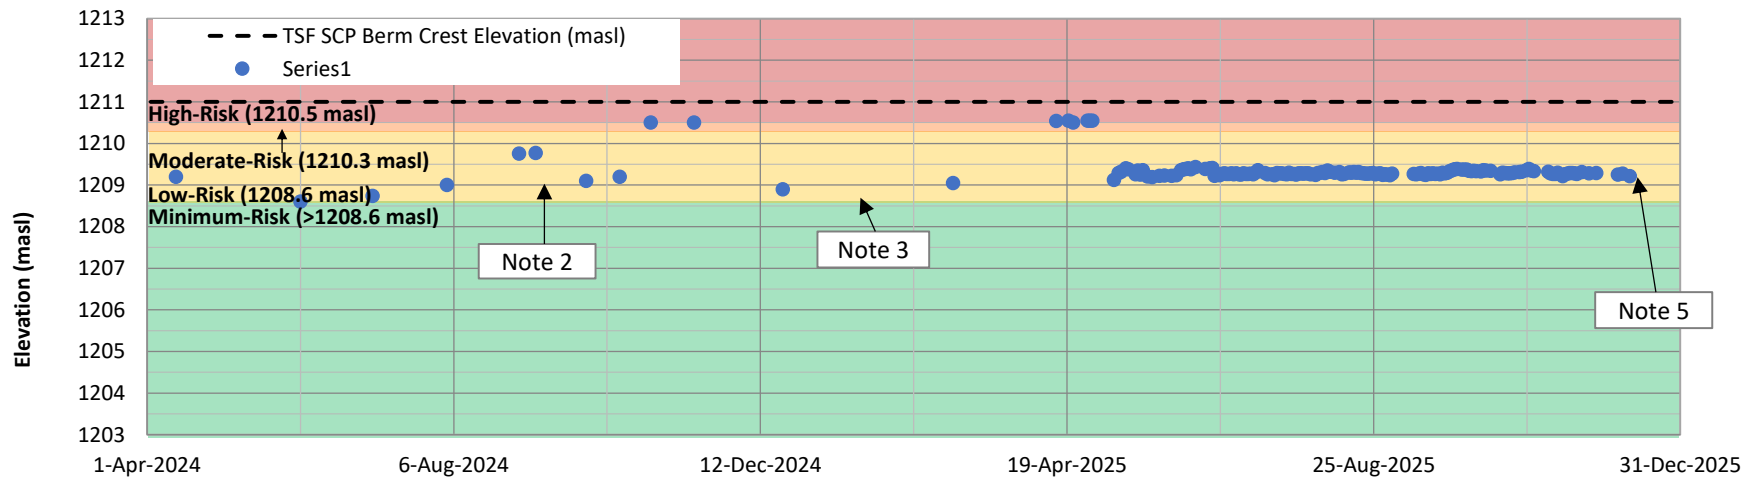
0	27MAR26	ISSUED WITH REPORT VA101-457/58-1	SY3	KTD
REV	DATE	DESCRIPTION	PREP'D	RVW'D

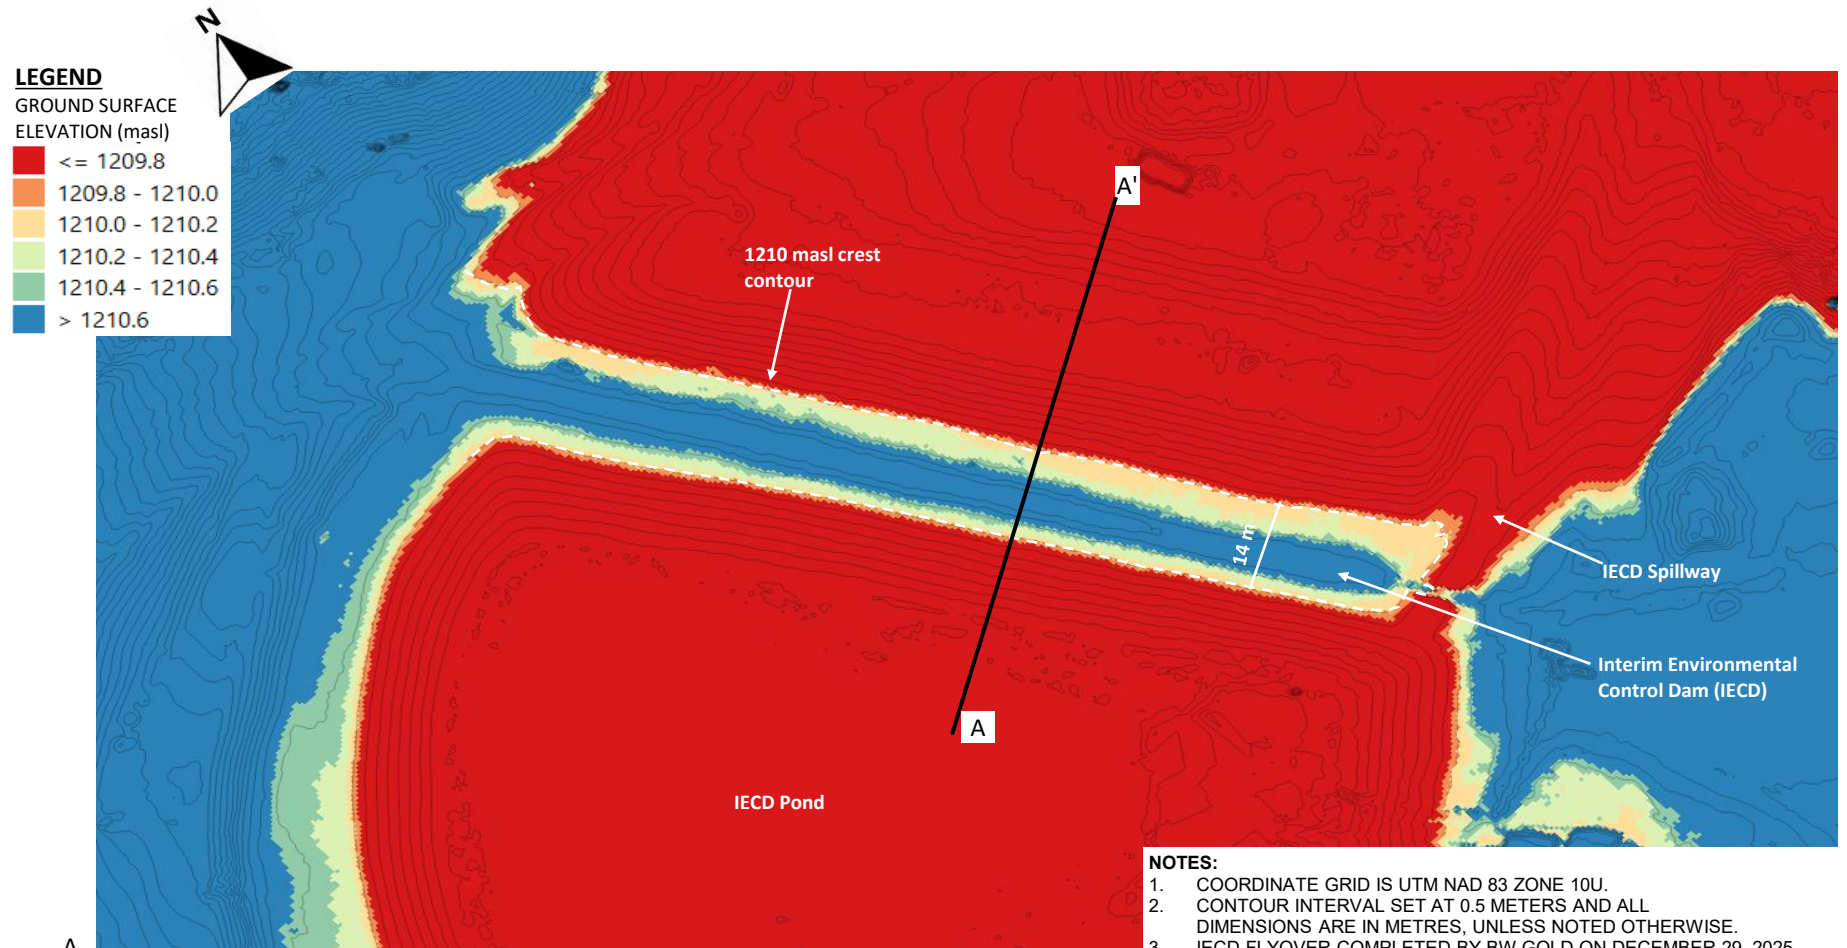
- NOTES:**
1. COORDINATE GRID IS UTM NAD 83 ZONE 10U.
 2. CONTOUR INTERVAL SET AT 0.5 METERS AND ALL DIMENSIONS ARE IN METRES, UNLESS NOTED OTHERWISE.
 3. IECD FLYOVER COMPLETED BY BW GOLD ON DECEMBER 29, 2025.

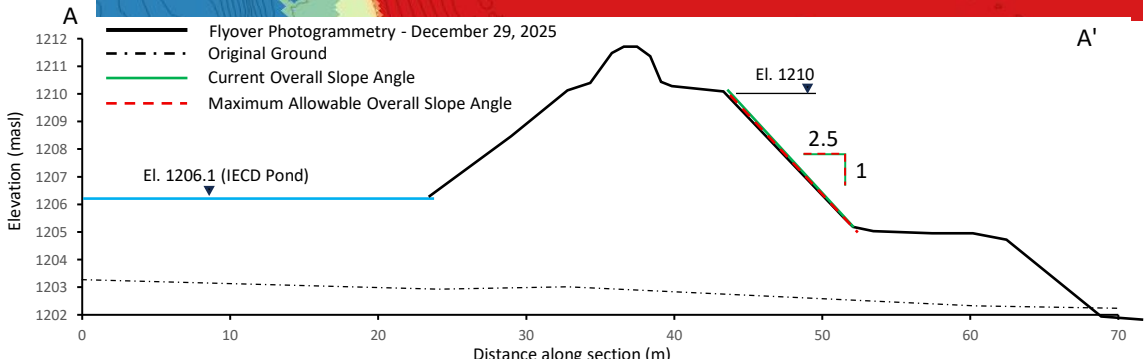
BW GOLD LTD.	
BLACKWATER MINE	
IECD & TSF SCP PERFORMANCE MONITORING PERFORMANCE MONITORING IECD GEOMETRY (QPO 2.1 & 2.2)	
	P/A NO. VA101-457/58
	REF. NO. 1
FIGURE D3.2	
REV 0

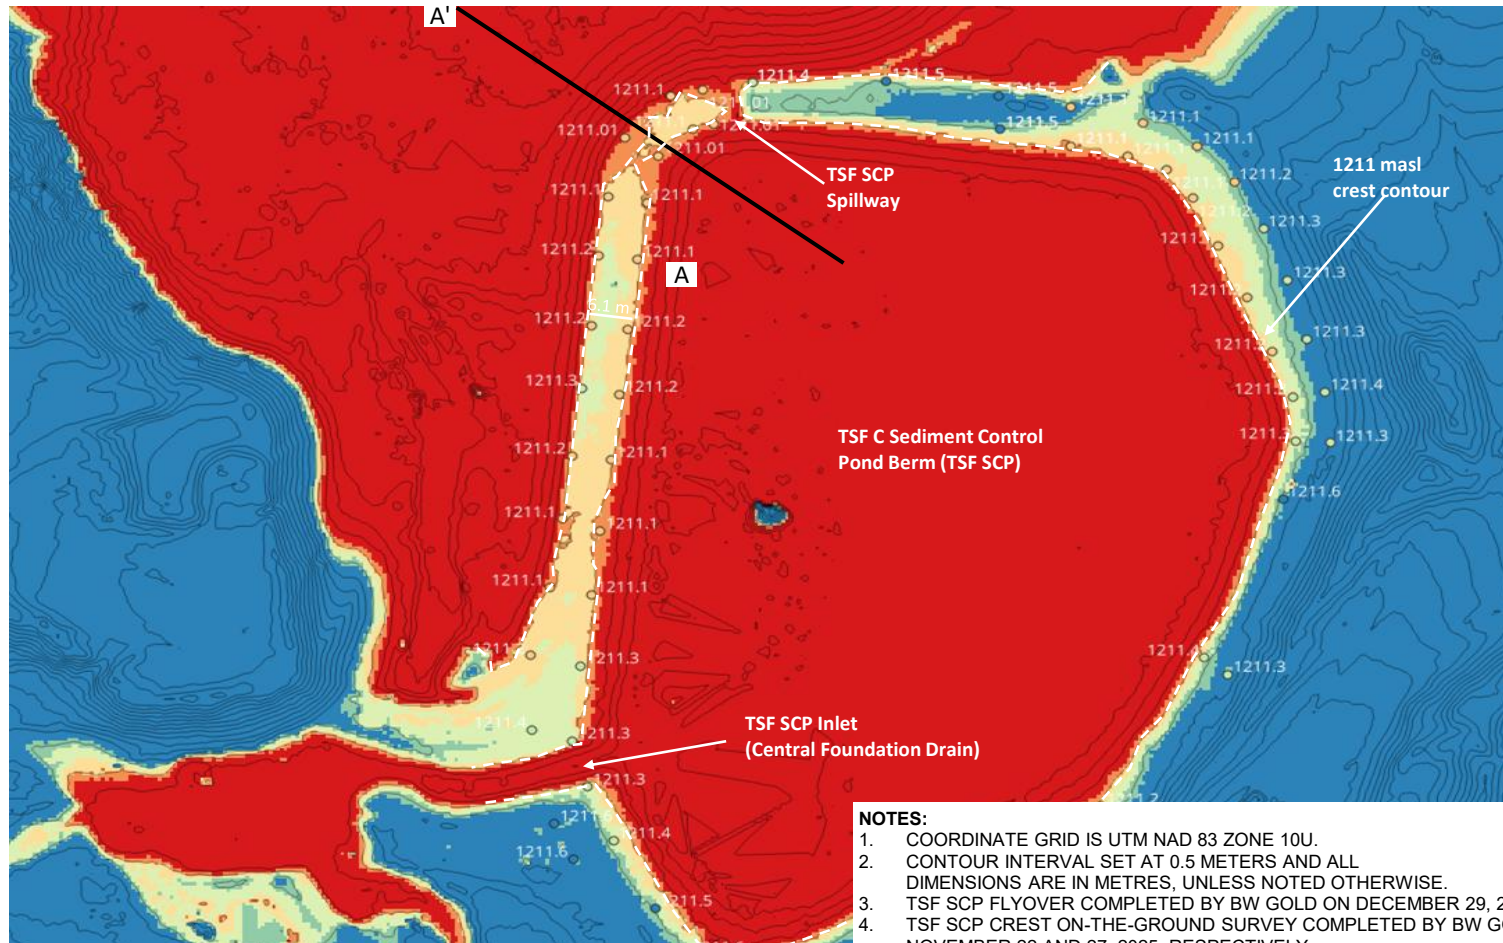
- 1210.8 - 1211.1
- 1211.1 - 1211.2
- 1211.2 - 1211.4
- 1211.4 - 1211.6

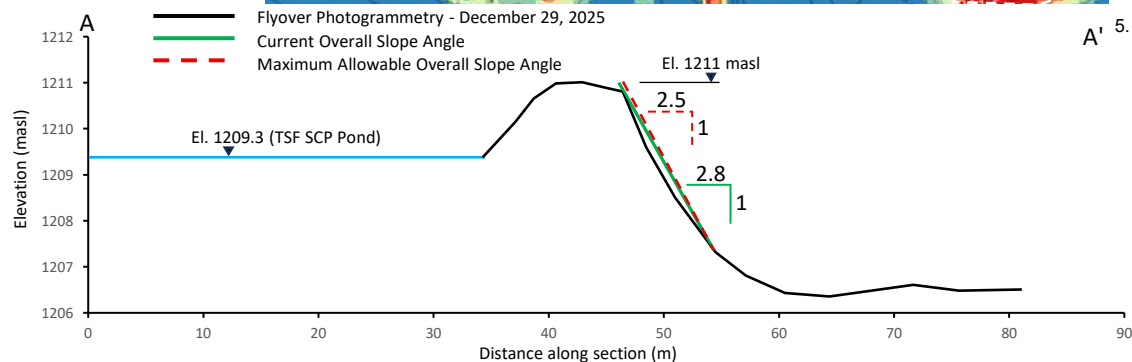
BW GOLD LTD.							
BLACKWATER MINE							
IECD & TSF SCP PERFORMANCE MONITORING PERFORMANCE MONITORING TSF SCP BERM GEOMETRY (QPO 2.1 & 2.2)

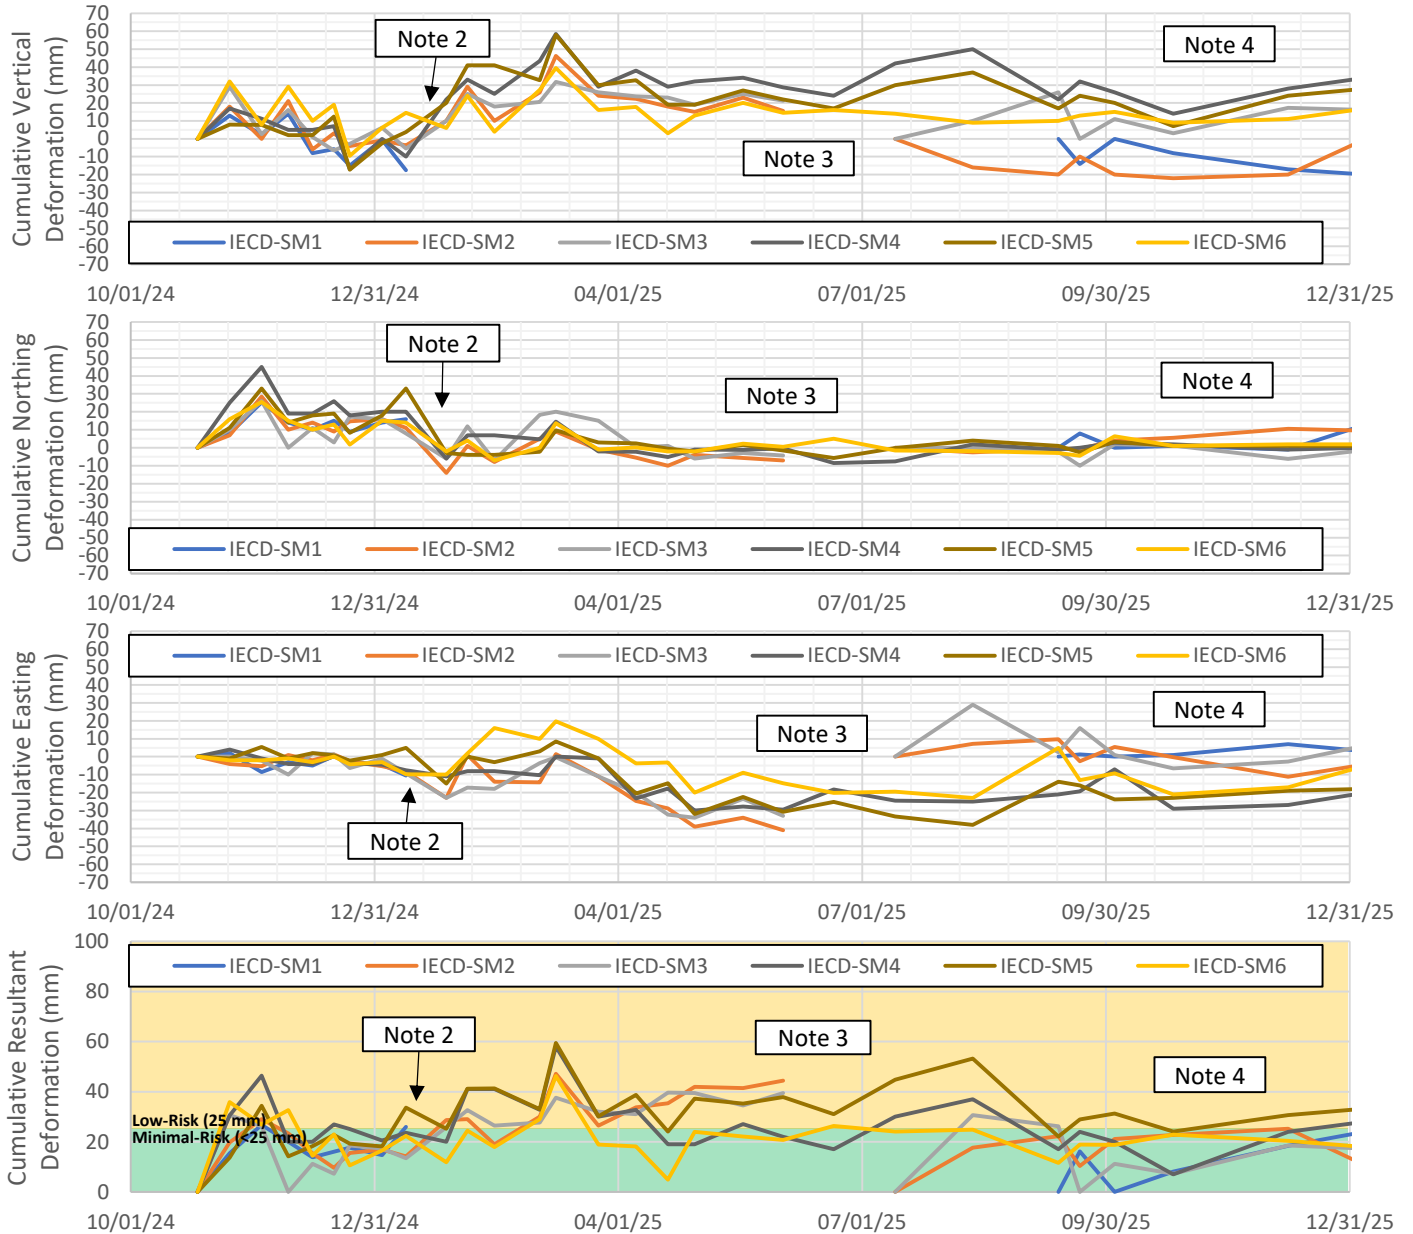
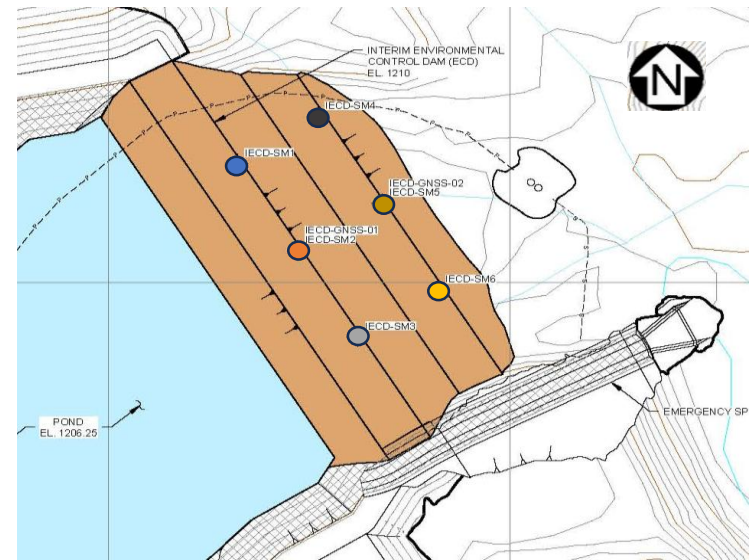
0	27MAR'26	ISSUED WITH REPORT	SY3	KTD
REV	DATE	DESCRIPTION	PREP'D	RW'D
