Prepared for
BW Gold Ltd.
3083-595 Burrard Street
Vancouver, British Columbia V7X 1L3
Canada

Prepared by
Knight Piésold Ltd.
1400-750 West Pender Street
Vancouver, British Columbia V6C 2T8
Canada

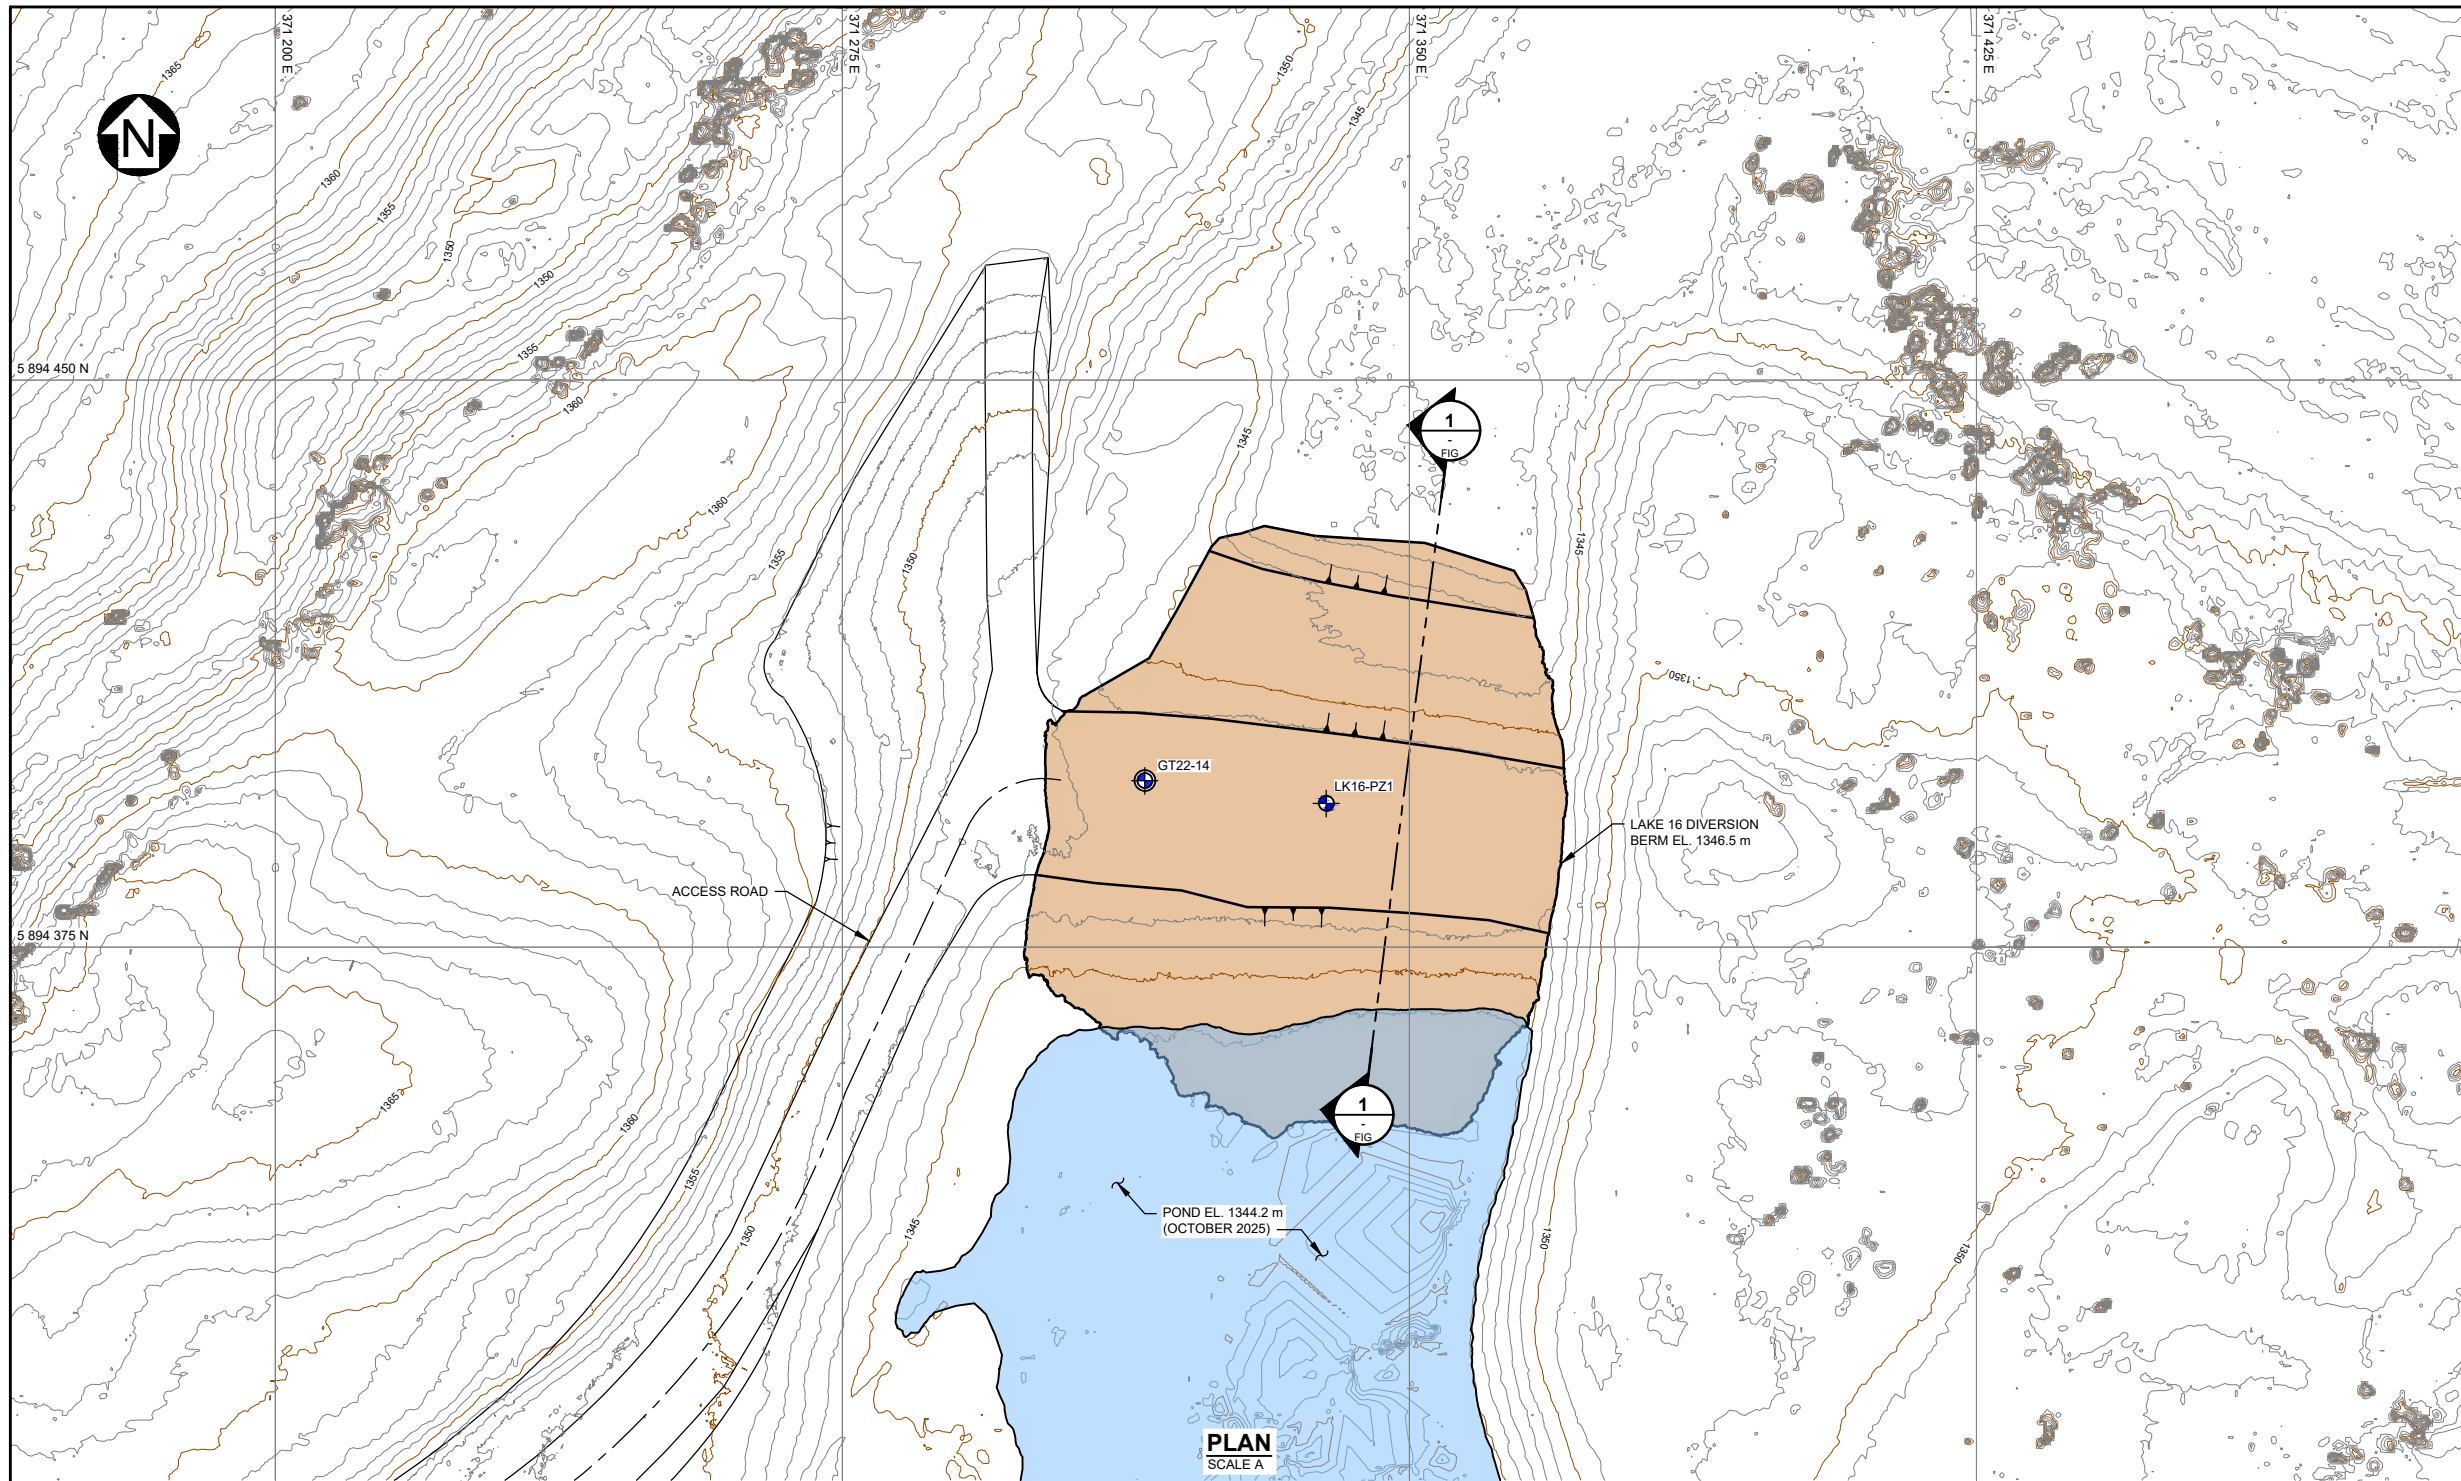
- LEGEND:**
- EMBANKMENT FILL
 - ZONE C
 - ZONE S
 - FRESH WATER
 - + VWP EMBEDDED WITHIN BERM FILL
 - + DRILLHOLE WITH VWP
 - VIBRATING WIRE PIEZOMETER (VWP)
 - W.L. xxx PIEZOMETRIC ELEVATION (m)

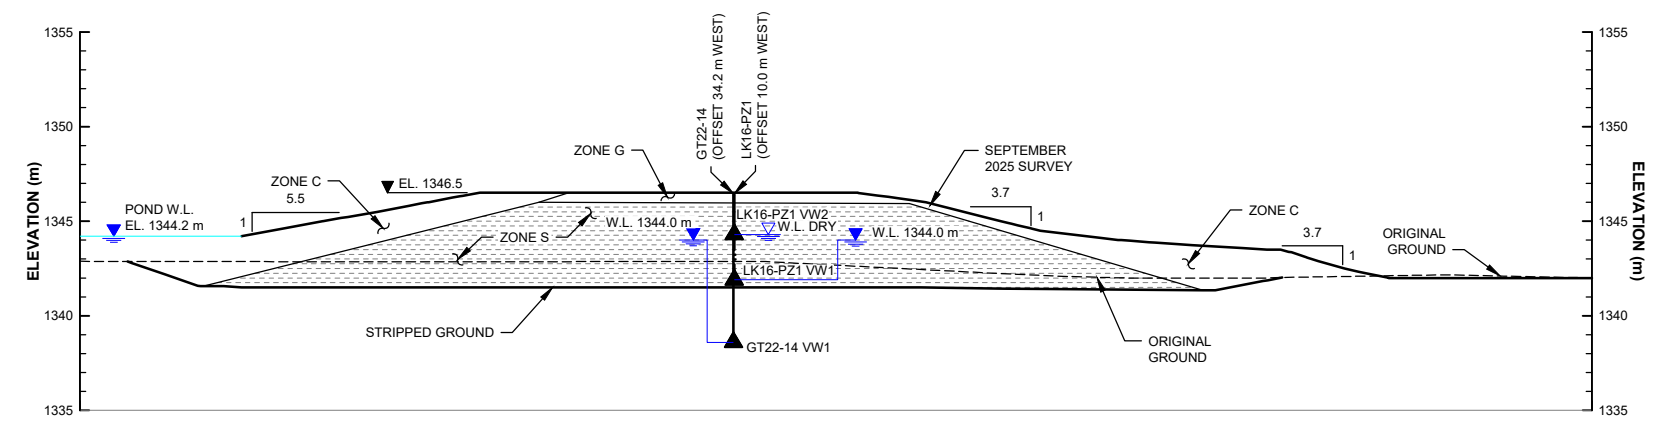
1 SECTION
LAKE 16 DIVERSION BERM
SCALE B

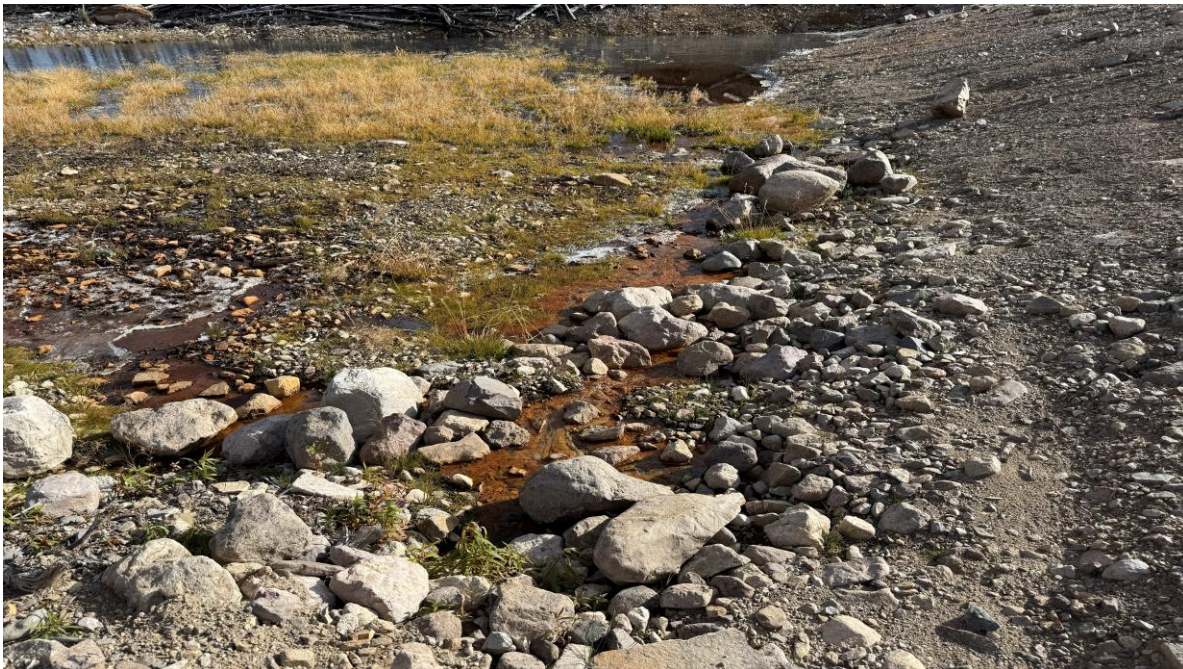
PHOTO 8 – Seepage observed at the downstream toe of Lake 16 Diversion Berm (Photo taken on October 13, 2025)

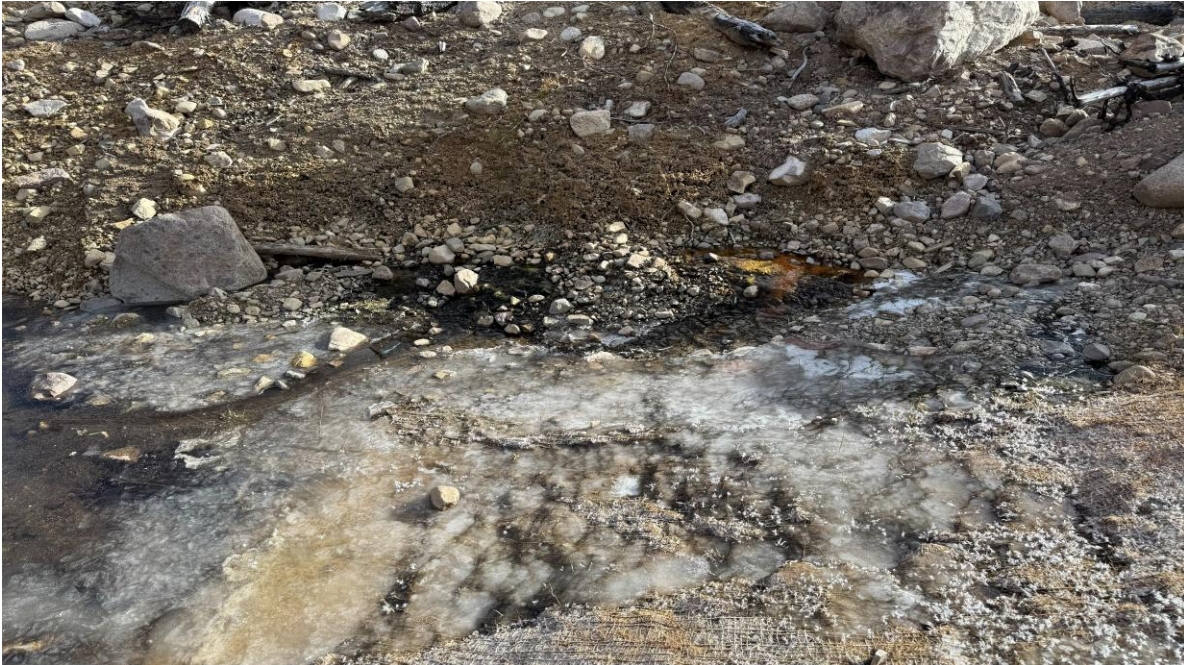
PHOTO 9 – Seepage observed at the downstream toe of Lake 16 Diversion Berm (Photo taken on October 13, 2025)

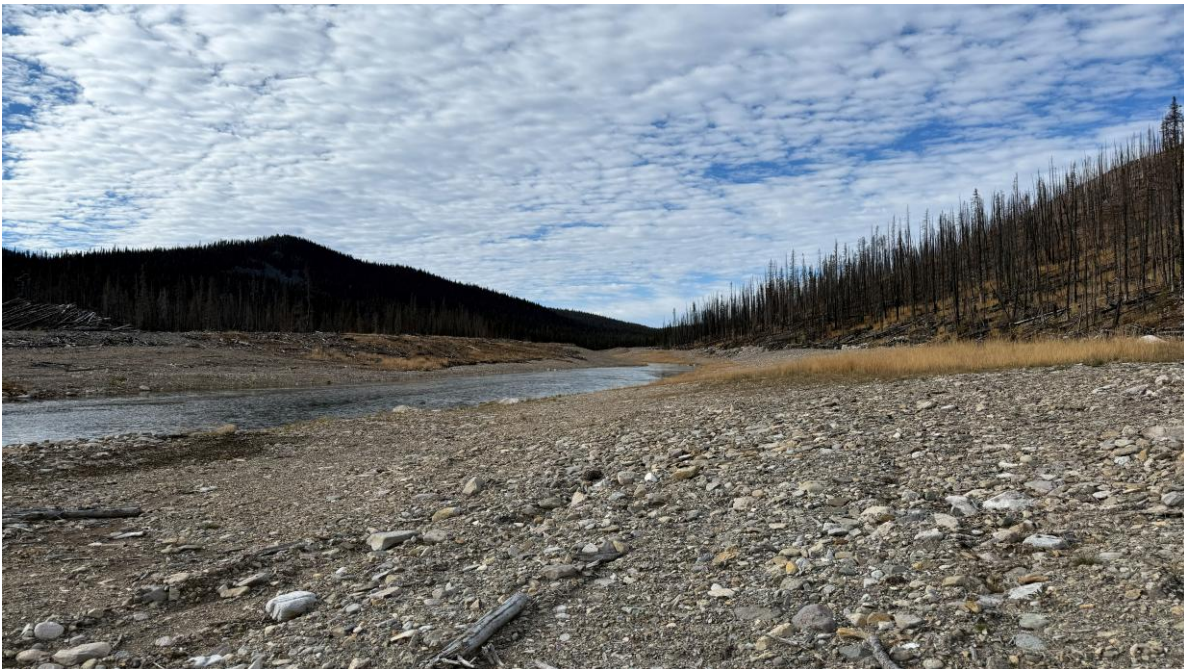
PHOTO 10 – Lake 16 Connector Channel (Photo taken on October 13, 2025)

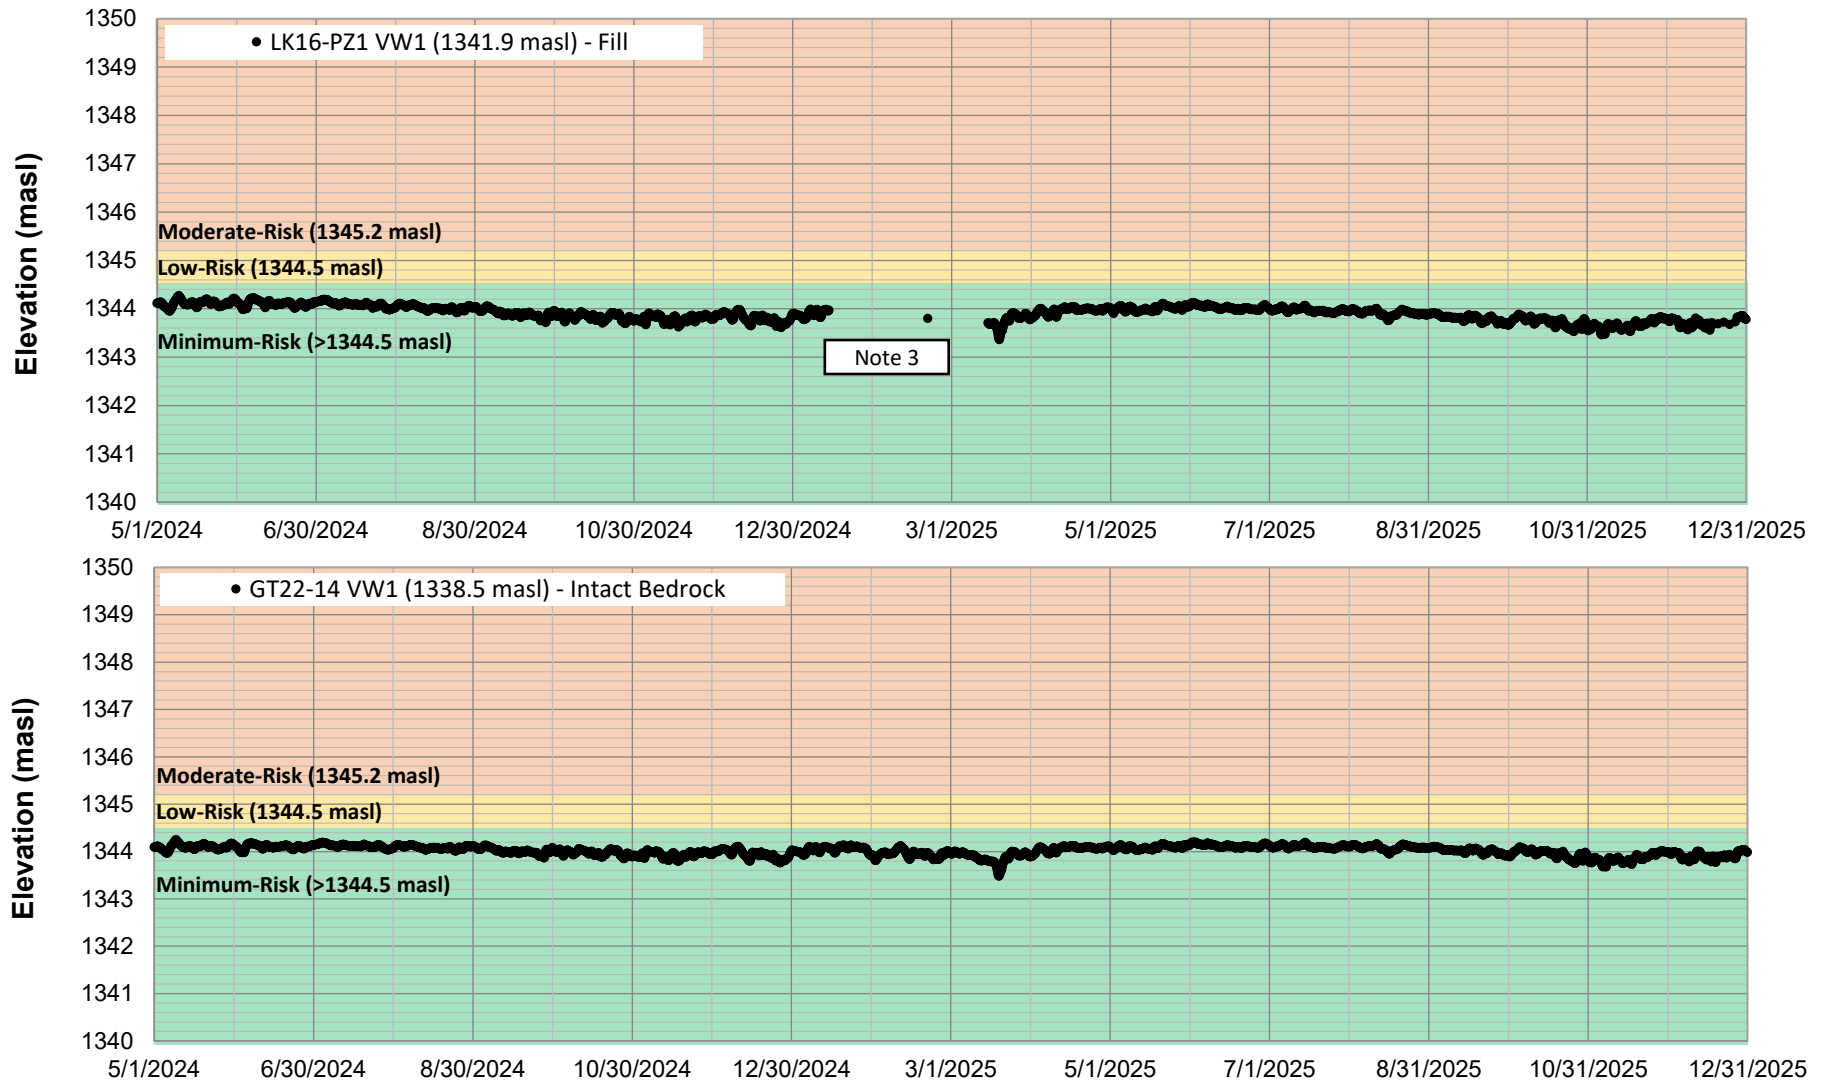
0	27MAR'26	ISSUED WITH REPORT	SY3	KTD
REV	DATE	DESCRIPTION	PREP'D	RVW'D

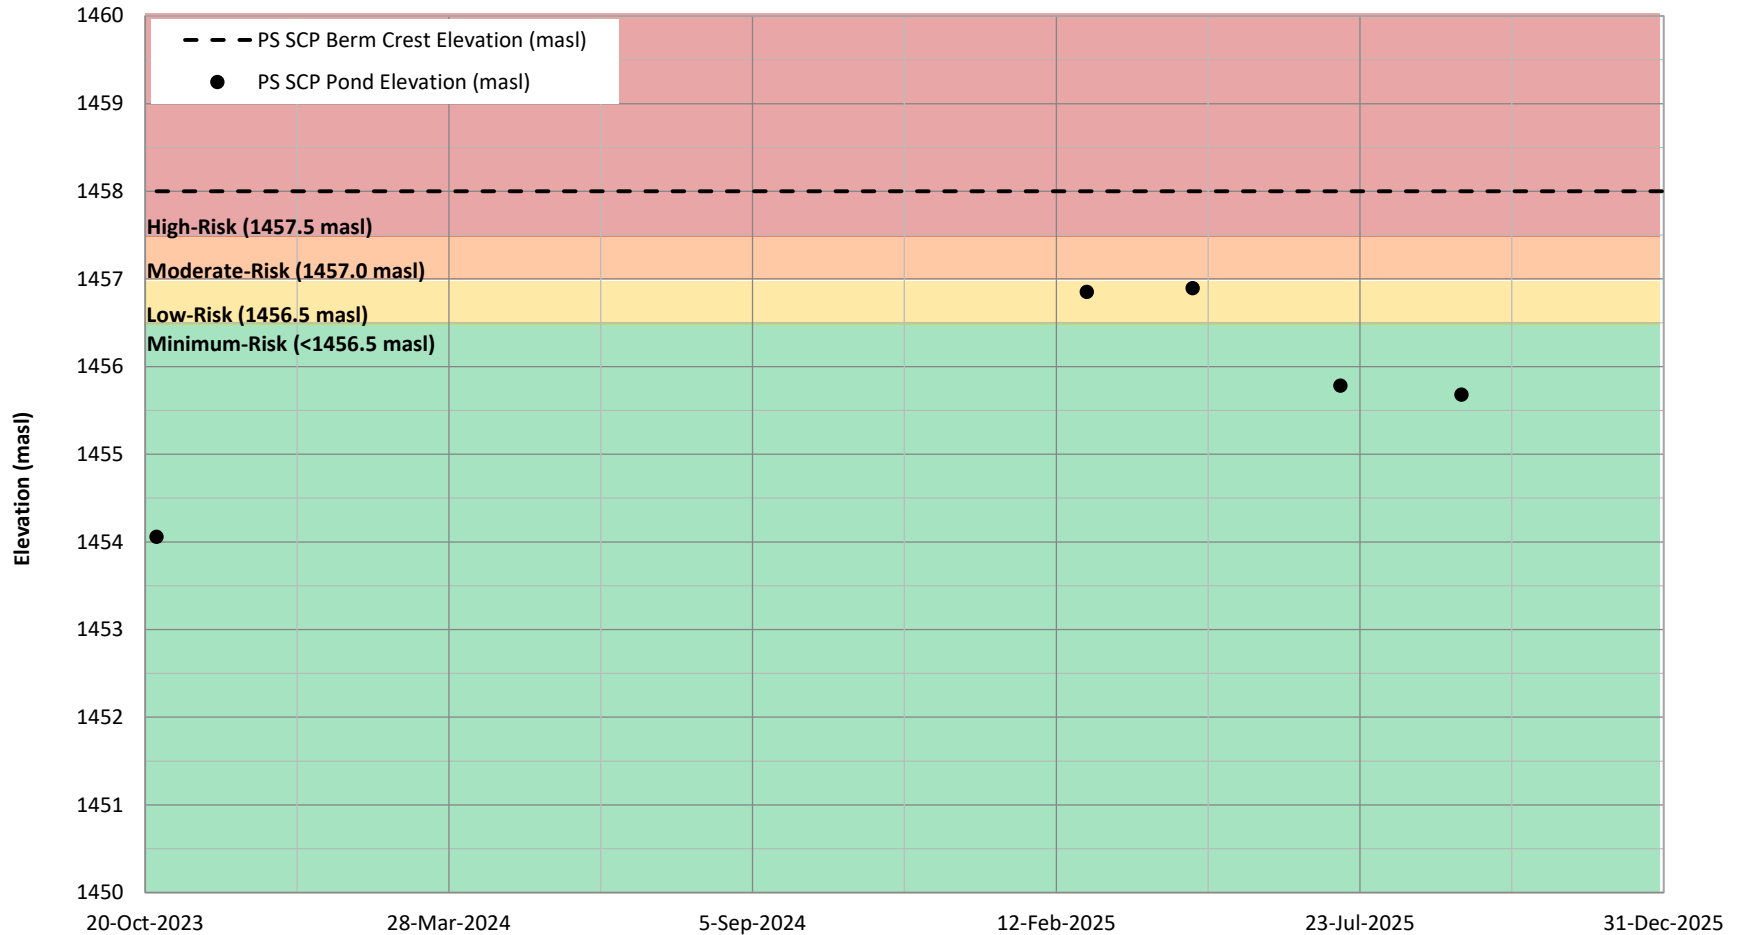
0	27MAR26	ISSUED WITH REPORT VA101-457/58-1	SY3	KTD
REV	DATE	DESCRIPTION	PREPD	RWWD

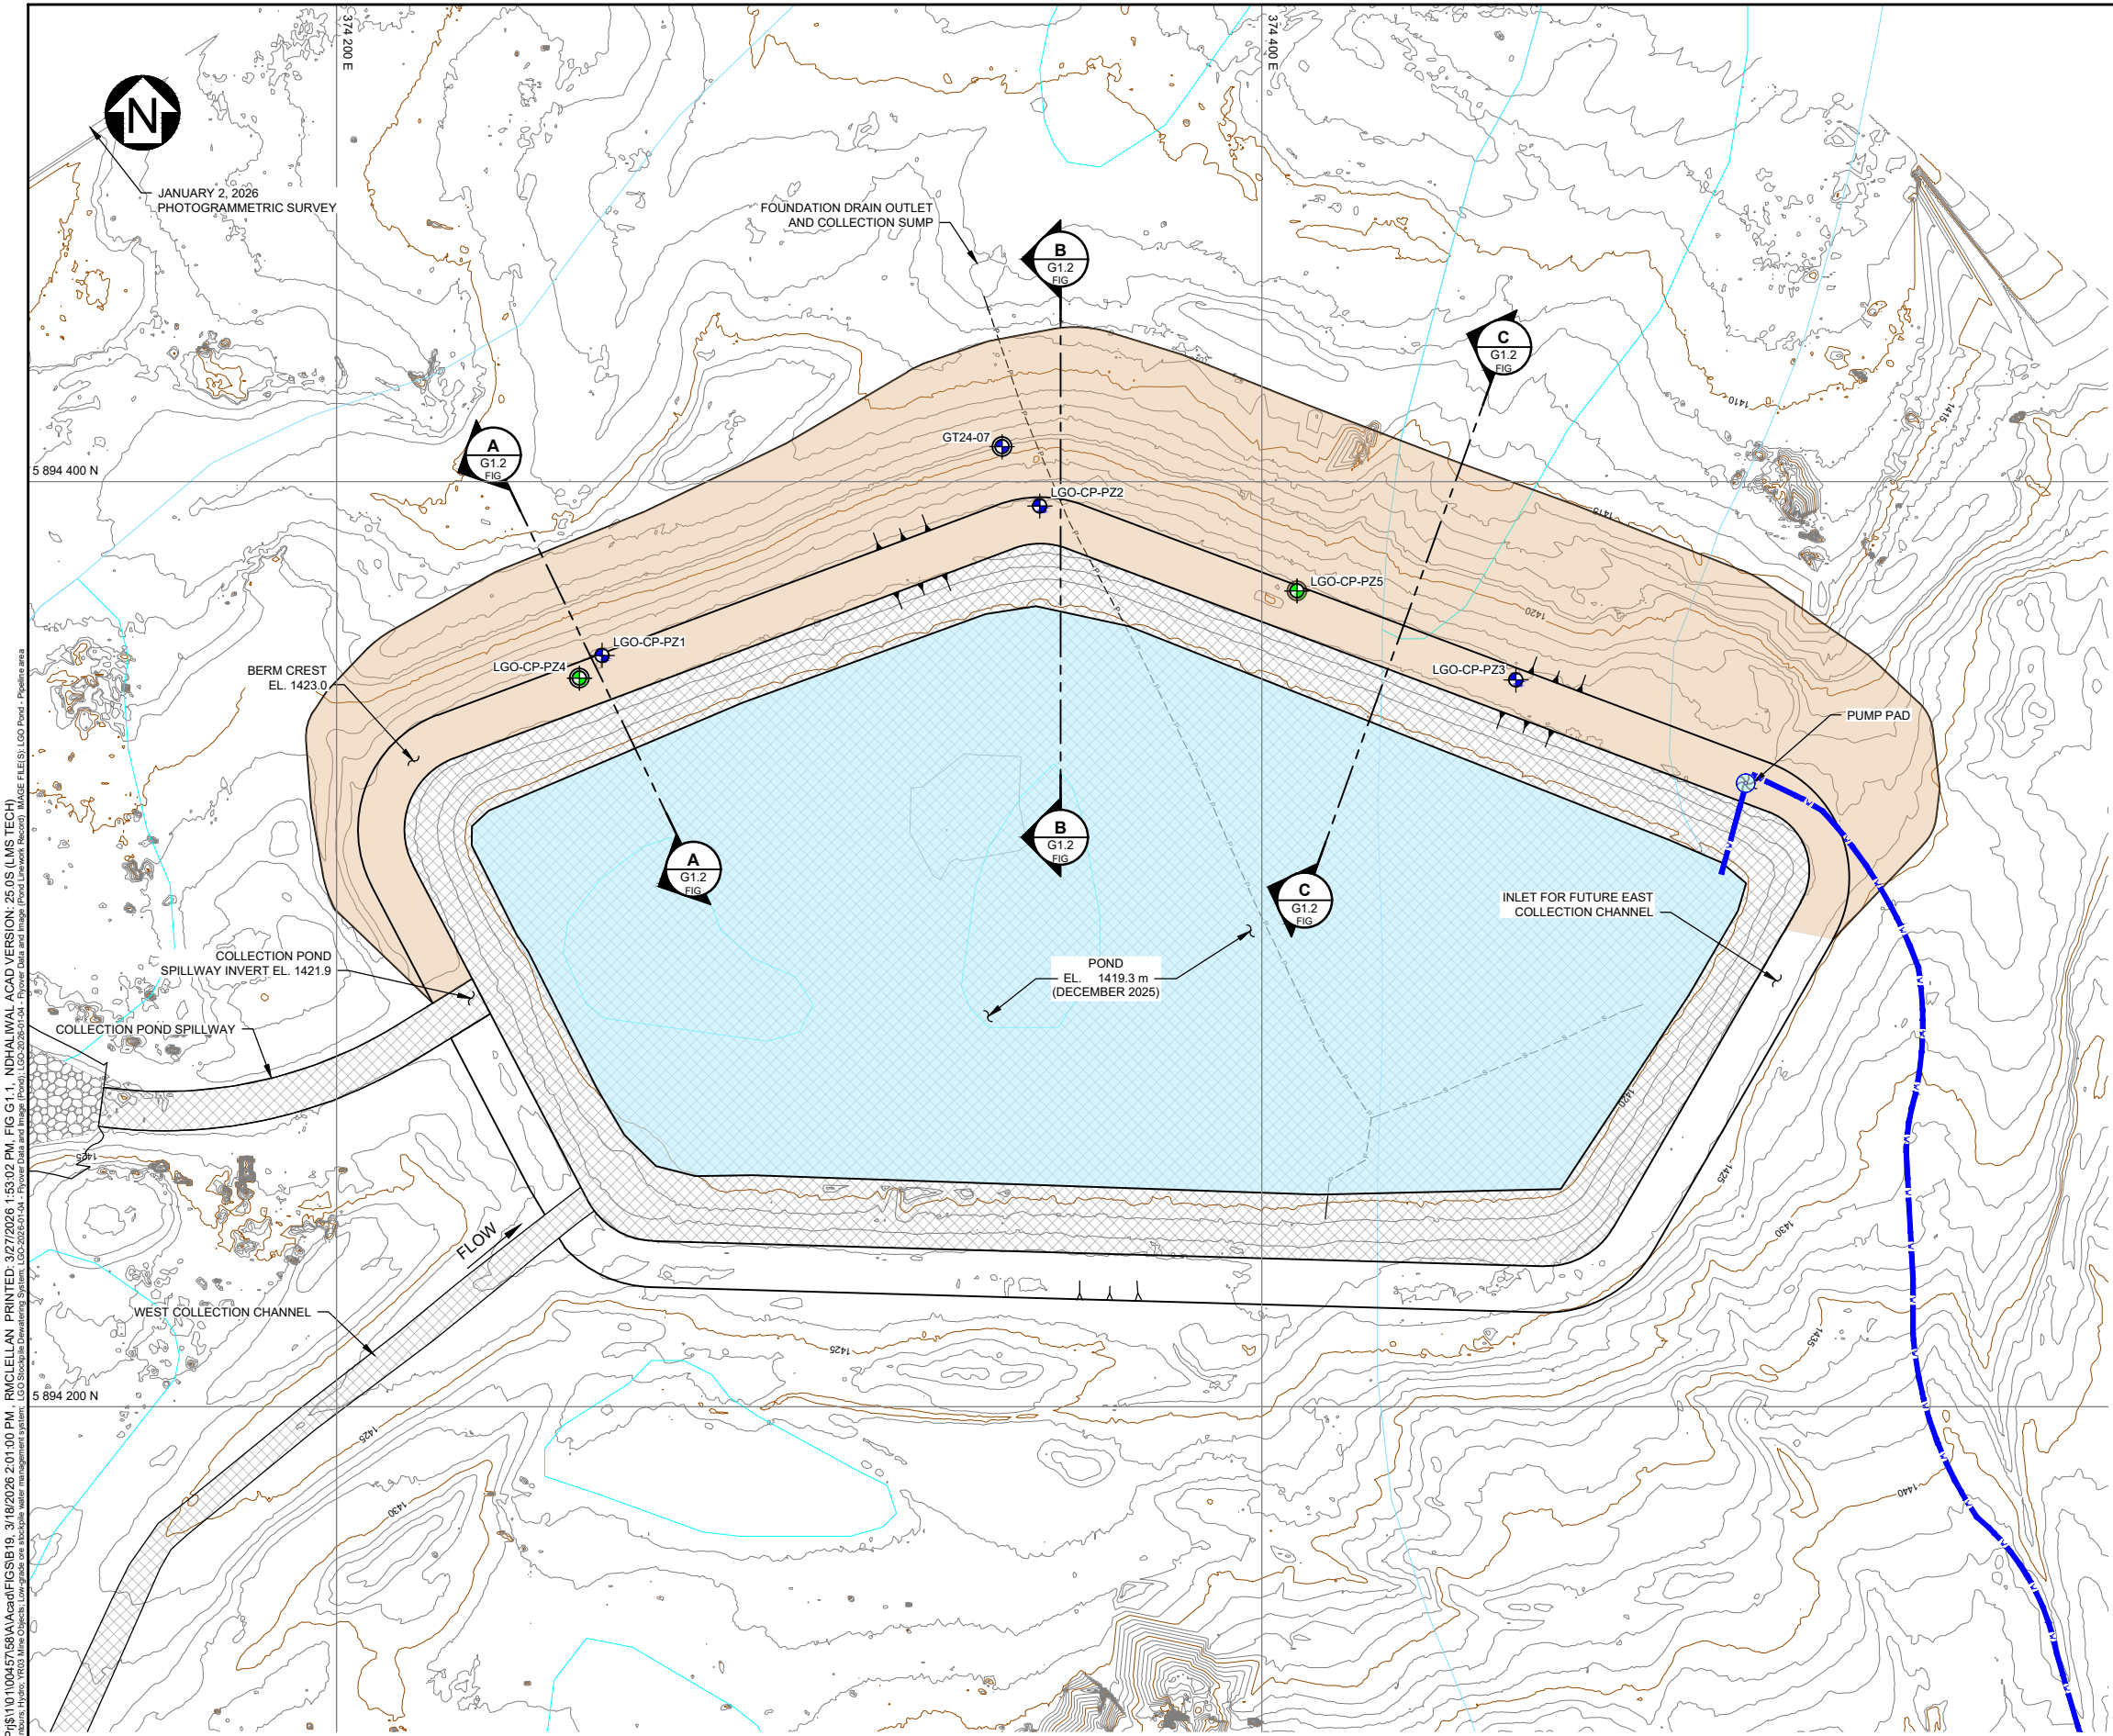
(Figures G1.1 to G1.3)

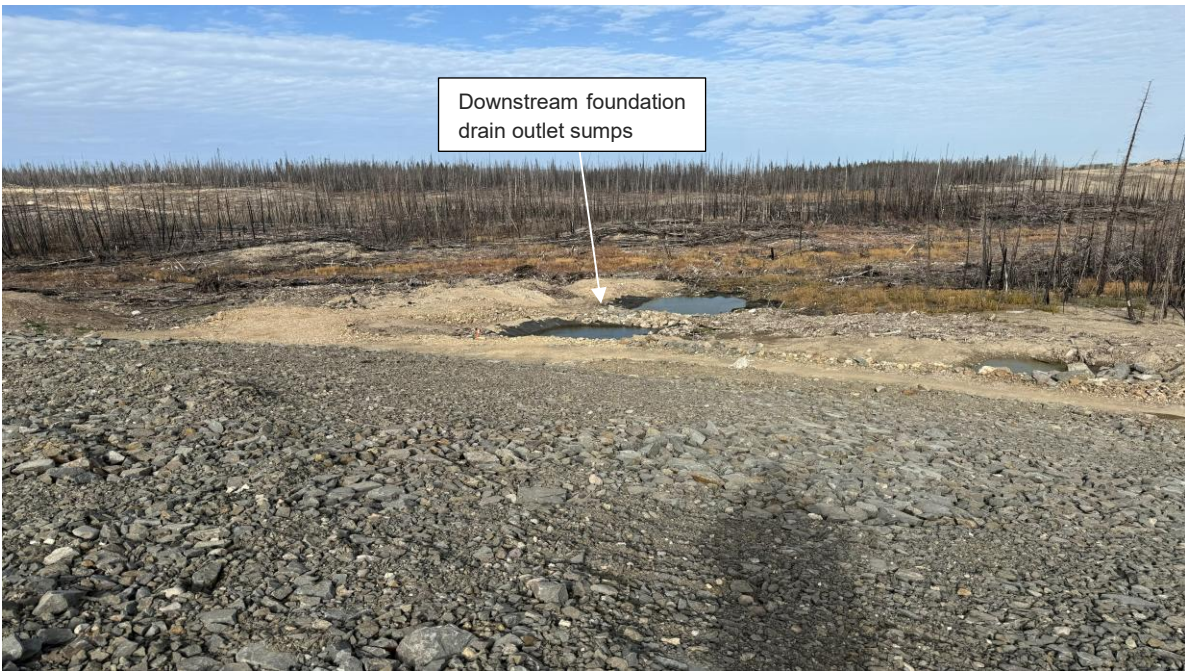
Downstream foundation
drain outlet sumps

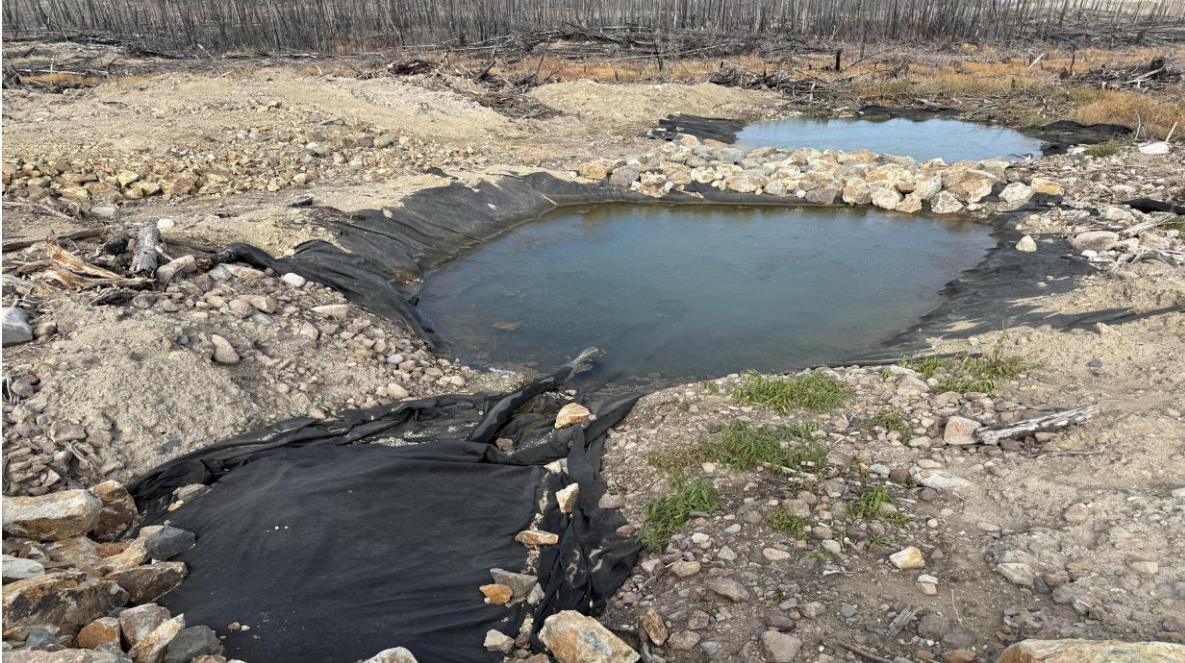
PHOTO 7 – LGO CP foundation drain outlet and downstream sumps, looking north (Photo taken on October 13, 2025)

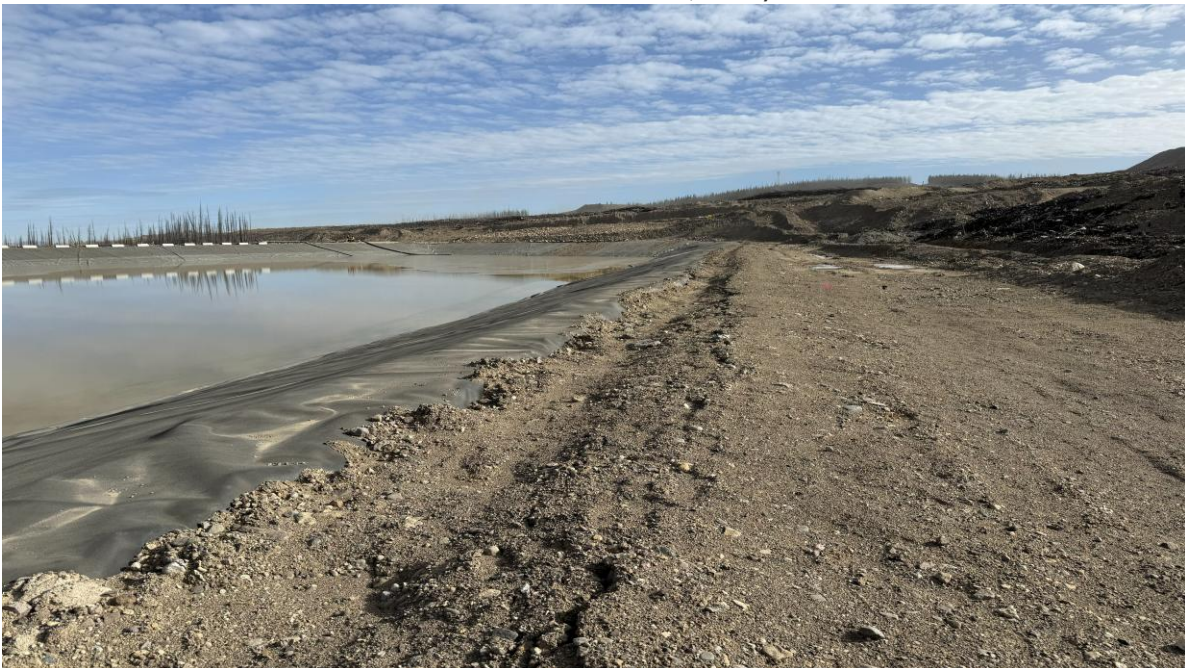
PHOTO 8 – LGO CP south cut crest and minor anchor backfill settling, looking east (Photo taken on October 13, 2025)

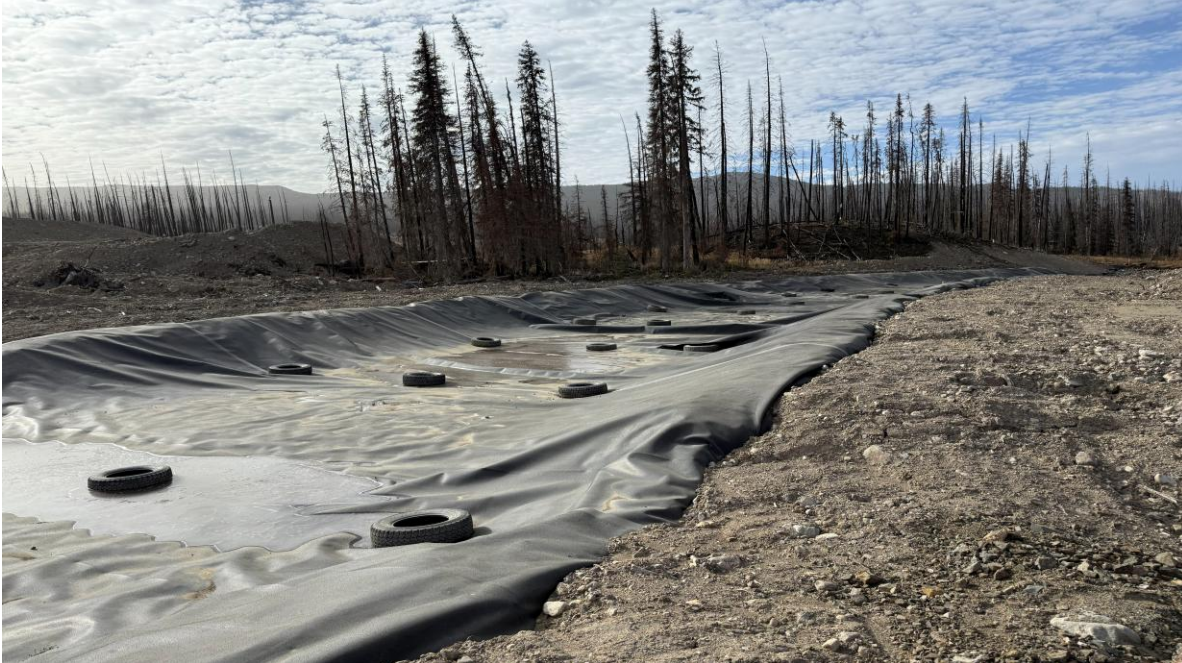
PHOTO 15 – LGO CP spillway, looking west from right side of spillway prior to liner replacement (Photo taken on October 13, 2024)

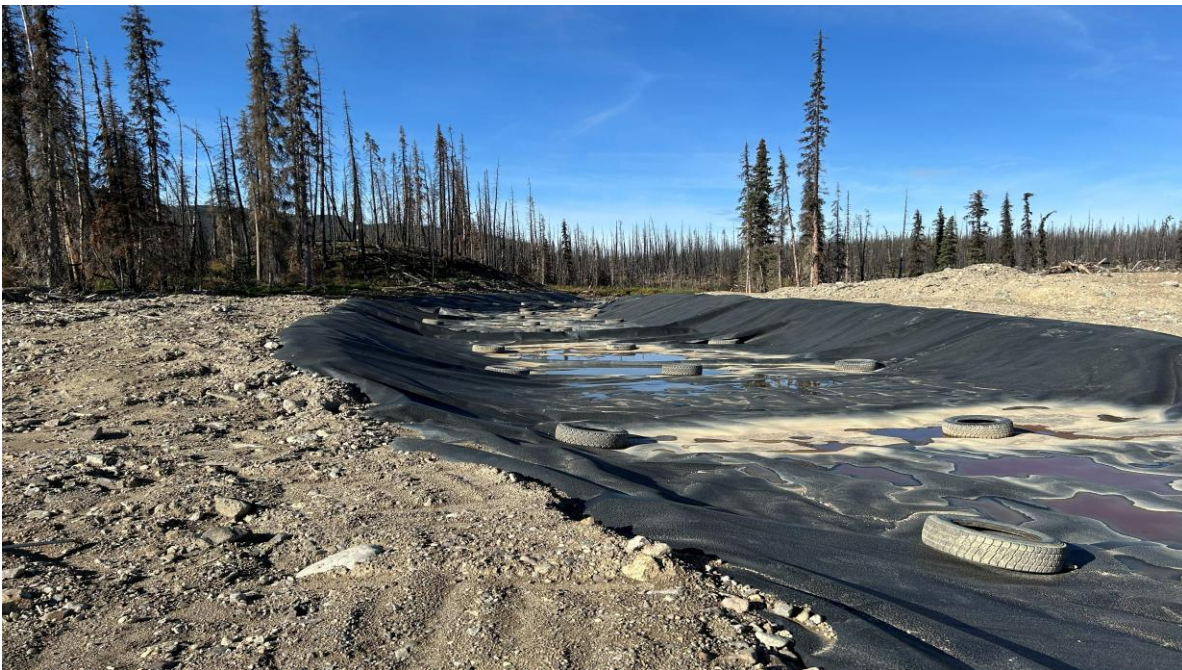
PHOTO 16 – LGO CP spillway, looking west from left side of spillway prior to liner replacement (Photo taken on September 19, 2025)

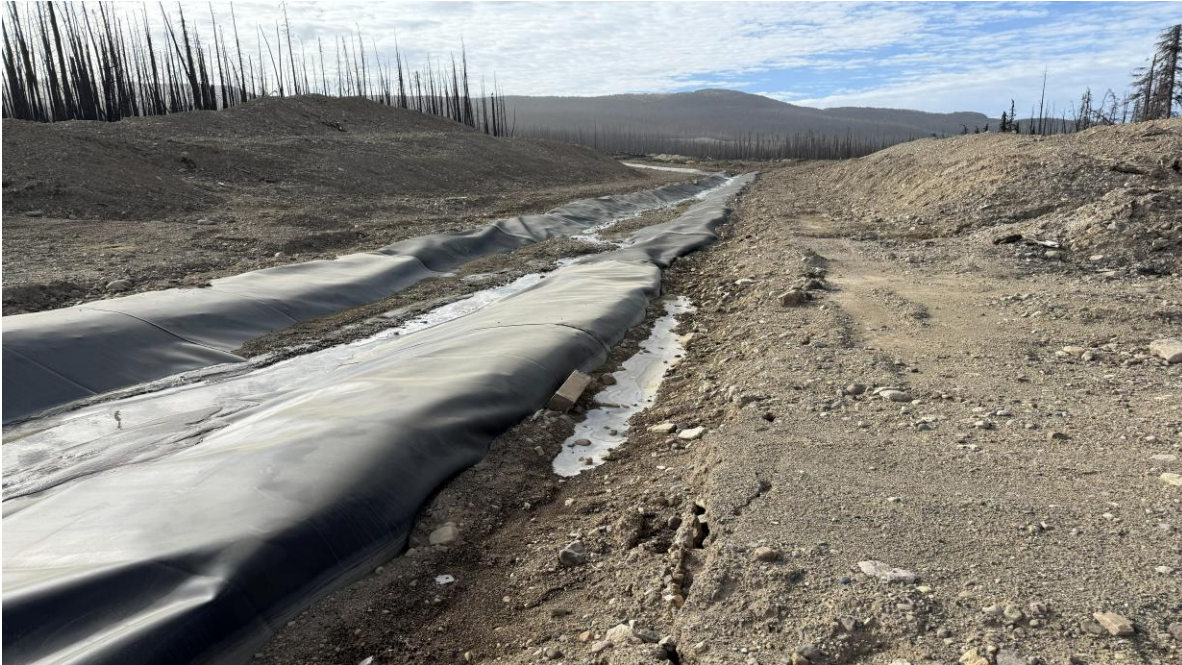
**PHOTO 17 – WCC sediment accumulation and anchor trench settlement, looking southwest
(Photo taken on October 13, 2025)**

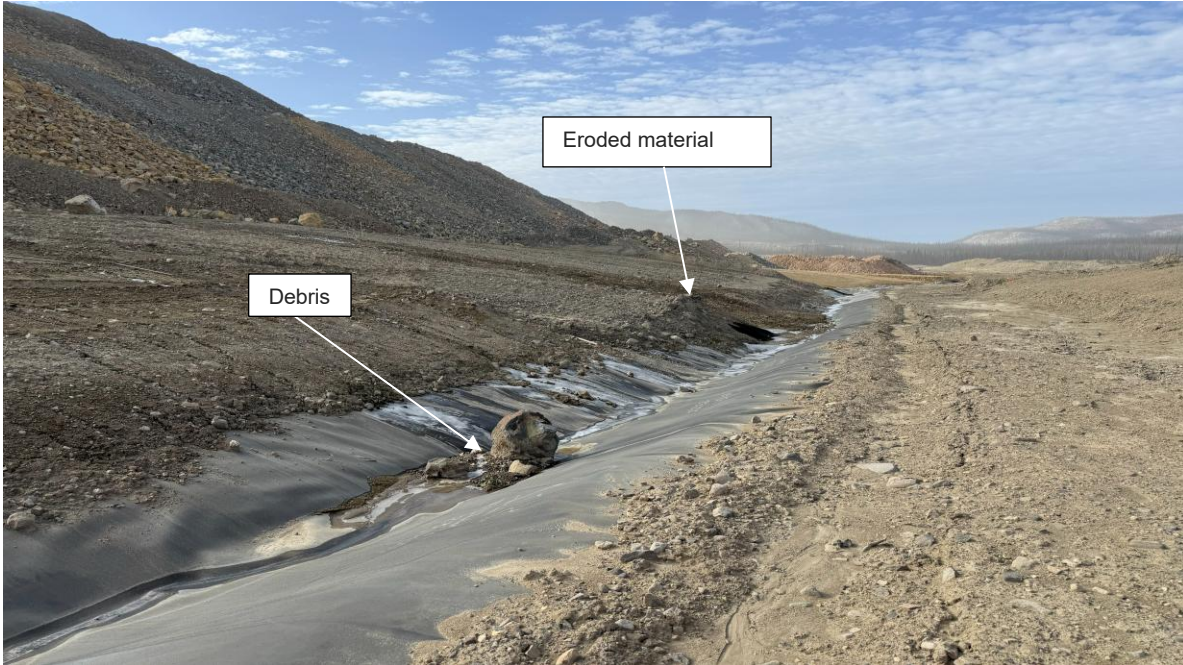
PHOTO 19 – MCC debris accumulation and minor sloughing into channel from the LGO foundation soil liner, looking west. Sloughed material was removed in November 2025 (Photo taken on October 13, 2025)

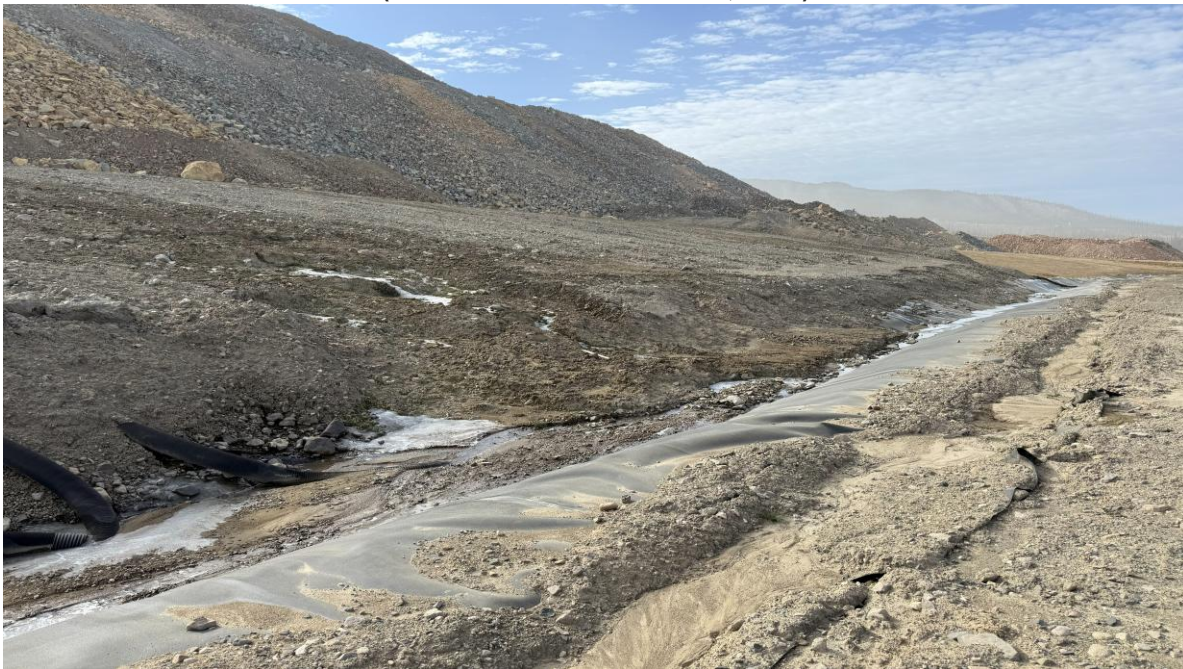
PHOTO 20 – Sloughing, sediment accumulation and anchor trench erosion along the MCC, looking west (Photo taken on October 13, 2025)

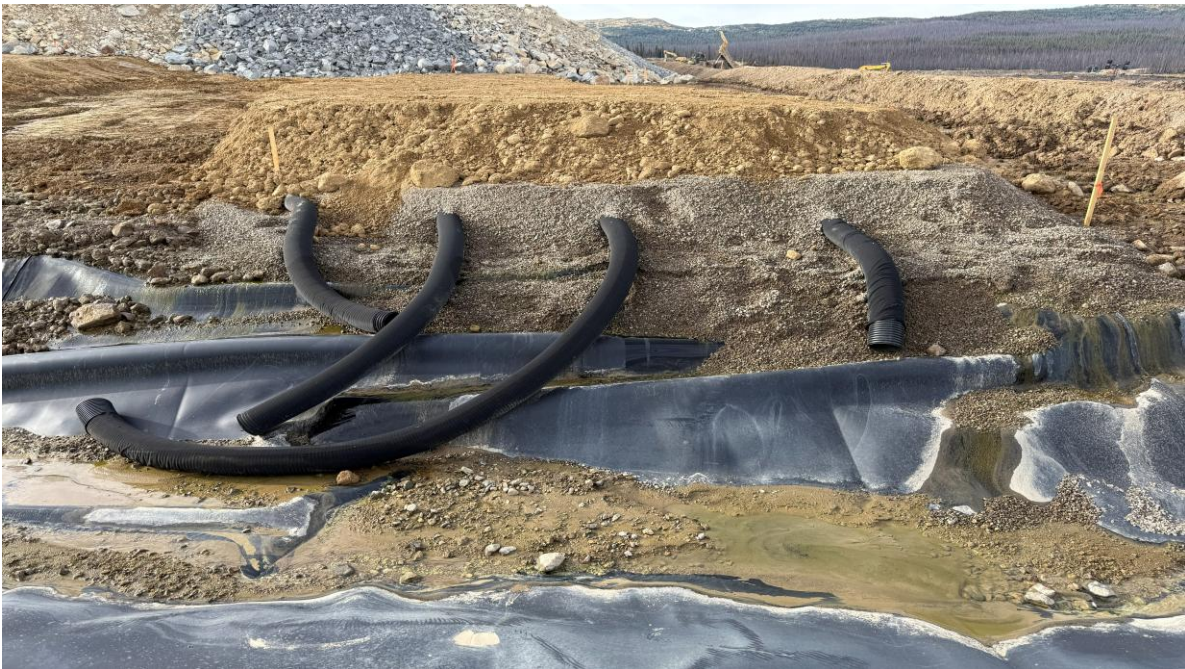
PHOTO 22 – LGO liner foundation drain outlet to MCC, looking south (Photo taken on September 15, 2025)

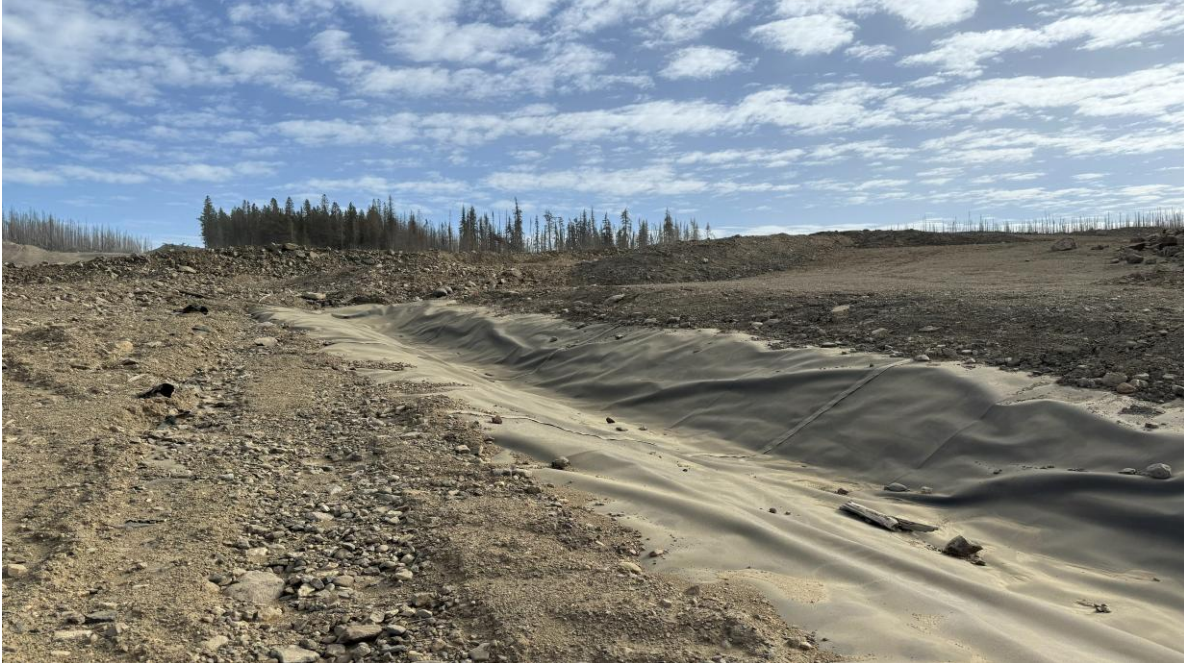
PHOTO 23 – Upstream extent of WCC lining (Photo taken on October 13, 2025)
