Prepared for
BW Gold Ltd.
3083-595 Burrard Street
Vancouver, British Columbia V7X 1L3
Canada

Prepared by
Knight Piésold Ltd.
1400-750 West Pender Street
Vancouver, British Columbia V6C 2T8
Canada

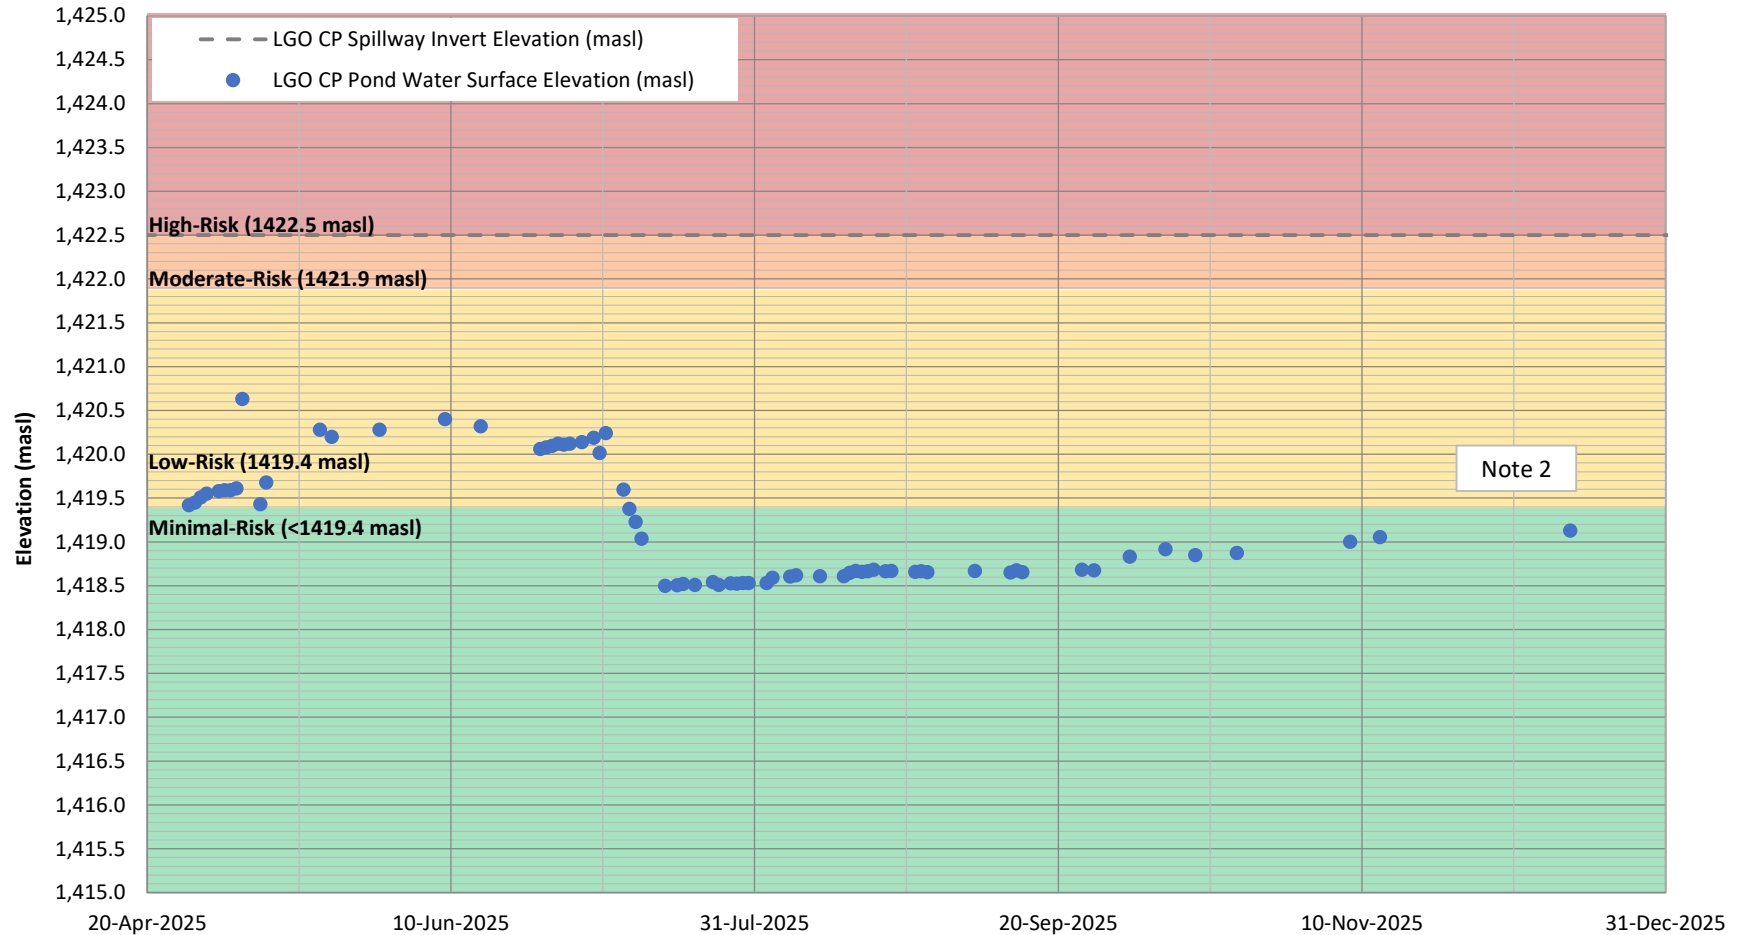
0	27MAR26	ISSUED WITH REPORT VA101-457/58-1	SY3	KTD
REV	DATE	DESCRIPTION	PREP'D	RW'D
