BW Gold Ltd.
Suite 2600 Three Bentall Centre
595 Burrard Street
PO BOX 49314
Vancouver, BC, V7X 1L3

As per Blackwater Gold's Accidents and Malfunctions Management Plan, the information below acts as the 30 follow up report to the "Initial Spill Report - January 11, 2026 - DGIR 260135" submitted on January 12th, 2026.

DGIR 260135 Attachments

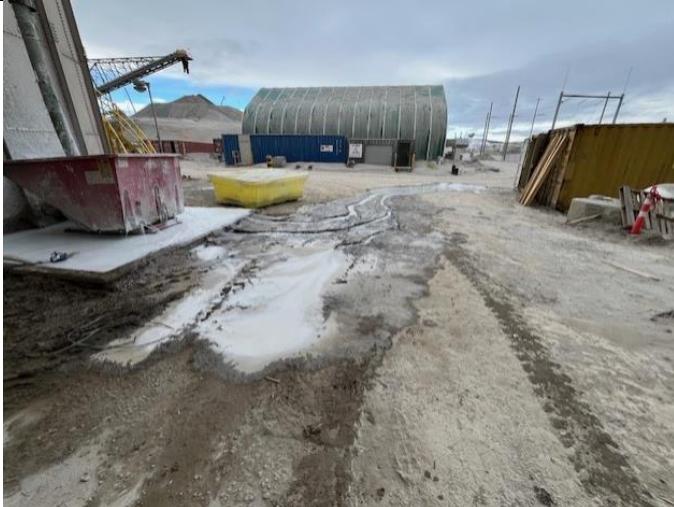
Figure 1. Initial spill photograph #1

On January 11th at approximately 11:05 am, it was discovered that the grit screen drain was blocked. This blockage caused the containment area to breach, and 2,008 L (final spill report quantity updated to from initial quantity) of diluted grit lime spilled to ground.

Upon discovery of this, a trash pump was deployed to drain the lime containment area and cease further substance breach at the source. Once access was feasible, the lime grit screen was cleared of the blockage. An exclusion zone was established at the spill site, and an excavator was deployed to contain and collect contaminated material for disposal. The disposal site was the Tailings Storage Facility (TSF).

- Addition of a new pump with a "do not remove" tag
- Implementation of more frequent drain screen replacement
- Addition of a drain to the grit containment to the reagent building

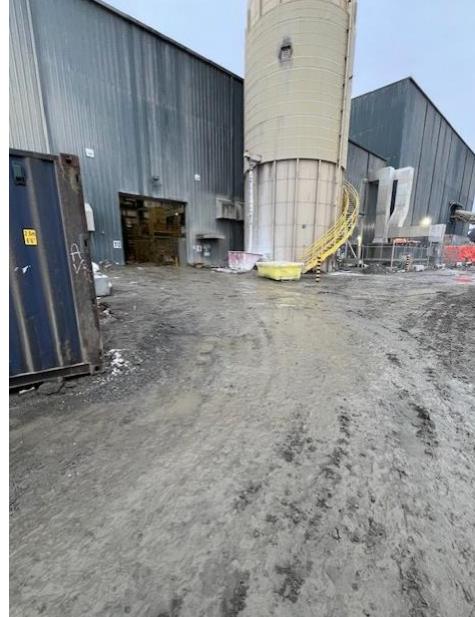
Figure 4. Post-clean up photograph #1

There were no adverse environmental effects resulting from this incident with no flora, fauna or watercourses being affected. This incident location on Blackwater Gold's plant site is surrounded by a containment system consisting of collection channels and the plant side sediment control pond. The contaminated material was collected and disposed of in the TSF.
