BW Gold Ltd.
Suite 2600 Three Bentall Centre
595 Burrard Street
PO BOX 49314
Vancouver, BC, V7X 1L3

As per Blackwater Gold's Accidents and Malfunctions Management Plan, the information below acts as the 30 follow up report to the "Initial Spill Report – November 26th, 2025" submitted on November 27th, 2025.

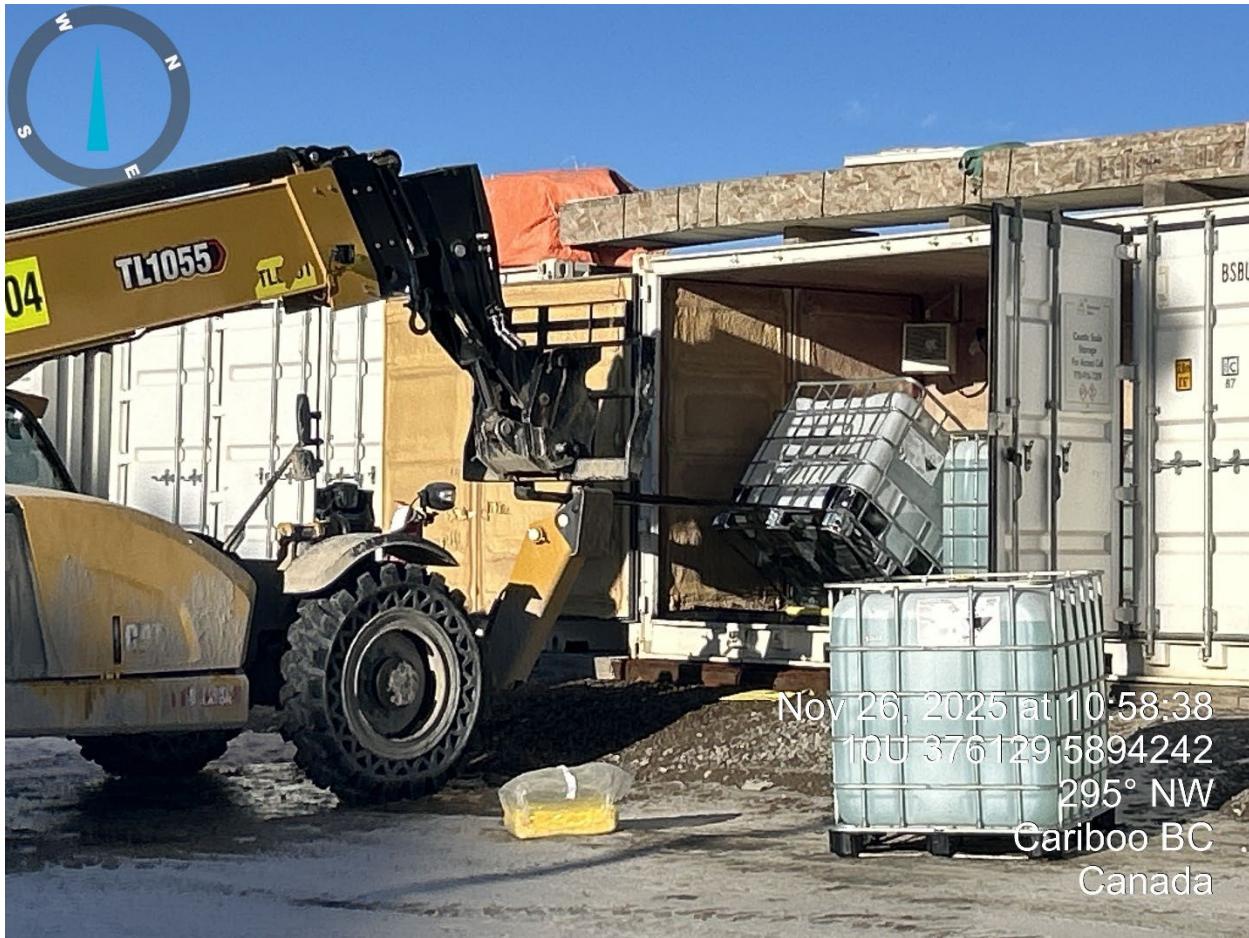
On November 26, 2025, an operator was placing totes of caustic soda into a storage sea can and punctured a tote in the second row with forks of the telehandler, resulting in a spill amount of 500L to ground. The affected location (10U 376107 5894241) (Image 7) was at the BWG warehouse laydown within the contained plant site footprint.

Image 1: Spill location with telehandler forks holding tote to prevent further spillage

Source of the spill was stopped by tilting the punctured section up so remaining liquid would not spill out. A portion of the released spill was contained within the sea-can built in secondary containment, and a tertiary berm was constructed around the spill area on construction aggregate ground to further contain the remaining release. Spill response included deploying chemical sorbent pads and absorbent organic compound on spilt material and a vac-truck deployed to remove pooled liquid for disposal in the tailings storage facility. Contaminated material was then excavated with heavy machinery into lined bags and transferred to a lined hazardous containment area for temporary holding. This material was then disposed of through the plant site crusher and processing mill.

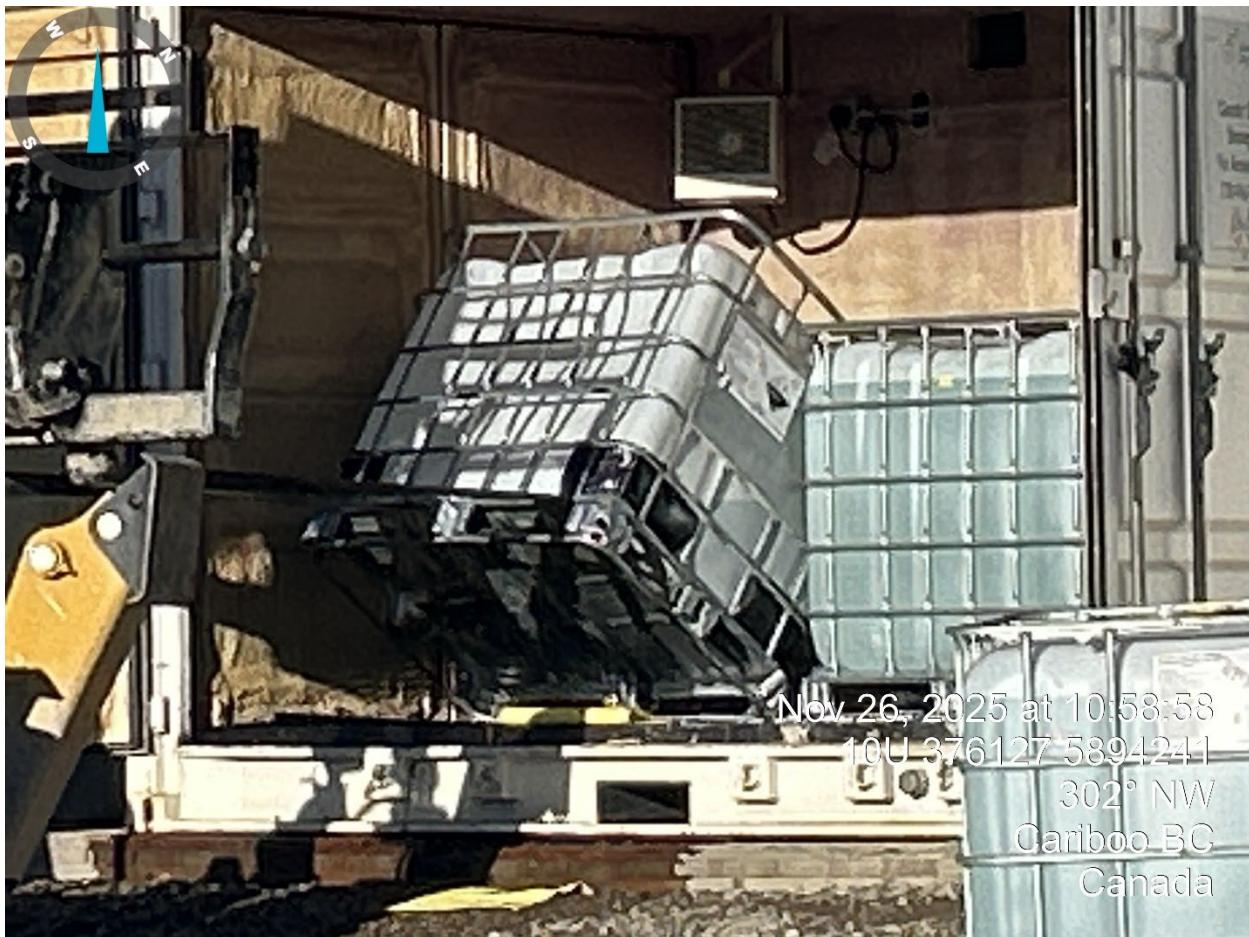
Image 2: Spill location close up

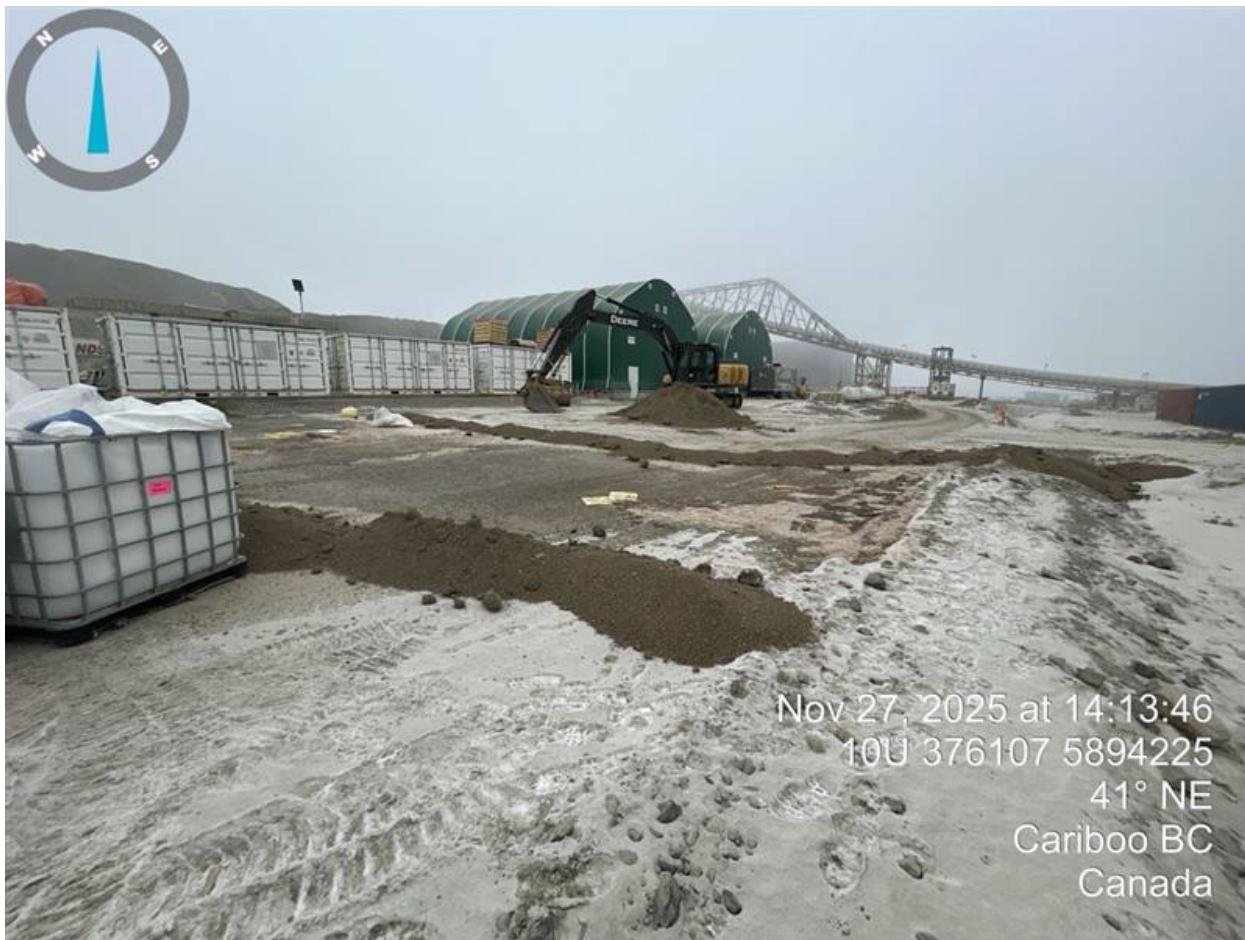
Image 3: Temporary berm constructed to provide tertiary containment for the spill.

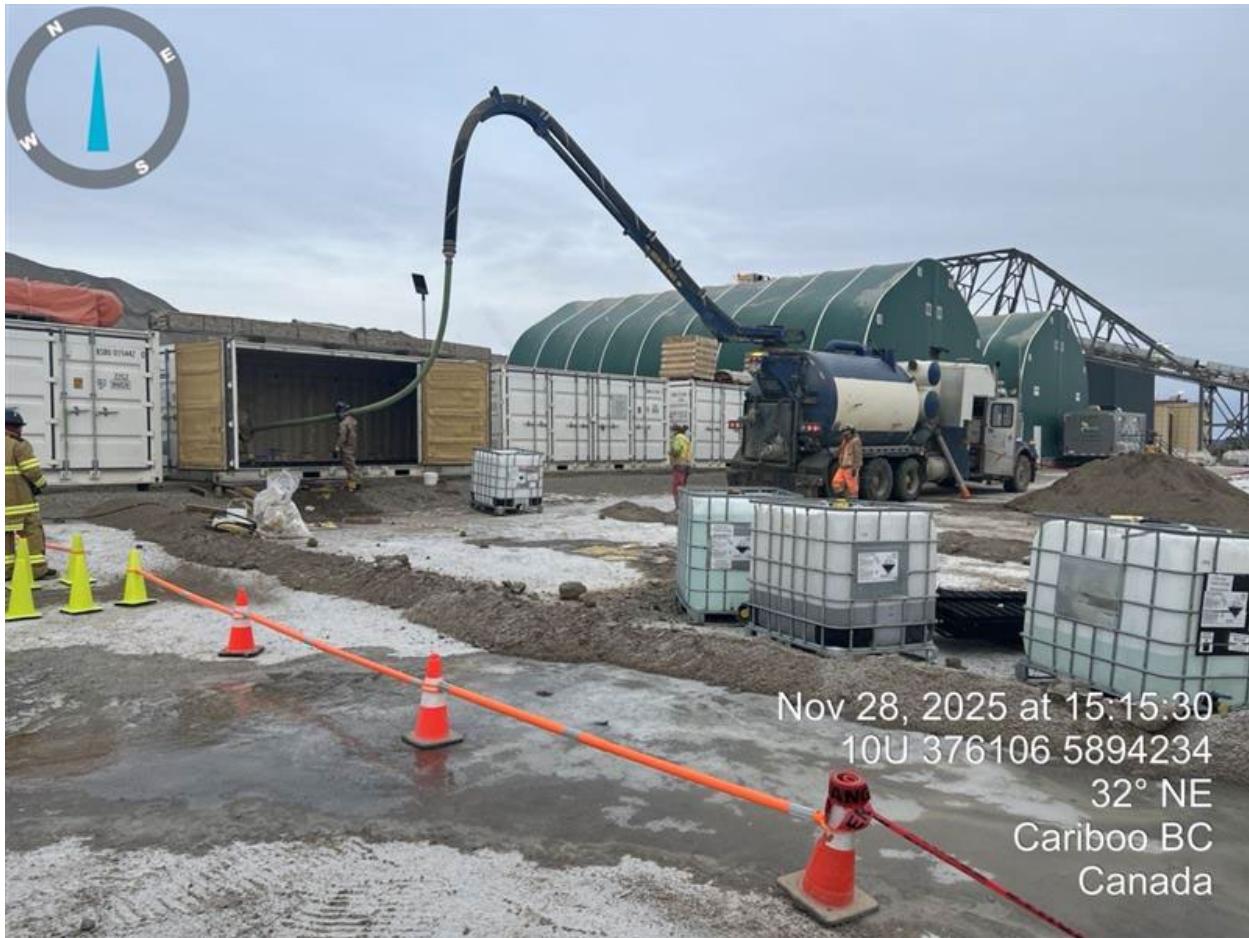
Image 4: Clean up of caustic soda within sea-canister with containment.

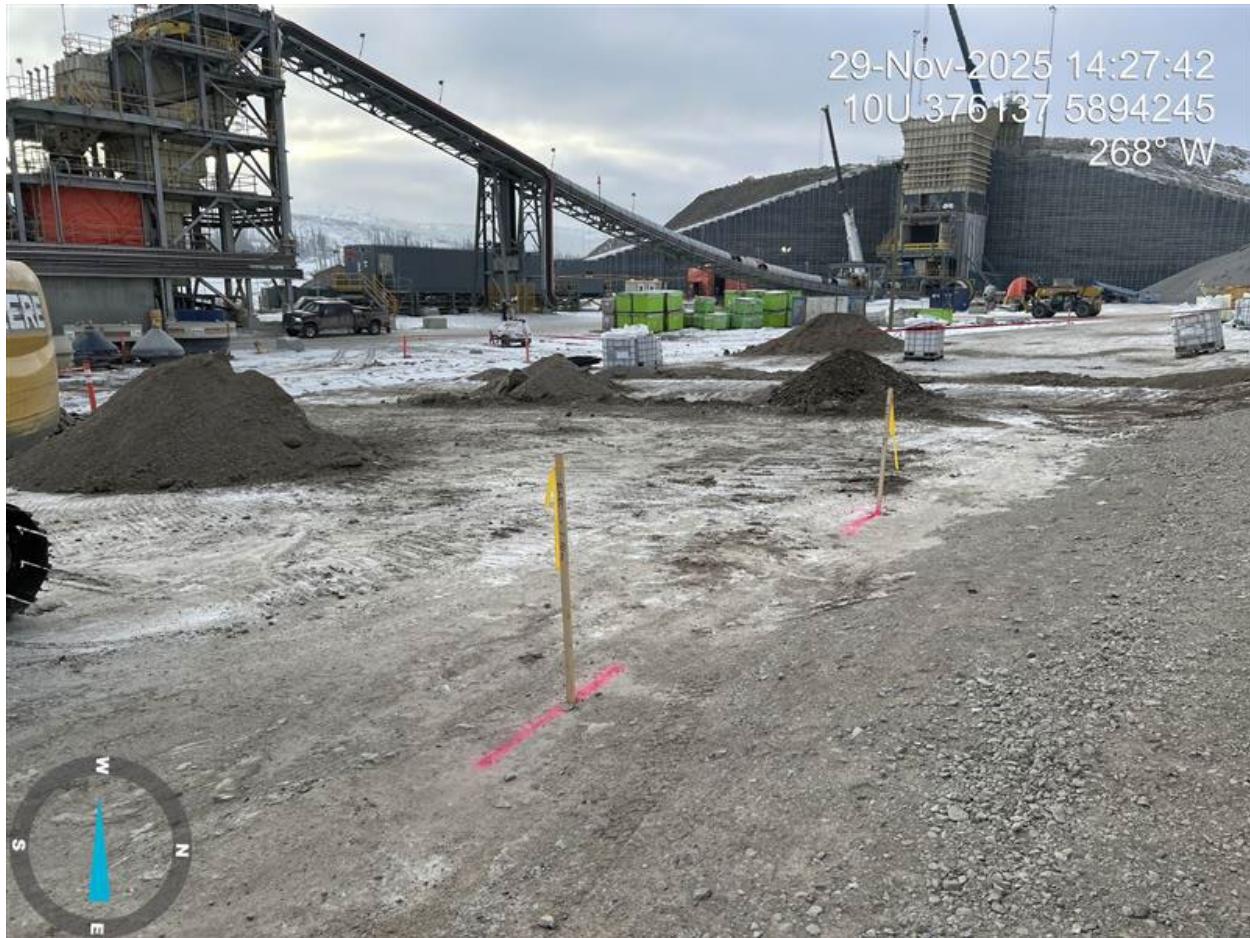
Image 5: Image of contaminated pile ready to be bagged and collected

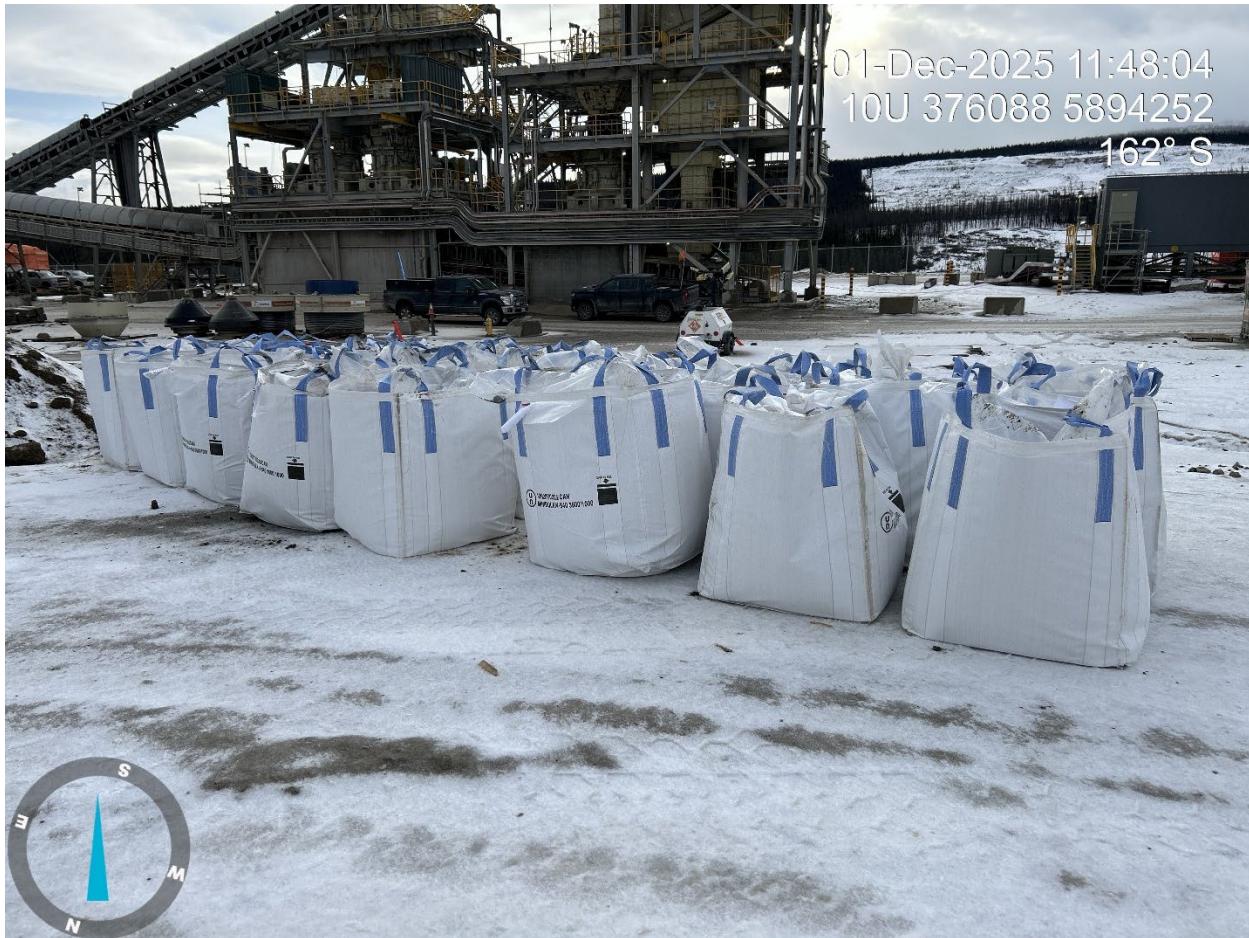
Image 6: Lined bags containing contaminated material prior to transfer to hazardous containment area for holding.
