Blackwater Mine

2025 Accidents and Malfunctions Summary Report

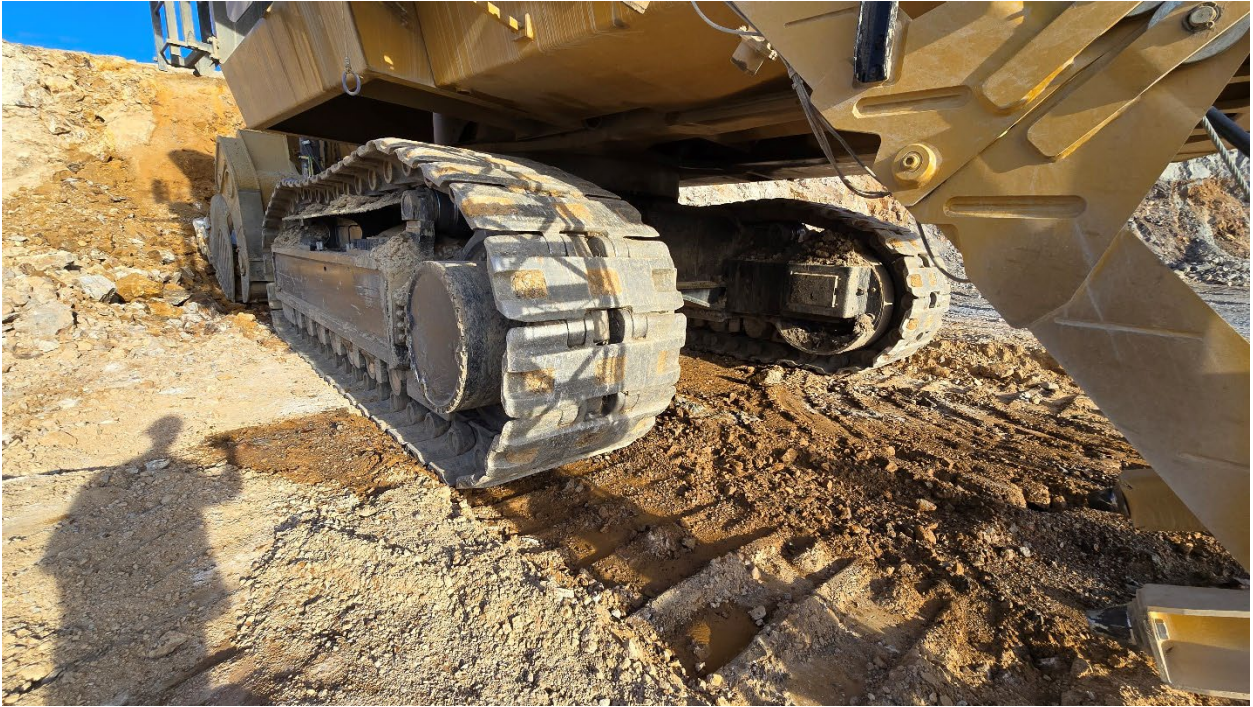
Photo One: Coolant Spill

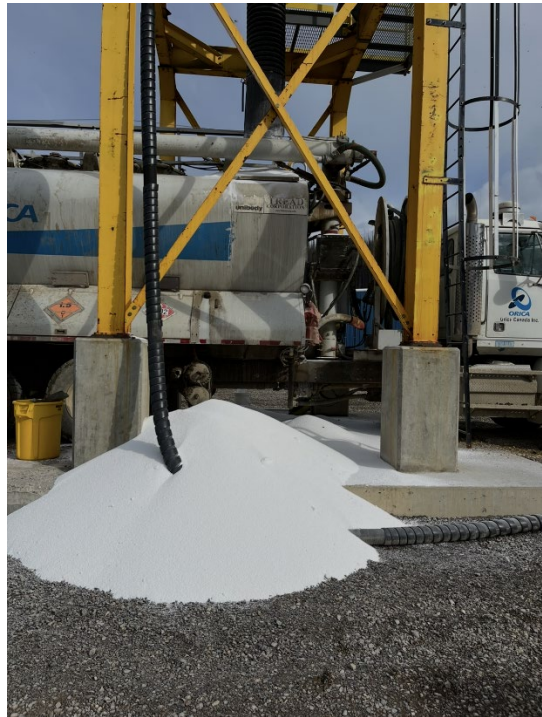
Photo 1: Spill Photo

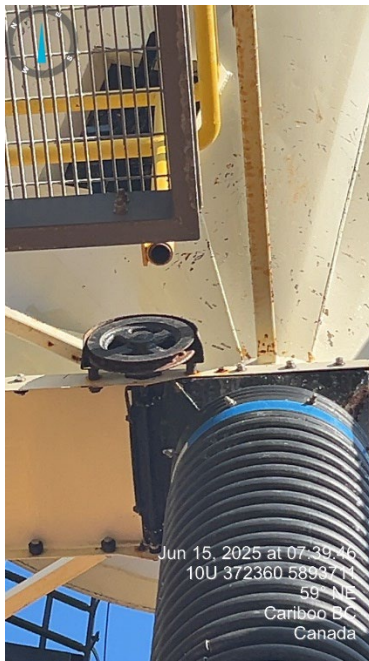
Photo 5: Gate Malfunction

Minor	June 14	Mixed mobile unit truck was filling tank with dry Ammonium Nitrate prill product when gate closure mechanism malfunctioned leading to an overflow and spillage. Spill site was Orica Laydown. Material affected was general construction aggregate, packed material for a laydown with no vegetation present. Closest watercourse was 475 m away, Mine Creek.	June 15	July 25	N/A	Investigation was done for mechanical issue of the gate closure, and they are working towards a more robust system to limit future failures.
Moderate	June 24	A slope failure was identified that resulted in the deposition of natural materials (soil, vegetation, etc.) into Davidson Creek.	June 25	July 25	N/A	<p>The area will be visually monitored and corrective actions taken if required and only when it is safe to do so. Monitoring will also continue under BW Gold's surface water quality sampling program. Resources at the mine are available to support monitoring and corrective actions as needed. Post event sampling and monitoring measures that occurred are listed below:</p> <ul style="list-style-type: none"> Bank Walks (800 m) Upstream SWQ Sample Downstream SWQ Sample SWQ Sample at DC-05 (approximately 800 m downstream) Gauges placed in downstream (to identify sediment deposition)

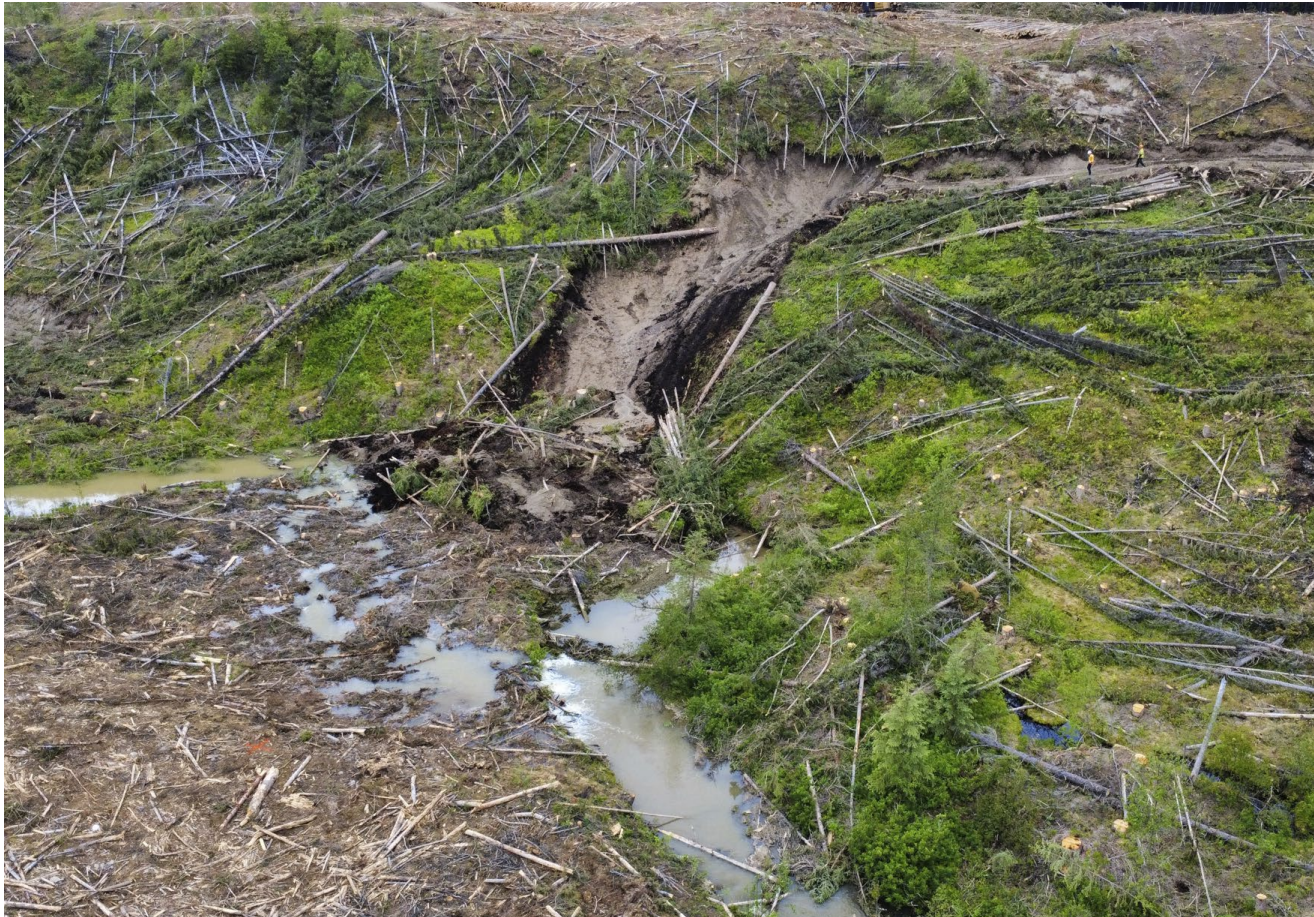
Photo 2. Aerial overview of slope failure impacting Davidson Creek post-incident.

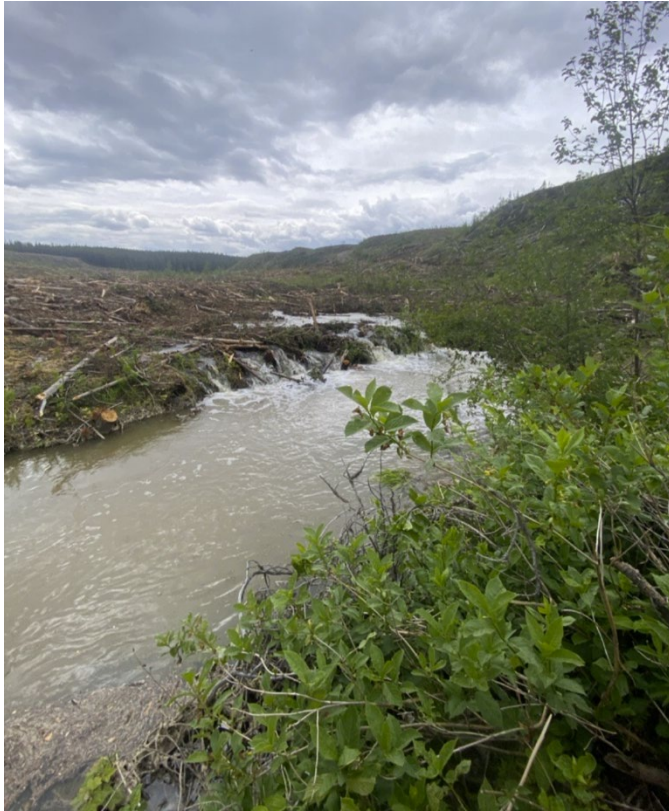
Photo 3. Ground photo depicting water circumventing the failure location and returning to Davidson Creek downstream.

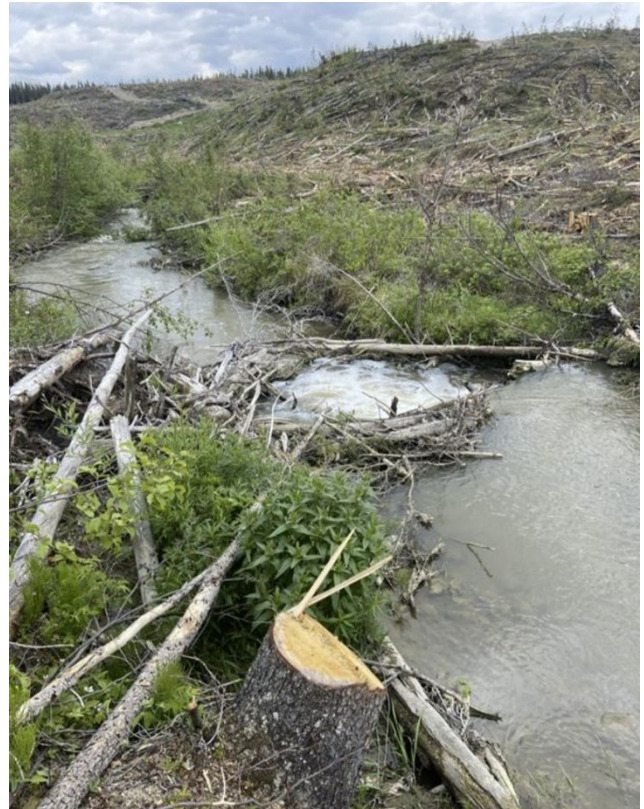
Photo 4. Downstream ground photo of Davidson Creek confirming wetted stream width maintained post-incident.

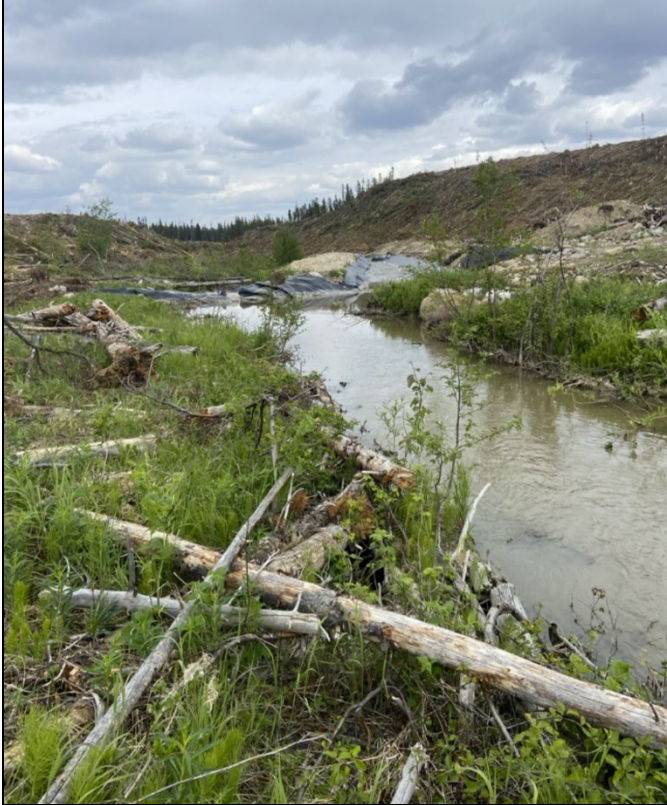
Photo 5. Downstream ground photo of Davidson Creek confirming wetted stream width maintained post-incident.

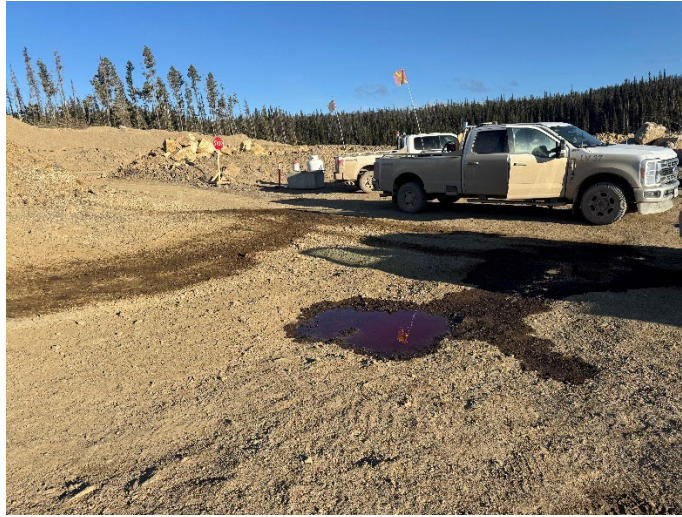
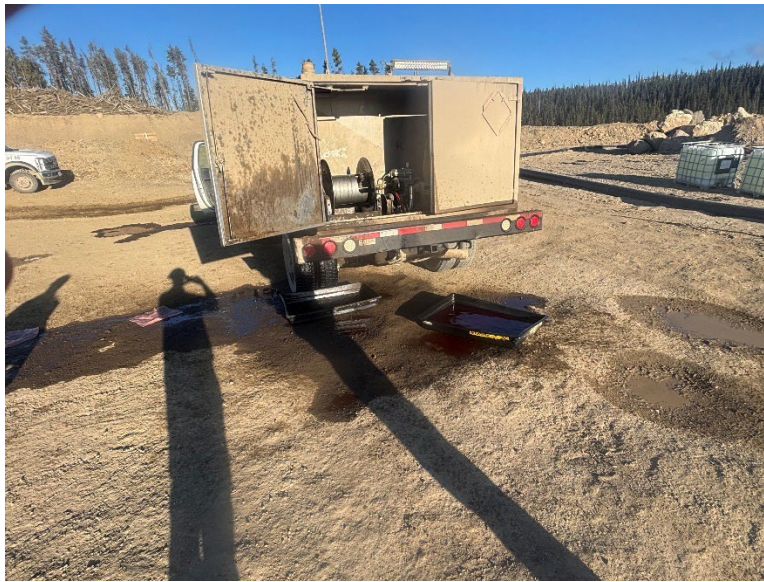
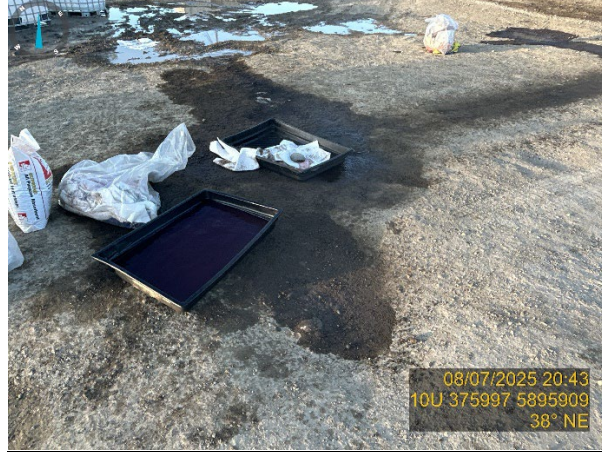
Photos 1: Spill Photo

Photo 2: Spill Photo

Photo 3: Spill Photo

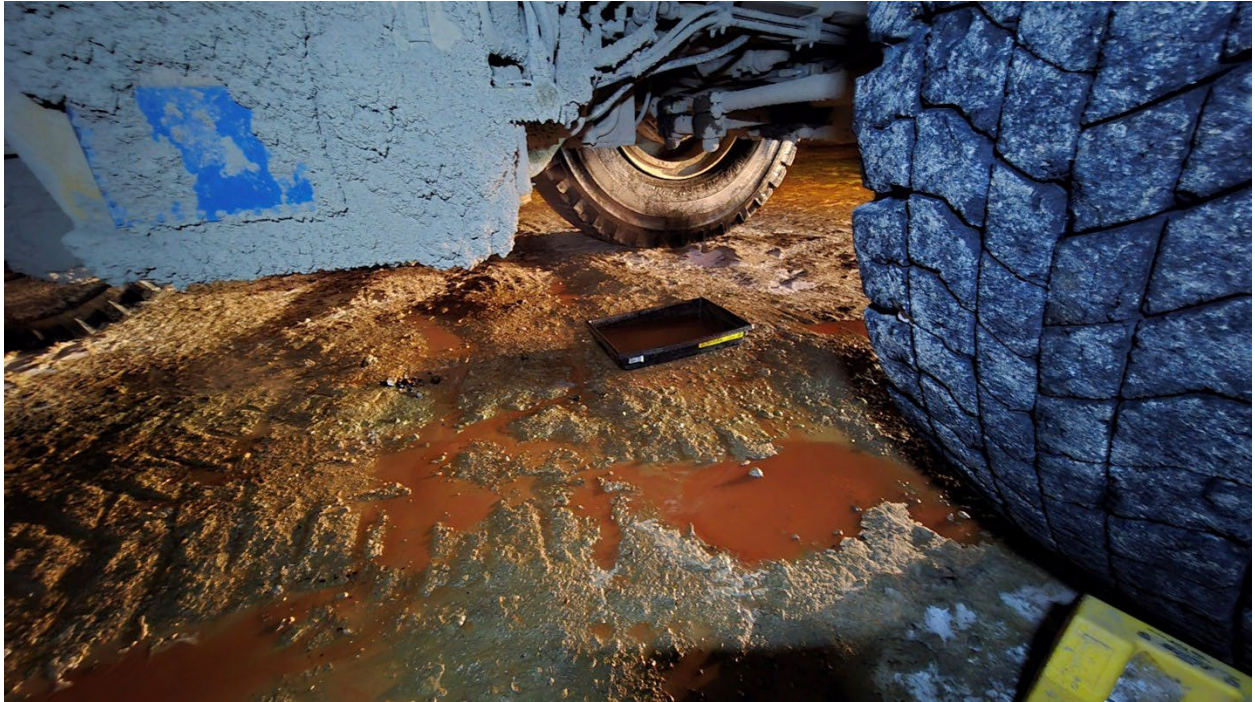
Photo 1: Immediate Spill Photo

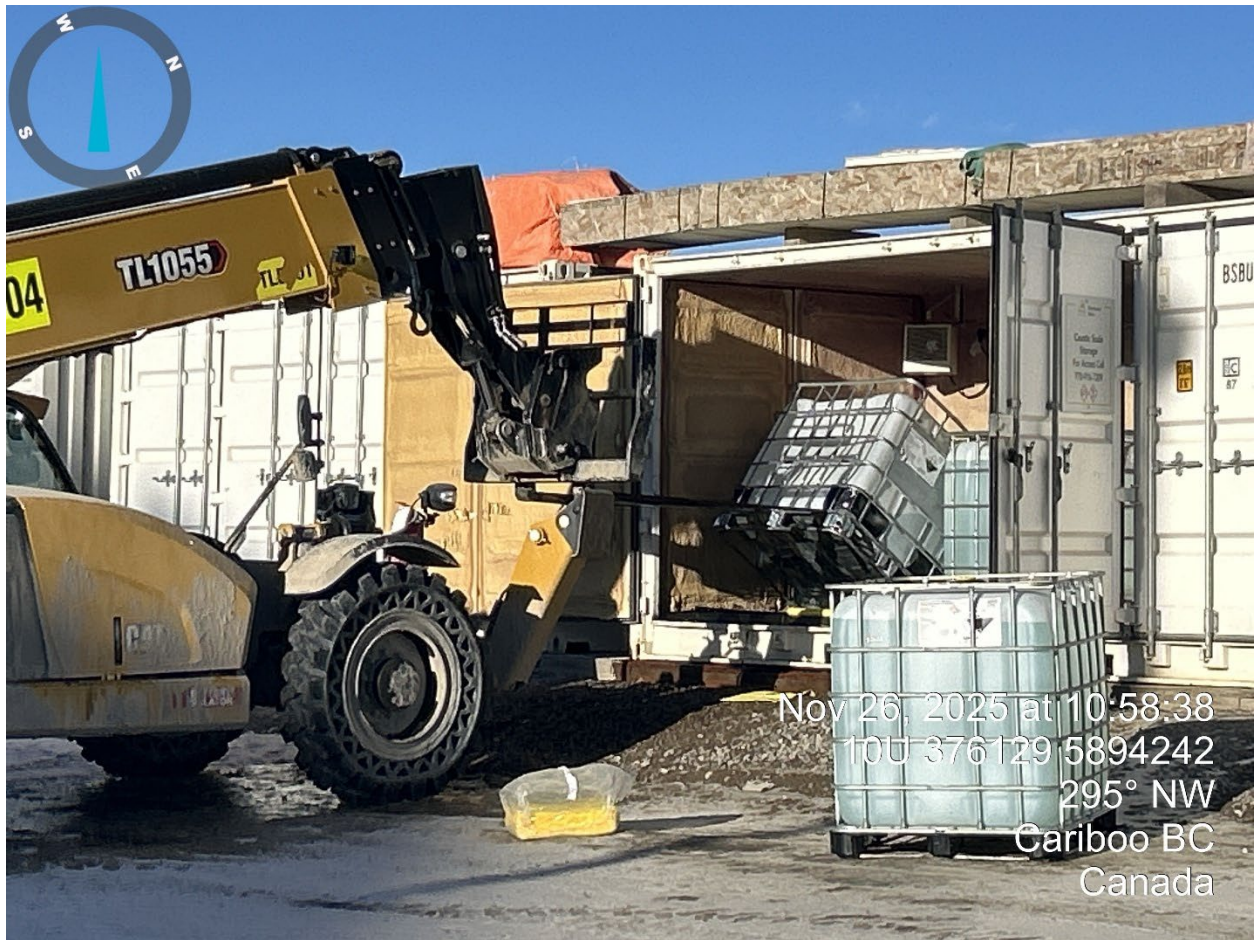
Image 1: Spill location with telehandler forks holding tote to prevent further spillage

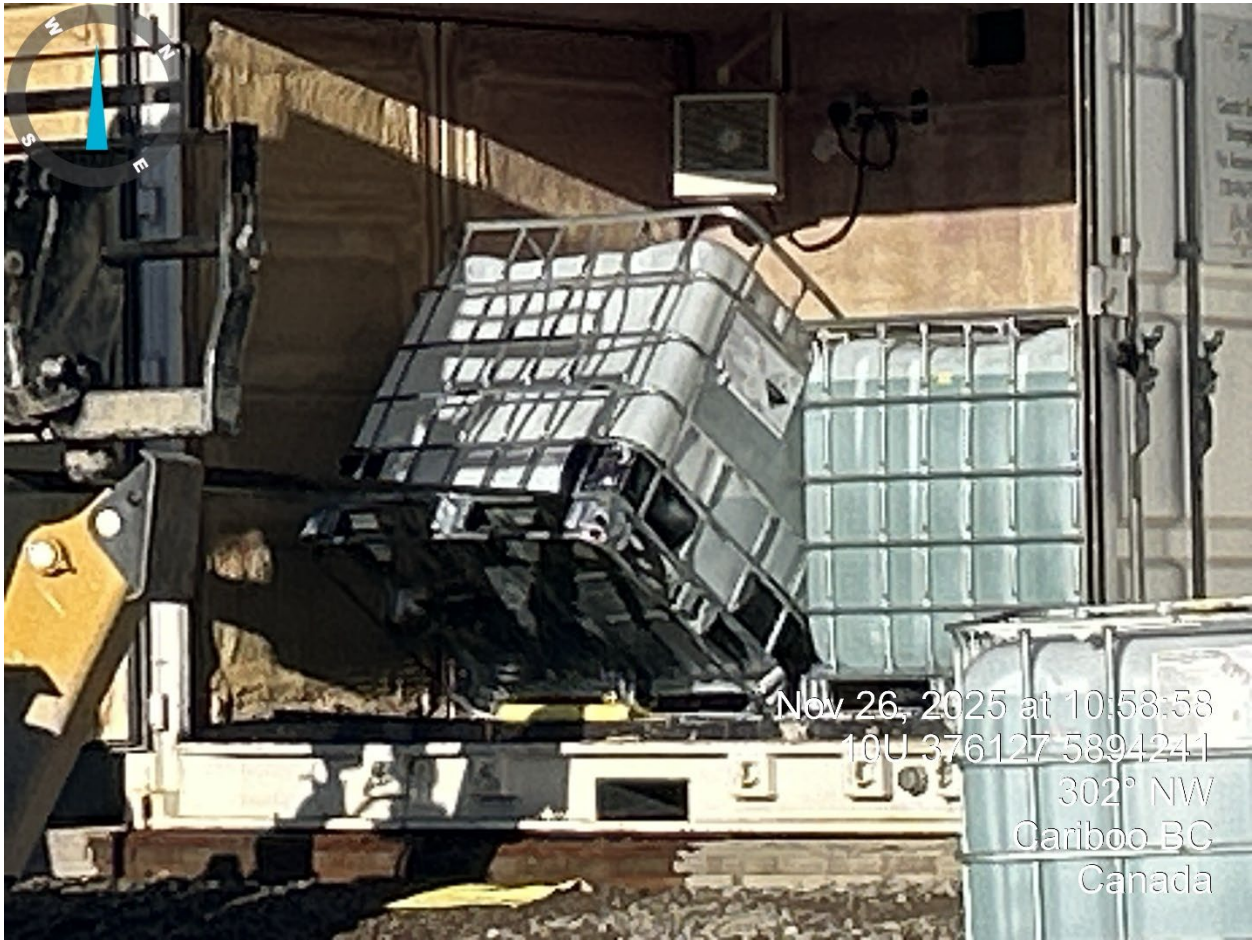
Image 2: Spill location close up

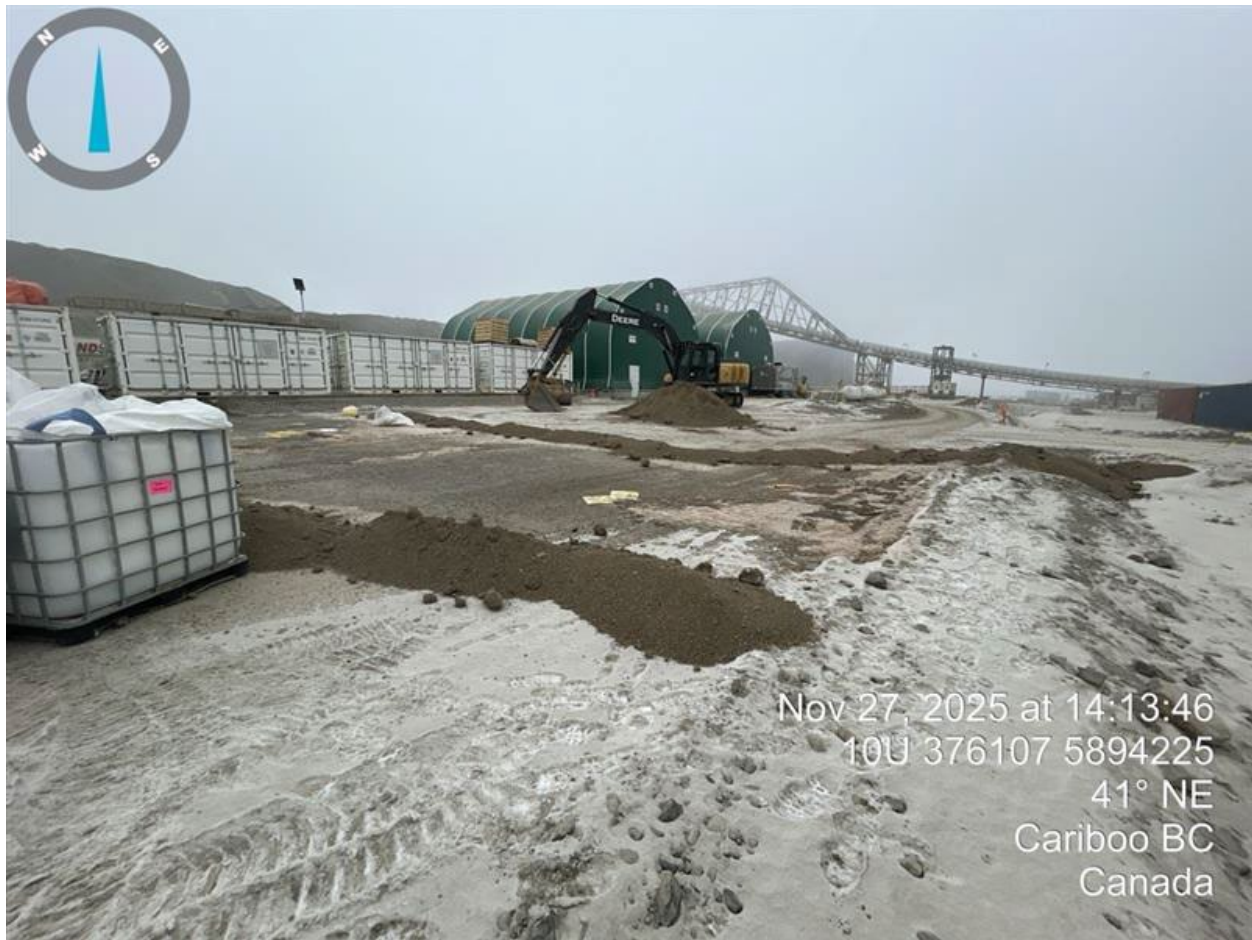
Image 3: Temporary berm constructed to provide tertiary containment for the spill.

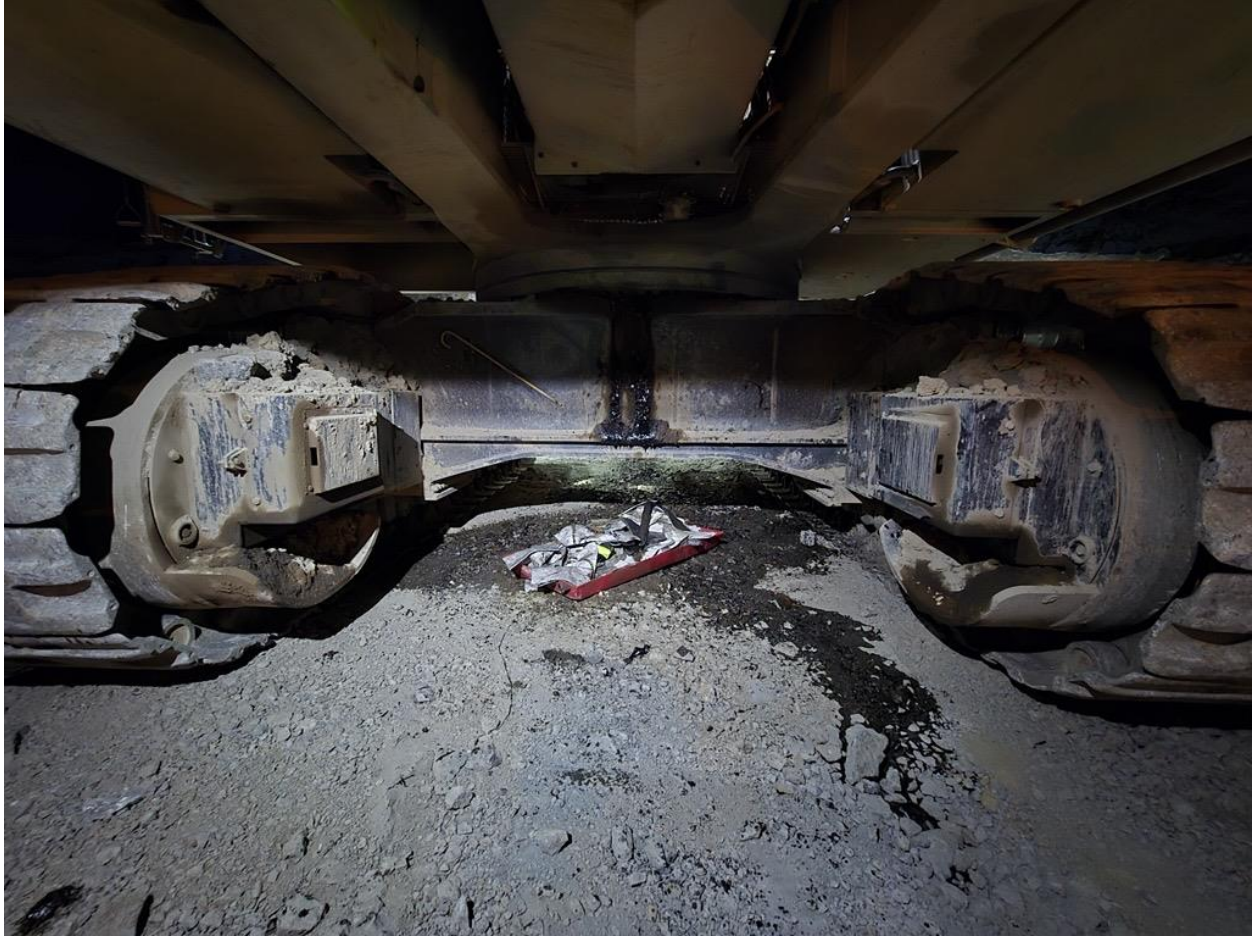
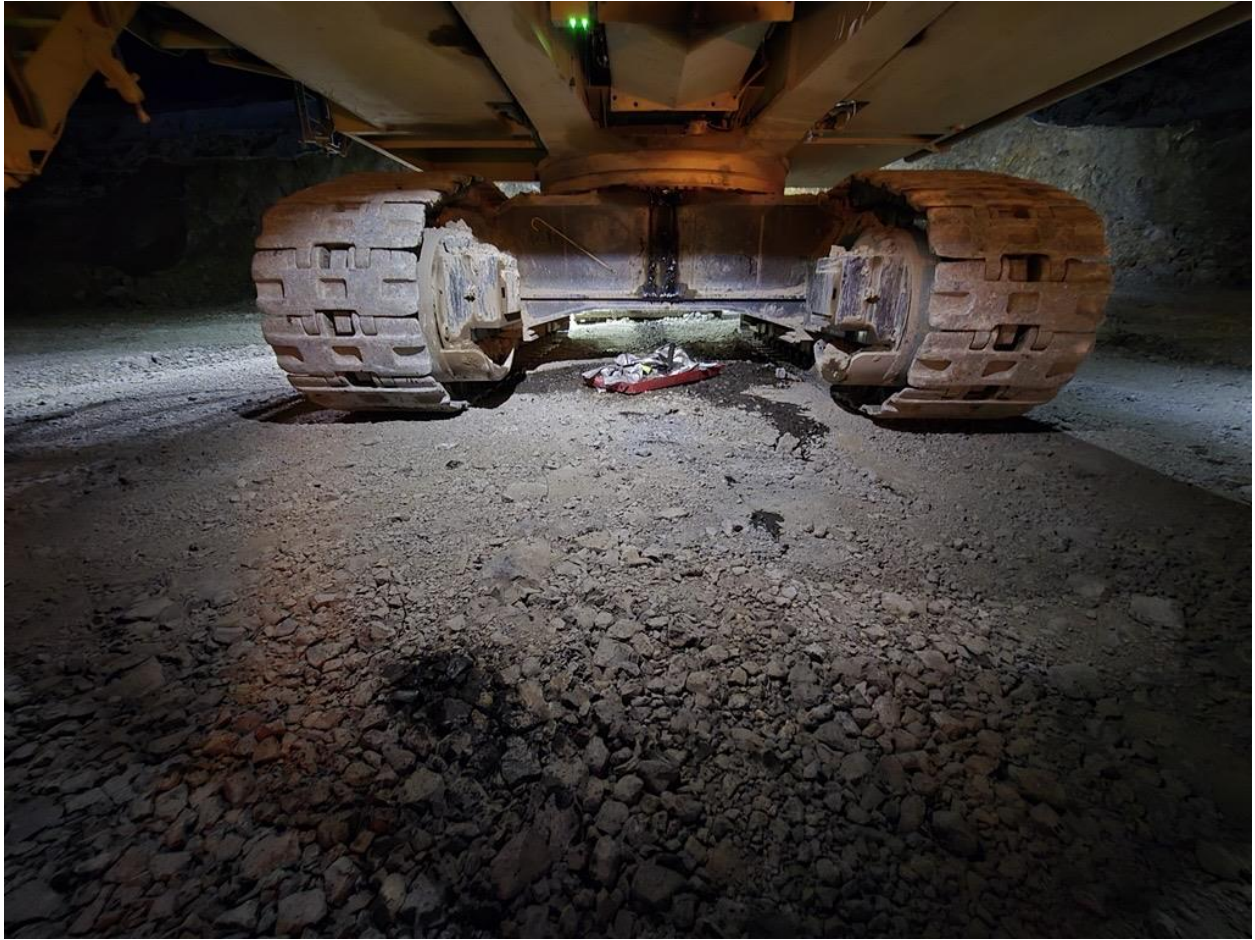
Photo 1: Immediate Spill photo

Photo 2: Immediate Spill photo

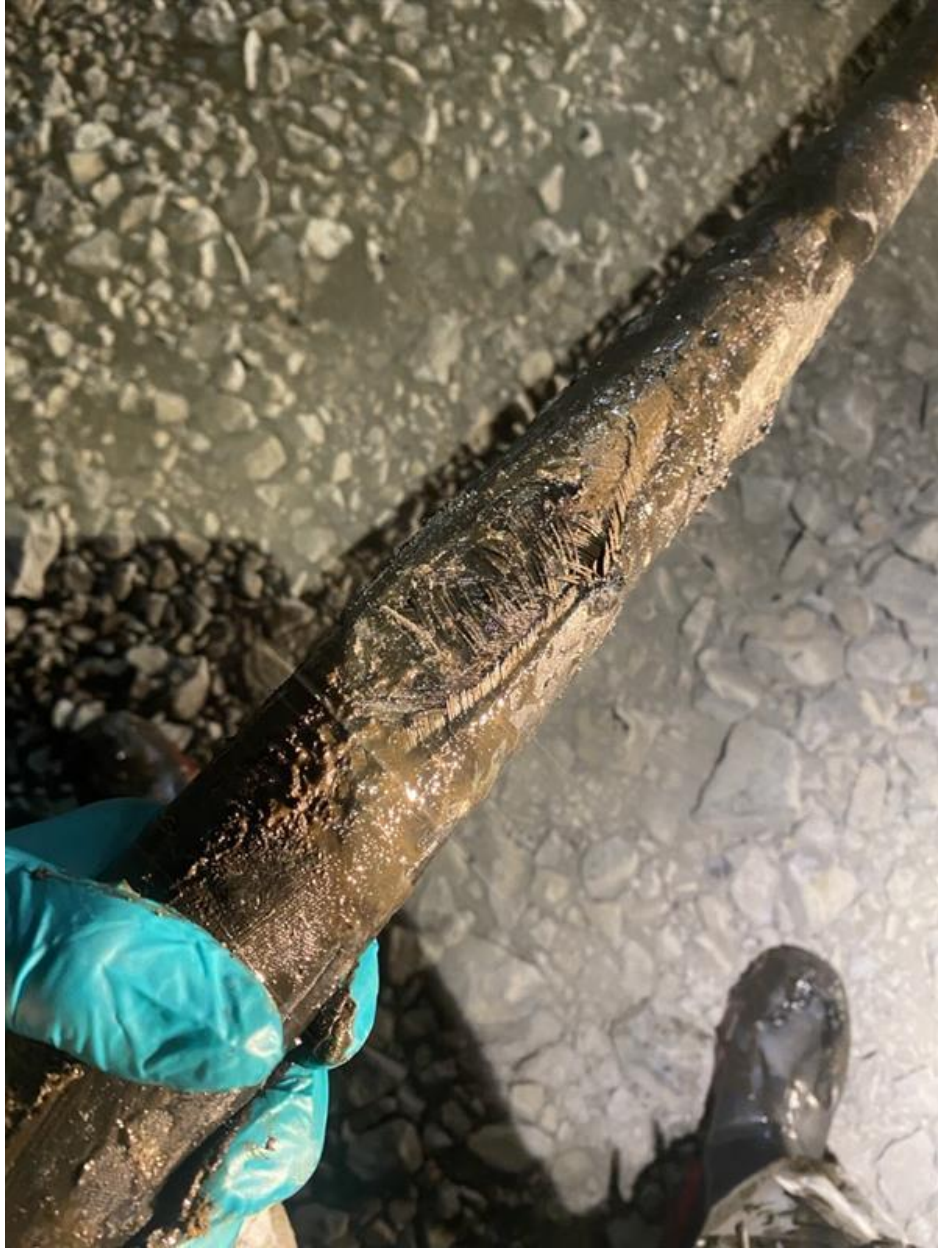
Minor	November 27	A hydraulic leak occurred in the swing circuit of the SH3601, resulting in the release of approximately 930 liters of oil. Of this amount, 500 liters were recovered by the lube truck from the deployed spill containment trays. A significant portion of the spill was effectively contained by these trays and absorbent pads.	November 27	December 22	N/A	<ul style="list-style-type: none"> Truck was shut down, Dispatch was informed. Maintenance was dispatched out to stop the leak. Spill tray placed under area of leak. Deployed absorbent pads around area Lube truck evacuated all surface hydrocarbon had pooled 988 loader collected all soiled material and loaded into 773 HT
Major	December 6	Operator was placing tote of caustic soda in reagents seacan and punctured a tote behind the one he was placing with the tip of his zoom boom fork that was protruding past the tote that he was placing.	December 7	January 6	N/A	<ul style="list-style-type: none"> Incident investigation resulted in corrective actions being identified and actioned including: Procurement of forklift collars to limit protrusion on other end of tote when handling totes. Procurement of materials to raise floor of sea can storage, increasing containment capacity. Procurement of materials to install external drain camlock and allow easier access for maintenance of secondary containment. Training audit for chemical handling of forklift staff. Phase 1A construction package has included installation of caustic soda bulk tank resulting in overall less chemical tote handling.

Photo 6: Hydraulic hose failure

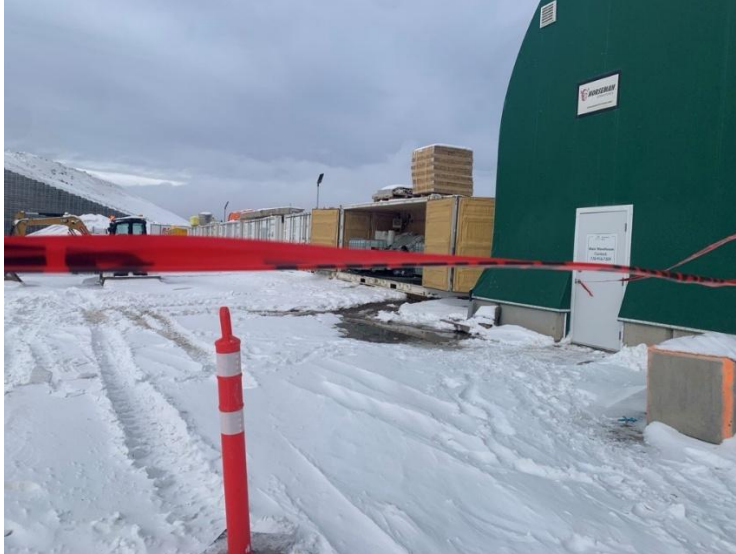
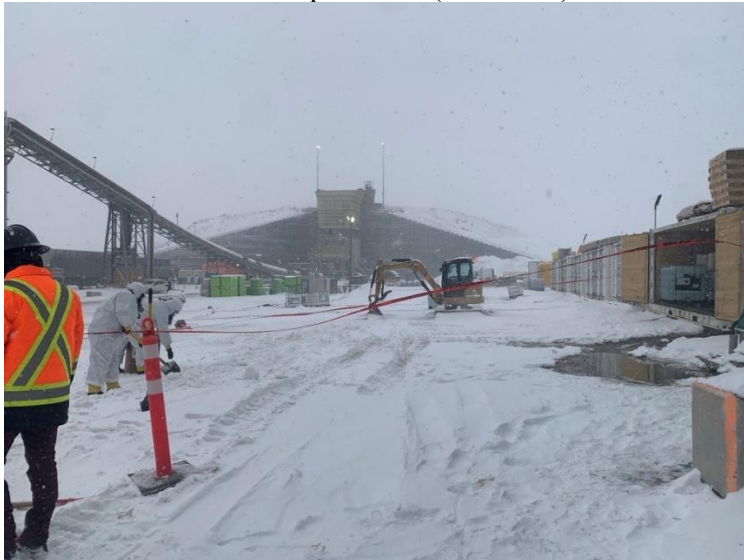
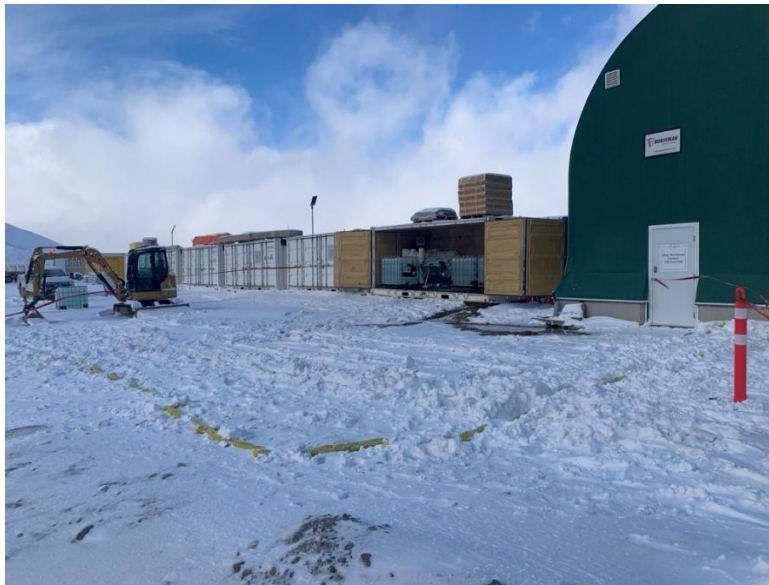
Photo 1: Spill Photo (12/6/2025)

Photo 2: Spill Photo (12/6/2025)

Photo 3: Spill Photo (12/6/2025)
